## At the Repair Bench – Conar 231 Tuned Signal Tracer – April 2024

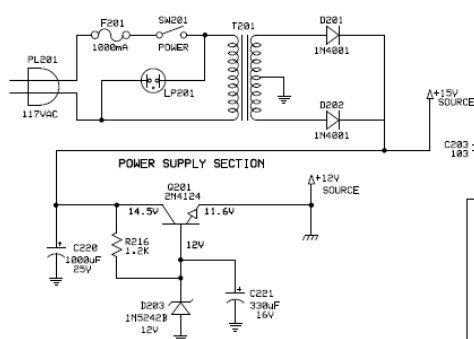
Figure 3 - Power supply section

On power-up, the +15VDC supply was found to be varying from about +6VDC up to about +19VDC, most likely as a result of heavy ripple imposed upon the source. The only possible cause of this ripple was the 1000µF filter capacitor C220. At the same time, the +12VDC supply was found to be dead. As a starting point, I removed and tested capacitor C220 and also C221 (the 330µF filter for the +12VDC source). The 1000µF capacitor turned out to be *extremely* leaky, while the 330µF capacitor was shorted. I replaced these two capacitors and went back to my testing routine. Now the +15VDC source was as it should have been, but the +12VDC supply was still dead. Voltage measurements at the 2N2124 pass transistor Q201 showed that the transistor was shorted, as was the 1N5242B 12V Zener diode. Replacement of both of these components restored the +12VDC source to proper operation.

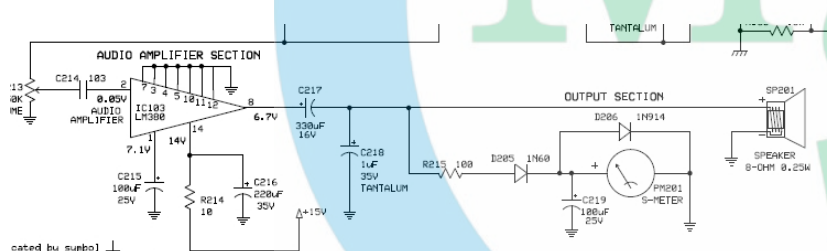
Figure 4 - Audio amplifier and output section

At this point, I thought that I had the problems solved, but it turned out that there was still another problem. In testing the operation of the signal tracer, I found that there was no audio from the speaker at all, and no activity at all on the front panel signal strength meter. It was

I fired up my signal generator and set it for a 1kHz sine wave output at about a half of a volt amplitude. I then injected that signal at the input of the LM380 audio amplifier, IC103 (Figure 4). There was no signal throughput to the speaker at this point. I checked all of the IC voltage readings and they were all right on the money, where they were supposed to be. That led me to the most likely culprit being C218, a 1µF/35V tantalum capacitor in a shunt position across the speaker. I removed and tested that capacitor and found it to be shorted. Replacement of the tantalum capacitor restored the audio operation to normal.

With three failed polarized capacitors in this unit so far, and considering the age of the unit and therefore its capacitors, I elected to go proactive and replace the remaining polarized capacitors, which included a pair of 100µF/25V axial electrolytics, a second 330µF/16V radial electrolytic, and a single 220µF/35V radial electrolytic. It was good repair practice to replace all of these capacitors based upon the rate of failure already seen and the overall age of the parts involved.
