# At the Repair Bench – Heathkit® HD-1234 – July 2022

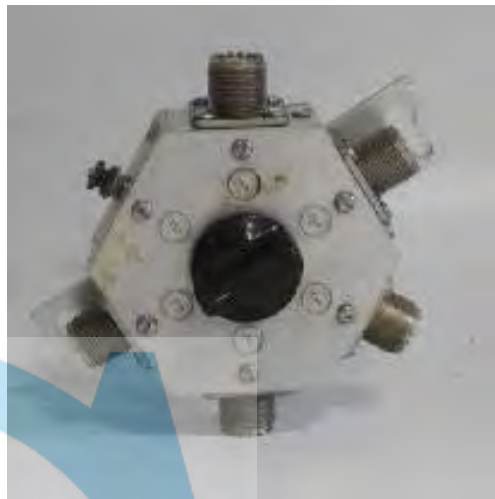
This unit has a six-position switch mechanism which connects each of the four live connectors to a common connector in turn as the switch is rotated. The device is of a hexagonal shape, with a standard SO-239 connector on each of five of the sides, and a ground post on the sixth side. The way the unit is designed, when a given position is selected, all of the other positions' connectors are grounded. The connectors are labeled “1” through “4”, “C”, and “G”. The internal switching mechanism has no physical stop, which means that it can be rotated a full 360° if so desired.
