## At the Repair Bench – Heathkit® IT-3121 Curve Tracer - February 2025

Figure 1 - Heathkit® IT-3121 Curve Tracer

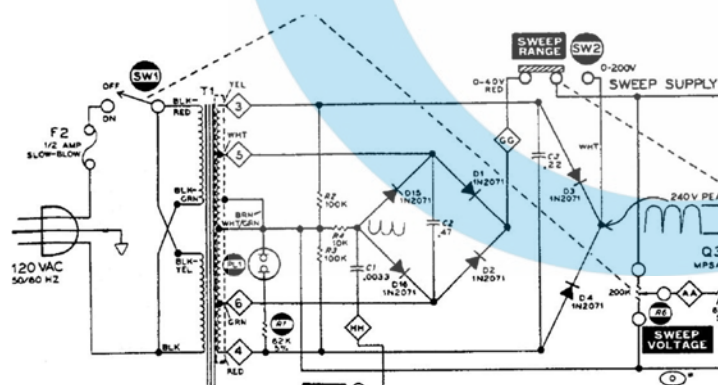
Figure 2 - IT-3121 sweep supply

A quick look at the schematic revealed that the IT-3121 has two separate internal power supplies, one of which is identified as the low-voltage supply, leaving the technician to assume that the opposite supply (*the sweep supply*) is a high-voltage supply. In fact, that supply provides output voltages as high as 200 volts. It also supplies AC to the neon lamp used as the pilot

A look at the schematic in this area (Figure 2) showed some likely candidates, so I set about taking some more measurements. The positive output of the full-wave bridge rectifier (or the collector of transistor Q13) should have measured about +22 volts, but this point in fact measured zero volts, meaning it was grounded. The most likely candidate here was the 200 $\mu$ F/25V axial electrolytic capacitor C5, whose job is to smooth the pulsating rectifier output somewhat. I opened this capacitor circuit, and voltage was restored at the Q13 collector. Replacing that shorted capacitor restored both the +15.5VDC and the +5VDC supplies. I used a 50-volt rated capacitor as the replacement – more about why shortly.

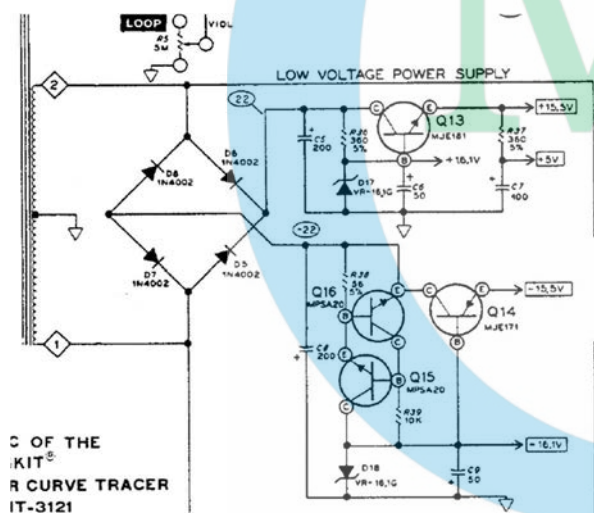
Figure 3 - IT-3121 low-voltage power supply

The fact that the pilot lamp was working simply meant that the incoming line voltage, the power switch, the main fuse, and the transformer primary winding were all intact, and it indicated that the HV supply secondary was also intact. This shifted my focus to the low-voltage power supply in the search for the problem. Some voltage measurements

showed that there were definitely some problems in the low-voltage supply. Specifically, the +5VDC, +15.5VDC, and -16.1VDC supplies were all missing. In fact, the only low-voltage supply that seemed to be present was the -15.5VDC supply.

Now for the -16.1VDC supply. In this case, I began by measuring the voltage at the collector of transistor Q15, and once again found it to be 0VDC, indicating that it was grounded and that Zener diode D18 was effectively bypassed. Once again, we were looking at a shorted capacitor, in this case, the culprit was the 50 $\mu$ F/25V axial electrolytic capacitor C9. As before, replacing the shorted capacitor resulted in the -16.1VDC supply coming back to life.

This entire unit uses only nine polarized capacitors, all aluminum electrolytics. There are four 10 $\mu$ F/25V radial types (C11, C12, C13, and C14) – all in the step generator circuit. There are two of the 200 $\mu$ F/25V axial types, one in each of the two low-voltage power supply sections, the positive supply and the negative supply. There are two of the 50 $\mu$ F/25V axial types, again one in each of the two low-voltage power supply sections, and finally one rated 100 $\mu$ F/35V, placed in the +5VDC part of the positive low-voltage power supply.

Note that the 200 $\mu$ F capacitors were rated 25V, and are used in  $\pm$ 22VDC circuits. Depending upon specific component tolerances and actual line voltage levels, these capacitors may have been operated at a point in excess of their rated voltage limits. For this reason, I elected to upgrade these capacitors to 50-volt types instead of the original 25-volt rating. In fact, in all cases, the working voltages of the capacitors were increased, partly due to smaller modern component sizes and my desire to keep to components of the same approximate physical size so that they fit the PCB placements properly.

Based on the age of this unit and therefore the associated ages of these electrolytic capacitors, I decided that it was worth replacing all of them with new.
