# At the Repair Bench – Icom IC-3210 – July 2023

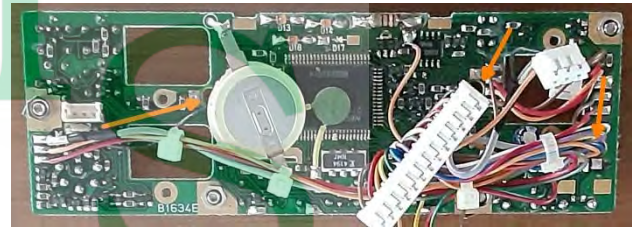
Figure 4 - Logic PCB with lamp holes indicated

The backlight problem was one that was to be expected with a radio of the age of this particular unit. The front panel on this model is backlit by a set of three T-1 12VDC incandescent lamps that are soldered in place on the front panel printed circuit board (PCB), called the *logic board* by Icom. Each of these lamps is covered with a yellow plastic boot (Figure 2) that provides the desired color to the illumination provided. The lamps sit down into holes in the PCB (Figure 3 & Figure 4) and have their wire leads soldered to pads on the PCB. The PCB holes index with recesses in the front panel carrier housing, directing the provided light into the rear area of the panel. All three of the lamps were burned out.

While replacements for the original lamps are readily available from standard component sources. I decided to replace them with LED's instead, so as to preclude the probability of a repeat failure of the backlight system. In order to access the PCB and remove the failed lamps, the front panel subassembly must first be removed from the radio chassis, and then further disassembled. This involves removal of the steel frame and the plastic front cover, followed by removal of the three rotary controls. Finally, the LCD panel and its insulator can be removed by

Once the PCB is stripped down as far as is possible, removal of the lamps was a simple matter of heating their soldered lead connections and lifting the lamps out of their holes. I then cleaned the excess solder off the pads using a soldering iron and some flux-impregnated braided solder wick.

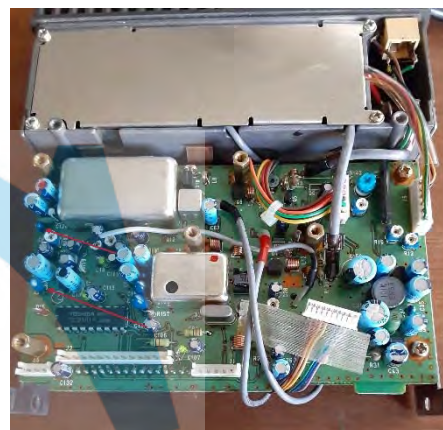
Figure 6 - Locations of failed capacitors

the main PCB are known to fail together with this switch. What happens is that two tantalum capacitors, C87 (0.22 $\mu$ F/35V) and C97 (4.7 $\mu$ F/35V) (Figure 5) have a tendency to fail with high leakage, causing the UHF phase-locked loop circuit to lose phase lock. The user causes the switch damage by repeatedly working the switch, often aggressively, in an attempt to get the radio to lock onto the UHF band. This action causes the switch to become fatigued internally, leading to the switch failure found on this unit. As a result, the switch merited replacement, as did the two tantalum capacitors. On testing of the removed capacitors, they both had extremely high DC leakage values, and had ESR readings of 14.6 $\Omega$  for C97 and 9.3 $\Omega$  for C87.
