## At the Repair Bench – Icom IC-703 – November 2024

Once in a while, a job will come in that is simple and straightforward, but is still a pain in the behind to complete. This is one of those situations. In this case, the job is the replacement of the output transistors in an Icom IC-703 QRP transceiver. This unit came to me with a diagnosis report from an authorized Icom repair facility. The owner had, at the time that the radio was evaluated, not wanted to spend the money that the repair facility quoted to repair the radio. Now, five years later, the radio ends up on my bench because the owner decided to go ahead and have the repairs made.

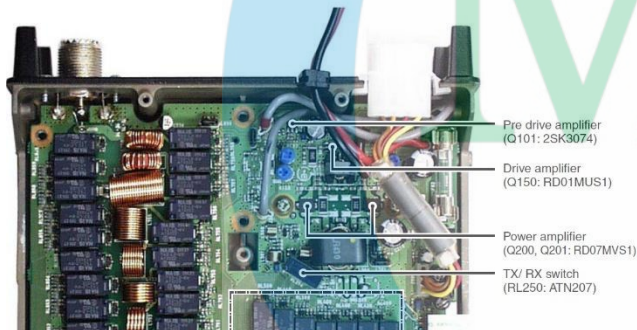
Figure 2 - IC-703 output chain transistors

The transmit signal was present at healthy levels through the pre-driver Q101, a 2SK3074, and the driver Q150, an RD01MUS1 type, both of which are N-channel power MOSFETS. The signal, however, was lost through the power amplifier transistors. This was a simple matter of tracing the signal through the radio using an oscilloscope.

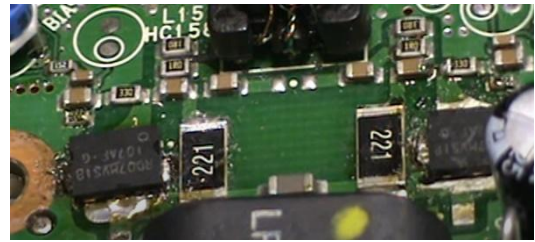
The biggest problem was actually in sourcing the transistors. These transistors, commonly referred to as “final” or “output” transistors, are in fact the last stage of RF amplification before the output RF signal is directed to the antenna for transmission. They are RD07MVS1 devices, and are N-channel enhancement-mode power MOSFETS made by Mitsubishi. The only sources of these transistors appeared to be in China, and there was therefore, as always, the question of whether or not the received parts would be genuine parts or counterfeits.

Figure 3 - Power amplifier transistors

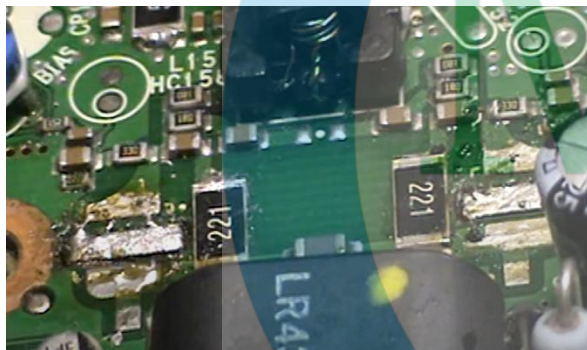
Figure 4 - Transistors removed but board not cleaned

Replacement of the transistors involved the use of focused hot air to de-solder the original transistors. I then used some solder wick to clean up the excess solder on the traces on the board, and cleaned the area afterwards

with some 99.9% IPA. The board was now ready for the installation of the new transistors.

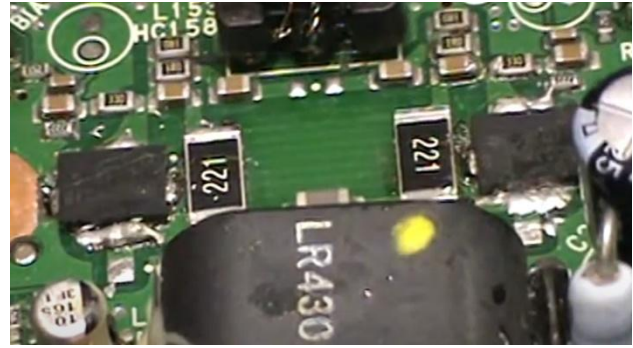
*Figure 5 - New transistors installed*

I applied some low-temperature CHIPQUICK® paste solder to the pads, and then applied plenty of liquid flux to the area, working with one of the transistor locations at a time. After positioning the transistor on the pads, I applied heat via the focused hot air again. This caused the solder to flow and to bond the transistor to the board. I repeated the process with the second transistor, and then cleaned up the excess flux with the IPA after the board had cooled.

Testing of the radio with a Bird 43 directional wattmeter into a dummy load showed that the output power was right where it should be, peaking at about 9.8 watts in CW mode, and easily reaching 9.5 watts in USB with a continuous 10kHz moderately loud audio tone into the microphone.
