## At the Repair Bench – Icom® IC-706 - November 2022

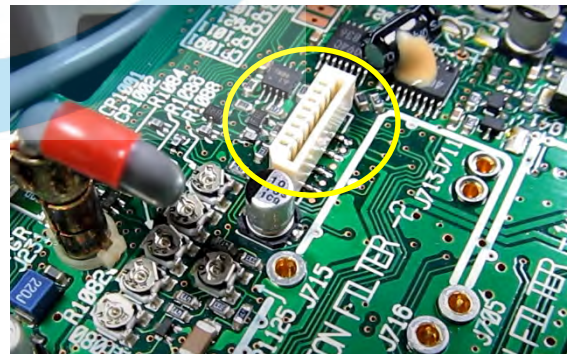
The Icom® IC-706 has a removable front panel, which connects behind the panel to a set of eight spring contacts, which in turn connect to the main PCB via a “flex circuit” or Kapton cable. Connection to the main PCB is made through the use of a top-entry edge connector that is surface-mount soldered to the main PCB. This connector was off the PCB and floating free inside the radio, tethered to the end of the Kapton cable.

Here is the part where the owner lost points... someone had been inside the radio and most likely pulled that connector off the board. How do I know this? Simple... the speaker connection (the speaker is mounted to the top cover) was unplugged.

The repair was simple enough. Fortunately, no damage was done to the PCB – all of the pads were intact and in fact had plenty of solder on them. All I had to do was to reflow the solder on the connector pins once I put the connector in position. Of course, I had to remove the FL-100 CW Narrow Filter and the FL-223 SSB Narrow Filter to allow clear work access to the connector location on the PCB. The Kapton cable itself was unhurt, so after I resoldered the connector in place, I was able to simply re-insert the Kapton cable into the connector slot.
