## At the Repair Bench – Icom IC-746 PRO – January 2025

Recently, I wrote about the repair of an Icom IC-756 PRO, wherein I replaced the VFO encoder. I had no sooner returned that radio to its owner when that individual presented me with another radio for repair. This time, it was an Icom IC-746 PRO (Figure 1), and the failure was in the realm of a lack of output signal from the radio as a whole.

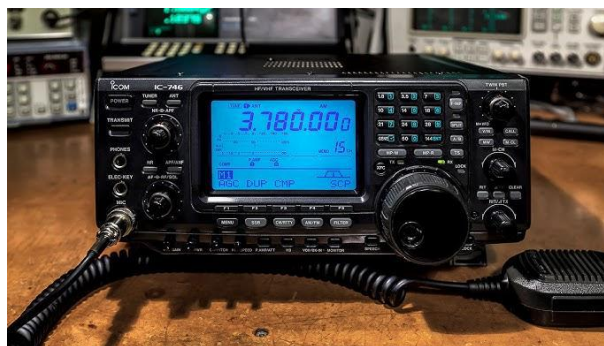
Figure 1 - Icom IC-746 PRO

output, it was found that the transmit power was nil on all bands and in all modes. The internet is full of stories about such or similar failures on this family of Icom transceivers.

With all of the failed parts replaced, it was time for the post-repair testing of the radio, followed by an alignment and tweaking job to ensure maximum performance. On delivery back to its owner, the radio performed flawlessly, making for a very satisfied customer.

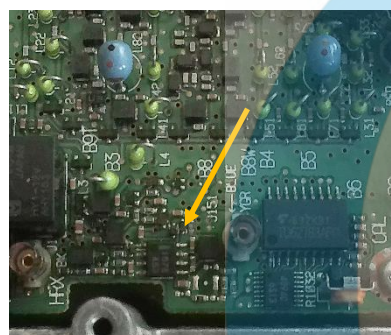
Figure 2 - IC151 location

There are some similarities among these web reports, with the most common cause being related to the failure of a component identified by Icom as *IC151* and referenced in the Service Manual as the wide-band *YGR Amplifier*. The conventional wisdom holds that this IC, which is an MMIC device, typically fails due to excessive heat being experienced by the IC. Investigation of this unit showed that the failures in this case went beyond the YGR amplifier, and affected the pre-driver transistor and both driver transistors.

The YGR amplifier, as already mentioned, is a surface-mount MMIC device carrying a part number of  $\mu$ PC1678G (Figure 2). The pre-driver is a silicon NPN power transistor in a TO-220 case. This transistor, a type 2SC1971, is obsolete and is *extremely* difficult to find. Fortunately, there is a suitable replacement still available, though in very limited quantities. The NTE-342 transistor is a good match and will serve nicely in place of the original 2SC1971 transistor. One of the factors that makes for difficulty in finding a suitable replacement for the 2SC1971 is not the operating voltages of the device; instead, it is the fact that this device has an unusual physical arrangement in that the center pin and tab are emitter-connected rather than the much more common collector-connected tab arrangement.

Replacement of the YGR amplifier IC is best done with the board on which it is installed having been removed from the chassis. This is the board identified by Icom as the *RF Unit*, and the IC is installed in the vicinity of the mounting hole identified as Hole 4, near one corner of the board.

Removal of this IC is most easily done simply by first cutting two three-eighths-inch-long pieces of bare 22 AWG wire. Lay each of these wire lengths across the IC leads on each side of the device, and solder them freely to the leads. Then, apply the heat of the soldering iron to the wire lengths, one at a time, and heat the wire until the solder all along the wire has melted. At

that point, gently lift that side of the IC using the tip of a pick or a fine tweezer. Lift it carefully, and just enough to keep it free of the solder puddle. Repeat the heat-and-lift operation on the opposite side of the IC, and the part will be free. Clean up the pads with some solder wick and then with some 99.9% isopropyl alcohol (IPA). After the clean-up is done, tin the pads lightly with some fresh solder, in preparation for the placement of the new IC. This removal method is a useful trick for removing many multi-pin devices from a PCB, and can be used with a wide variety of device types.

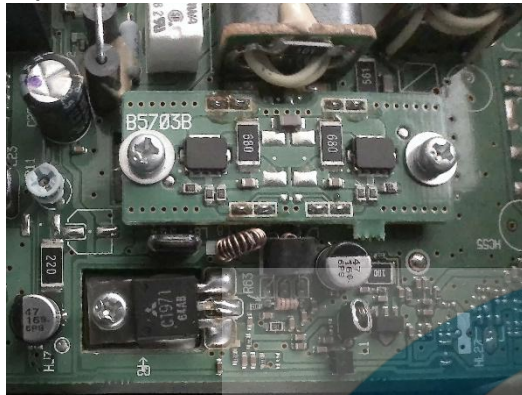
Figure 6 - Driver daughterboard

The driver transistors are a pair of 2SK2975 surface-mount N-channel enhancement-mode power MOSFET's. These transistors are mounted to a small daughter board that is equipped with a large heat-sinking metal base, directly to which the *source* connection is

Replacement of the driver transistors on their daughter board (Figure 6) required removal of the board from the chassis. This was a simple matter of desoldering four sets of four pins and removing two screws. While the transistors were the only items needing replacement on this board, it was actually easier to clear the board of all components and

to start with a clean board. This board holds a total of twelve surface-mount passive devices. These included (2) 100Ω 0805 resistors, (4) 1Ω 0805 resistors, (1) 150Ω 0805 resistor, (2) 68Ω 2512 resistors, (2) 0.1µF 0805 capacitors, and (1) 22pF 0805 capacitor. The reason that it was best to wipe the board clean was because of the high heat developed in the heatsink first in removing and then in installing the driver transistors. The heat of removal was sufficient to “float” the nearby components.

Once the board was stripped and cleaned, paste solder and liquid flux were applied to the board and heatsink, after which the driver transistors, one at a time, were installed, soldering them in place via the application of focused hot air. Then, it was a simple matter to replace the passives, using the hot tweezers to install each of those devices.
