# Icom IC-756 VFO Encoder Repair

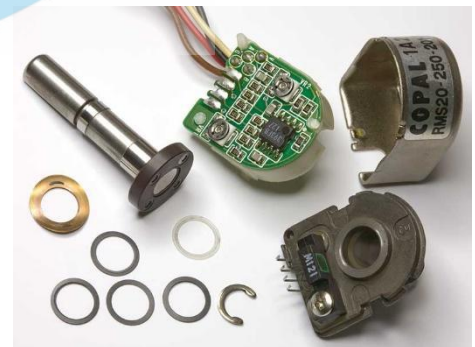
Figure 3 - Encoder fully disassembled

For now, let's take a closer look at the encoder. This encoder, shown fully disassembled in Figure 3 and unlike many that are found in amateur radio applications, is magnetic rather than optical. Physically, there is a wheel that is mounted to the shaft and therefore rotates with the shaft. This wheel consists of a

series of small magnets mounted into an epoxy structure. Mounted in close proximity to the rotating magnet set is a Hall-effect sensor unit that puts out two separate signals in response to the motion of the magnets. These signals are basically sinusoidal and are out of phase with each other by ninety degrees. The leading/lagging relationship can be used to determine direction of rotation. These signals are processed on the PCB that is mounted to the encoder body, converting them into a series of square-wave pulses of varying duty-cycle or pulse width. The width of the pulses produced is directly proportional to the rotation speed.

Unfortunately, there is another failure mode for these encoders. The circumstance can exist whereby the encoder produces a single pulse train in its “normal” condition, but if the shaft is held outward or away from the body of the encoder, it will produce both pulse trains. The user indication of this condition is the fact that when turned normally, the VFO seems to “skip” or jump in steps rather than varying smoothly. However, if the VFO knob is pulled outward while it is turned, the VFO adjustment seems to vary normally. I have seen this failure mode a few times, and the solution in every case is to replace the encoder *unless you have a source of proper shim washers*. I believe that in these cases, the cause is the disintegration of one or more shim washers that start out life on the shaft of the encoder, between the magnet wheel and the body of the encoder. In every case with this type of encoder failure, it has been accompanied by a fine black powder emanating from the encoder, coming out along the shaft. These shim washers can be seen in the photo of the disassembled encoder presented earlier.

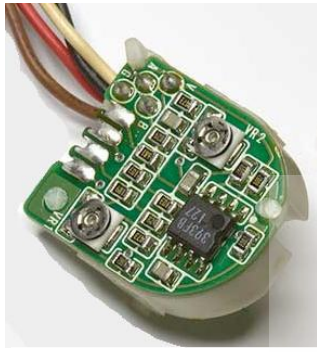
Figure 4 - Encoder PCB

The processing circuitry is comprised of an LM393 dual comparator IC, a pair of potentiometers, and several resistors and capacitors. While the LM393 is primarily responsible for the square or digital shaping of the pulse train, the pulse widths of the two separate pulse trains generated must be equal (or *balanced*) in order for the pulse trains to be meaningful and reliable. This balance between the independent spontaneous widths of the two pulse trains is adjusted via the twin potentiometers on the circuit board, with each potentiometer affecting one of the two pulse trains.

There are four wires attached to the PCB (Figure 4), as well as the four leads from the Hall-effect sensor body. The wires are as follows:

The LM393 comparator IC used in this encoder is in the SOIC-8 package, a surface-mount type measuring a mere 4mm x 6mm body size. It is best removed using some solder wick to pull most of the solder out, and then using a dental pick and the soldering iron to heat and gently lift the chip at the same time, one side at a time. Be careful not to overheat the PCB or to pull traces off the board, because at that point, the encoder must be replaced. Work slowly and carefully, using limited heat, and you should be successful.

Once the IC has been removed, clean the pads with the solder wick, and then clean the PCB with some 99.9% IPA. Lightly tin the pads, and then apply an abundance of liquid flux to the area. Place the new IC onto the pads and heat its leads enough to bond them to the tinned pads. Touch up the soldering of the leads as necessary. Clean up the excess flux with some 99.9% IPA, and then you are ready to adjust the pulse train balance.

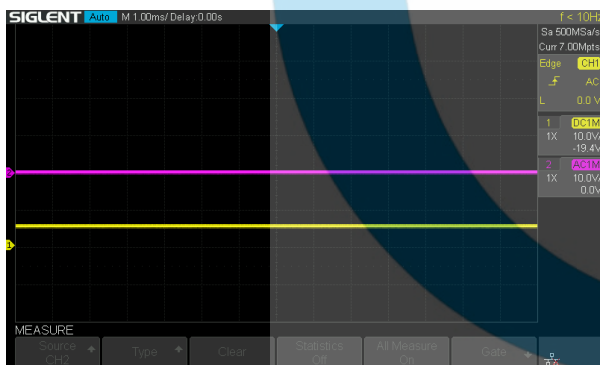
Figure 5 - No pulse train outputs

1. No output traces at all:
  - a. power supply inoperative;
  - b. misconnected encoder;
  - c. open circuit(s) on PCB; or
  - d. failed comparator IC.
2. Two flat traces (no pulses) (Figure 5):
  - a. failed Hall-effect sensor;
  - b. badly imbalanced encoder; or
  - c. failed comparator IC.
3. One flat trace and one pulse train (Figure 6):
  - a. failed Hall-effect sensor;
  - b. imbalanced encoder; or
  - c. failed comparator IC.
4. Two pulse trains with one pulse train having a greater amplitude:
  - a. imbalanced encoder.

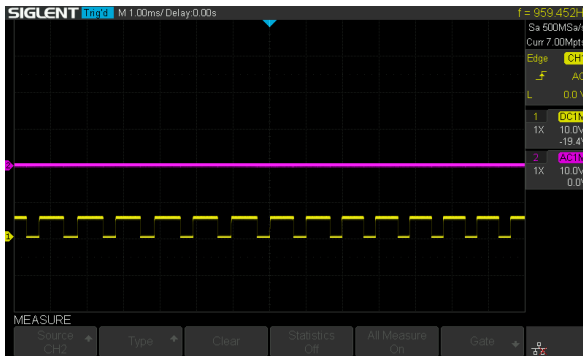
Figure 6 - Single pulse train

With a helper, it is possible to adjust the potentiometer(s) while the encoder is turning. Be sure to turn the encoder at a relatively slow rate, but fast enough to produce a consistent pulse train. If no pulse train at all can be developed, or if only a single pulse train can be produced, it is most likely time for a replacement of the comparator IC.

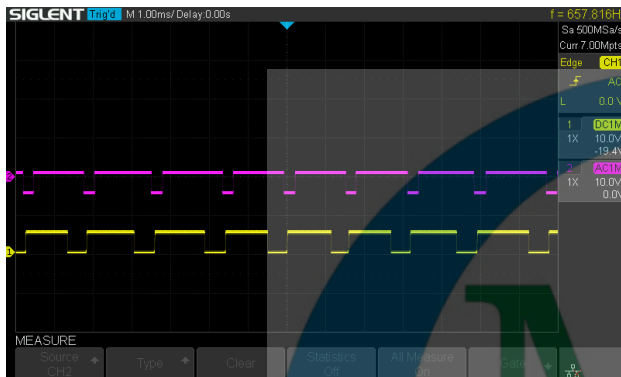
Figure 8 – Imbalanced pulse trains

5. Two pulse trains with unequal pulse widths (Figure 8):
  - a. imbalanced encoder.
6. Two pulse trains of equal heights and widths (Figure 9):
  - a. normal indication of a properly working encoder.

If, while testing the encoder with the oscilloscope, any imbalance in the pulse trains or missing pulse trains are noted, attempt to adjust the potentiometers before condemning the comparator IC. Each potentiometer controls the pulse formation on one of the two outputs. When adjusting the potentiometers, adjust in very small increments, as it is easy to turn right through the active portion of the range. These potentiometers are full-rotation devices without limit stops in their design, so they can be adjusted continually in one

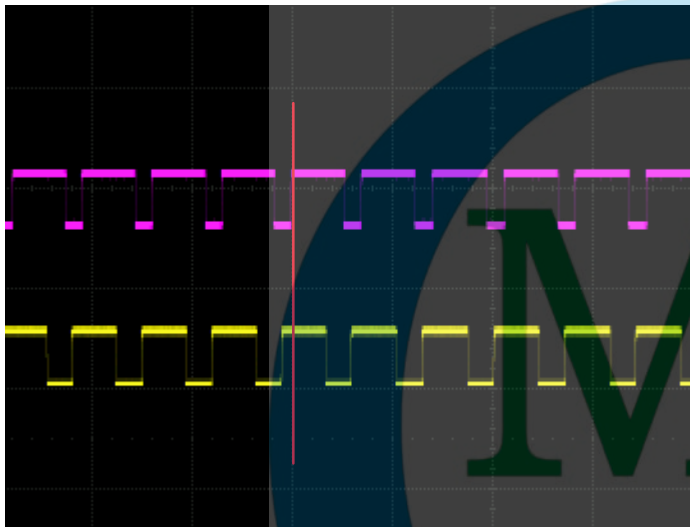
Figure 10 - Phasing indicated by red line on photo

Set up the encoder in the test configuration again, and then adjust the potentiometers for a pair of balanced pulse trains. When properly adjusted, the pulse trains will have equal amplitudes and the pulse widths will be equal between the pulse trains. Note however that the pulses will be out of phase with each other, as illustrated in Figure 10. If you reverse the rotation direction, the phase difference should reverse, swapping the leading and lagging status between the pulse trains.
