# At the Repair Bench – Icom IC-756 PRO – June 2024

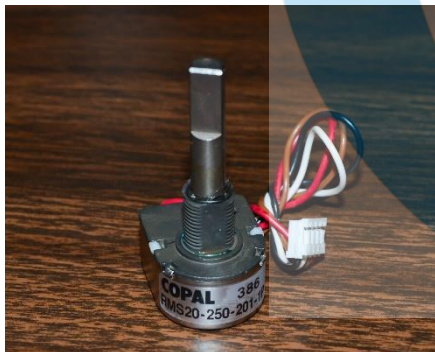
A quick look at the IC-756 PRO schematic showed that the VFO utilizes a magnetic encoder as its control device. Removal of the front panel, and partial disassembly of that panel, was necessary to access the encoder in its installed location. I quickly determined that the encoder has suffered some sort of a mechanical failure in that a black powdery substance was coming out of the encoder body along the encoder shaft. I attempted a cleaning of the encoder, but to no avail. The encoder still behaved badly, so I determined that a replacement encoder was required.

The encoder has a part number on it (RMS20-250-201P), which turned out to be a Nidec

Figure 2 - Icom IC-756 PRO encoder

magnetic encoder having 250 pulses per revolution and designed for operation on 5VDC, with “A” and “B” square wave outputs in quadrature. I ordered in a replacement encoder from one of my standard suppliers, knowing that the received encoder would not have the four-pin plug on it, being terminated as wire leads instead. It took only a couple of days to receive that encoder, but when it came in, I discovered that the encoder used by Icom in this case, while carrying that part number, was in fact a custom variation of that part, having a shaft that is approximately 15mm longer than the shaft on the standard part.

I ended up locating another encoder, this one having the correct length shaft and the pre-installed four-pin plug. It carried an Icom part number of 6910011090. I was fortunate in being able to obtain this part at a price somewhat reduced from the normal Icom asking price for the part, which was quite expensive.

When the Icom encoder came in, I installed it and tested the operation of the radio. All worked as it was intended to, and the tuning was, of course, back on track. I put the radio through its

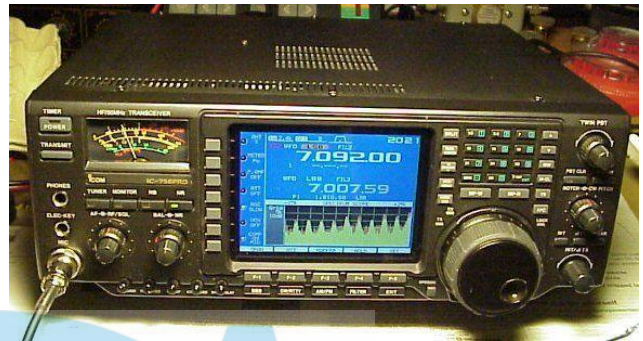
I found that *almost* everything was normal with the set, with one glaring exception. The VFO worked very intermittently. If the dial was turned very slowly, it would tune, but it would skip for one half of the revolution of the VFO knob. If the knob was spun rapidly, it would not tune at all.

Figure 1 - Icom IC-756 PRO

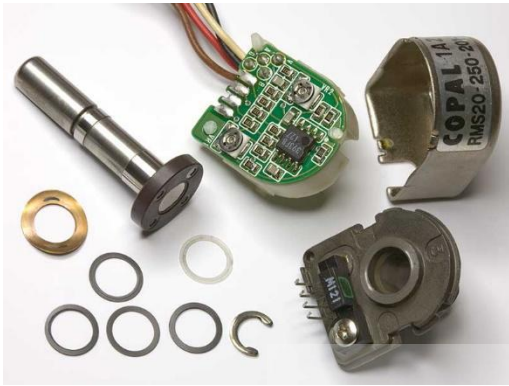
Figure 3 - Icom IC-756 encoder fully disassembled

As a final point, I had done some research into Icom IC-756-series encoder issues and I found that this is a quite common failure, in most cases with the encoder going out of alignment or failing due to the failure of one or both halves of the dual comparator IC that is integrated into the encoder assembly. There is information on the web about repairing these encoders from a realignment standpoint and also from a replacement of the IC standpoint. It turns out that an ubiquitous LM393 dual comparator IC in its SMT form factor will do the job nicely.

The reason that I opted for replacement of the encoder is two-fold: (1) while the price of the LM393 comparator is minute, the time that it takes to disassemble the encoder and replace the IC would cost the owner more than the cost of the replacement encoder, and (2) the fact that the black powdery substance was coming out of the encoder tells me that there was physical damage internal to the encoder as well as whatever electronic damage existed.
