## At the Repair Bench – Icom ID-4100A Shutdown – March 2023

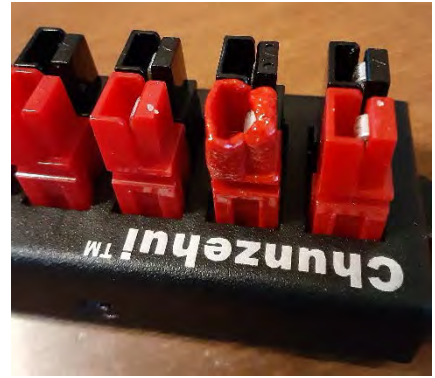
I went to the Powerpole® distribution block and carefully examined both it and the power cords connected to it. Much to my surprise, I found that the port to which my 2-meter radio was connected looked melted, very slightly on the black connector shell, but quite heavily on the red shell (*Figure 3*). This melting had occurred on both the cable end (*Figure 4*) and the distribution block port. I disconnected the cable from that port and got another surprise. Inside the red shell of the cable, the contact was not all the way out to the end of the connector shell as it should have been. Instead, it was pushed back a little bit, enough to cause the connection made when the plug bodies

*Figure 4 - Melted block port*

were joined to be somewhat less than optimal. Apparently, this connection would occasionally open, usually when heavier current was drawn during transmission. The heat caused by the resistance formed there is what melted the connector bodies.

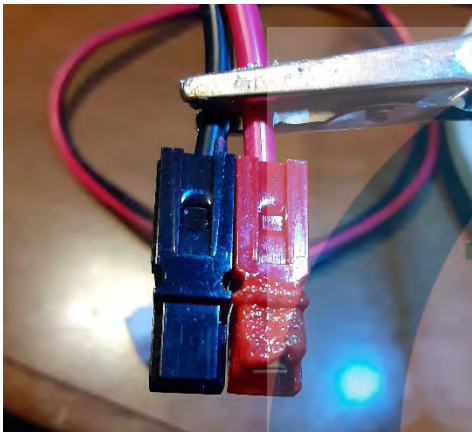
*Figure 3 - Melted cable end*

This particular cable was an ebay.com buy that I picked up before I got my Powerpole® assembly kit in house. I needed a power pigtail for the mobile-type radios, so I bought a couple of inexpensive ones on the auction site. My guess is that the actual contact was never fully inserted into the connector body far enough to lock into place. It simply pushed away from its mating contact, maintaining a light touch with its mate, but opening up under load. This caused

The fix for the cable was simple. Cut off the melted connector and crimp on a new pair of Powerpole® connectors. I keep the Powerpole® parts on hand, so that was no problem. The repair to the distribution block was not quite as simple.

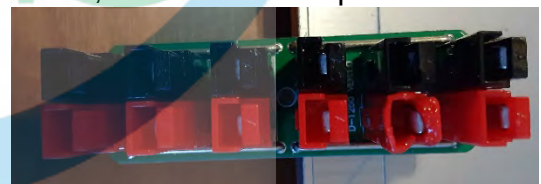
*Figure 5 - PCB with bus bars*

exposing the inside of the unit. Inside, there was a small printed circuit board (*Figure 5*) having bus bars along its outer edges to help handle the rated current of the unit. Each of the Powerpole® shells was installed to a blade-type contact that is soldered into the PCB. I fooled around with trying to release the contact from the body and to slide the body off, but that was going nowhere fast. Ultimately, I decided to try a more direct approach. I took a pair of pliers and simply crushed the melted red connector body, causing it to separate from its contact a bit. Then it was just a matter of using pliers to grip and wiggle it off the contact, sort of like pulling a tooth (*Figure 6*). After that, all that was left was the job of

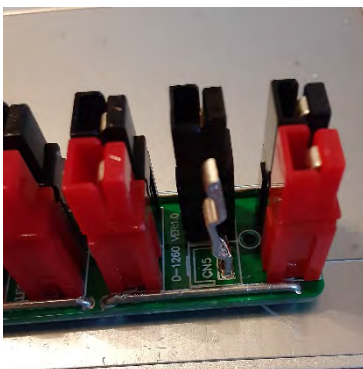
*Figure 6 - Connector shell removed*

forcing a new connector body down in place of the melted one. The black connector body was intact, so I was able to leave that one alone.

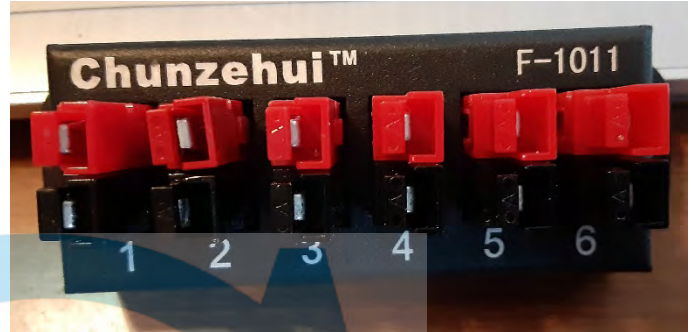
*Figure 7 - Repaired distribution block*

After the connector shell was replaced, reassembly of the distribution block was the reverse of the disassembly procedure. The only tricky part was reinstalling the three miniature truss-head machine screws that secure the PCB to the lower enclosure half, as they are buried down between the Powerpole® shells.

With the distribution block repaired and reassembled (*Figure 7*), it was time to put it back into service, which I did. The new connectors on the power cable, properly assembled this time, worked as they should, and the problem of the dead radio has not occurred since the repairs.
