## At the Repair Bench – MFJ-259 SWR Analyzer – February 2023

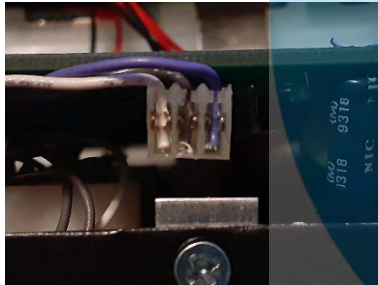
Figure 1 - Meter plug

Diving in “under the hood”, so to speak, I quickly found some cracked solder joints on the unit's main printed circuit board. There are two meters on the front panel of this unit. One is the SWR meter, and the other is a resistance meter. These two meters are connected to the main PCB via a three-wire harness with a 90° plug at its end (Figure 1). The plug connects to a three-pin right-angle pin header on the PCB.

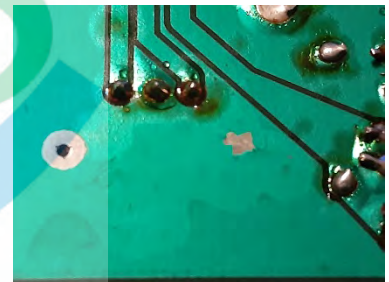
Figure 2 - Cracked solder joints

It was this header that had the cracked solder joints (Figure 2). A simple fix – I simply reflowed the solder on those pins and the meters worked as intended. However, I did not stop there.

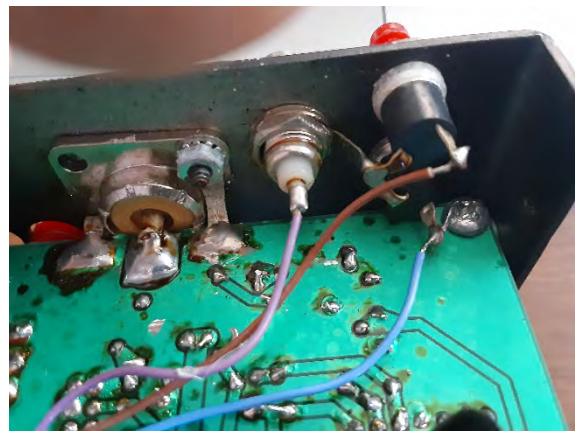
*Figure 3 - Factory treatment*

239, when the main PCB is in place, sits about an eighth of an inch above the PCB. That gap is simply filled with solder at the factory. Each of the two mounting screws used for the SO-239 has a solder lug installed under its nut. The lugs are then bent over to reach the main PCB and are soldered to pads on the PCB. These solder lugs also do not quite reach the board surface, and so their gaps are also solder-filled in production (Figure 3). Large solder bridges of this type are prone to cracking with time, a condition with which I was not happy. I therefore decided to correct this as well.

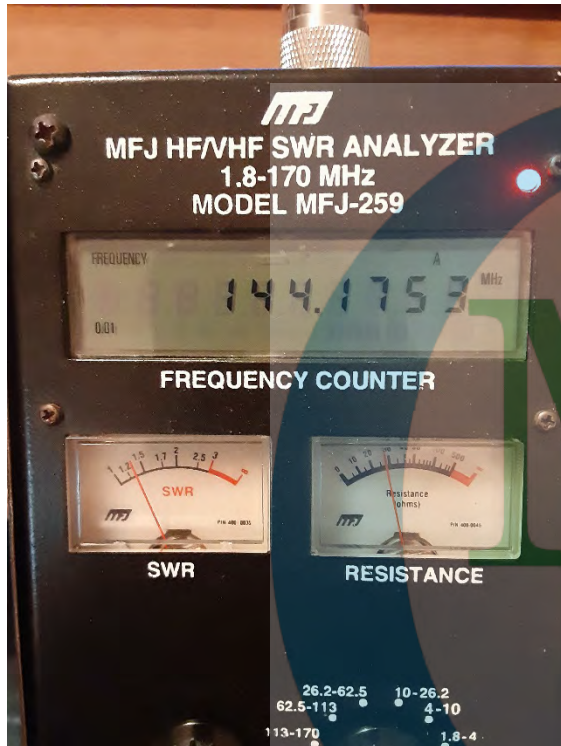
Figure 6 - Working unit

As mentioned earlier, the pushbutton switches are normally-open switches, so connecting that last switch should not have made any difference, but it did... which meant that the switch was obviously *not* open! I checked the switch with

an ohmmeter, and sure enough, it was a normally-closed switch that had somehow gotten mixed in with my supply of normally-open switches.

Swapping out that switch for another (verified NO) switch from my stock solved the problem (Figure 6).

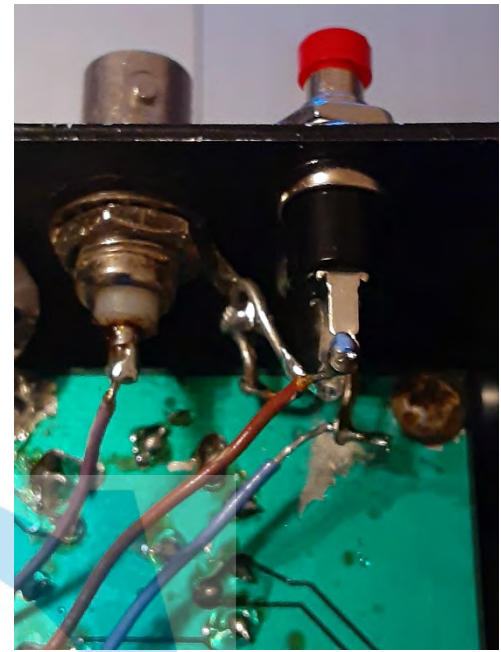
Figure 5 - Pushbutton switches as repaired

Another poor manufacturing technique, in my view, was the manner in which the BNC jack and the pushbutton switches were connected. The two pushbutton switches are normally-open switches that, when pressed, connect their respective circuits to ground. The way that MFJ chose to implement this was to bend one solder lug of each switch over and solder them to the solder lug under the nut on the BNC jack (also shown in Figure 3). It was a stretch at best, and it put undue stress on the bodies of the pushbutton switches. As it turned out, when I removed these switches, I found that the bodies of both switches were cracked. Solution? Two new switches... which turned out to be an adventure in and of itself.
