# At the Repair Bench – MFJ-407D Keyer – October 2024

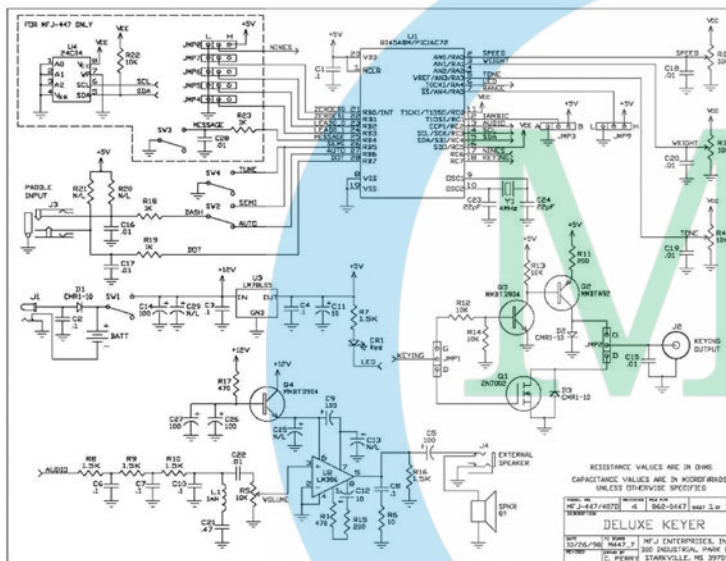
Figure 2 - MFJ-407D schematic diagram

Replacement of the failed output transistor, Q1 in the schematic (Figure 2), an enhancement-mode MOSFET, was straight-forward. The transistor in question is a 2N7002 surface-mount device in an SOT-23-3 package. This transistor is one of the few components in the direct output path for the keyer. There is a selectable parallel path designed for use in grid-block or tube-type systems rather than in solid-state systems. The grid-block path has considerably more components, but they are all moot because this keyer was configured for use in the **Direct** mode of operation.

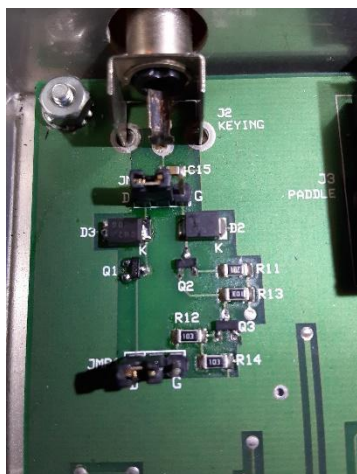
Figure 4 - Output component area

Selection of the output mode is made through a pair of three-pin headers with a shunt cap on each header (Figure 4). Selection of the **Direct** mode requires placement of both shunt caps on the center and **D** pins of each of the respective pin headers. It is at these pin headers that the problem arose which apparently led to the failure of the 2N7002 transistor. Specifically, the problem was on the foil side of the PCB, where the pin headers are soldered through the board.

A short-circuit path had been formed at each of the pin headers between the D pin and the ground plane. The green corrosion formed there was conductive and led to a condition wherein both the gate and the drain of the MOSFET were shorted to ground. It is unclear exactly what the failure mechanism of the MOSFET was, but there is no doubt that it showed itself to be failed

when the transistor was tested under both in-circuit and out of circuit conditions. The corrosion was completely removed from the board and the cleaned areas were sealed with clear enamel.

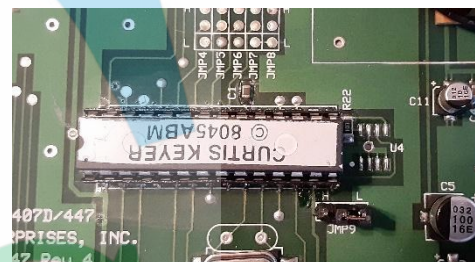
Figure 5 -  $\mu$ Controller area of PCB

I set out next to cure the intermittent problems that this unit exhibited. I noted that I could affect the intermittency by putting pressure on the board in various spots, which led me to look closely at all of the solder joints on the board. As this is largely a surface-mount construction, most of these joints were on the component side of the board. Ultimately, I found and repaired cold solder joints at the IC socket pin rows for the microcontroller ( $\mu$ C or  $\mu$ Controller), a PIC16C72 device (Figure 5). Reflowing the joints along this IC socket cured the intermittency problems that had existed. As it turned out, one of the indications of power drop-out that I mentioned earlier was the fact that

the front panel LED would intermittently go out. It happens that the LED ground is made through the  $\mu$ C, and that the LED's behavior was part of the larger cold solder joint intermittency issue.
