# At the Repair Bench – MFI-941E – July 2024

Figure 1 - MFJ 941E Versa Tuner II

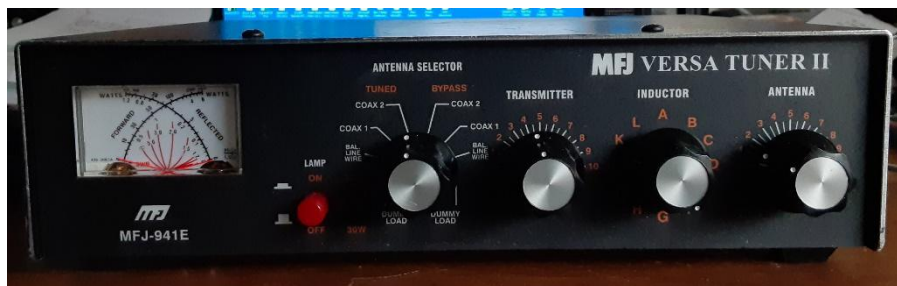
A short while ago, one of our fellow GCARC Club members asked me about making a repair to his MFJ antenna tuner, a model 941E Versa Tuner II. It seems that he had grown tired of having to shine a flashlight on the panel meter to read the crossed needles at night. Apparently, the factory illumination for the panel meter, a 12V incandescent lamp, had failed, as they are prone to do. I decided to make a far more permanent repair by fitting a white LED in place of the incandescent lamp. I also noted that one of the four rubber bumper “feet” for the unit was missing.

At that point, I remembered the missing rubber bumper “foot” on the unit. I removed the remaining three bumpers, which were barely holding on, and cleaned the surface thoroughly with some 99.9% IPA. Then, I installed a matched set of four new bumpers to the bottom of the unit. Job done.

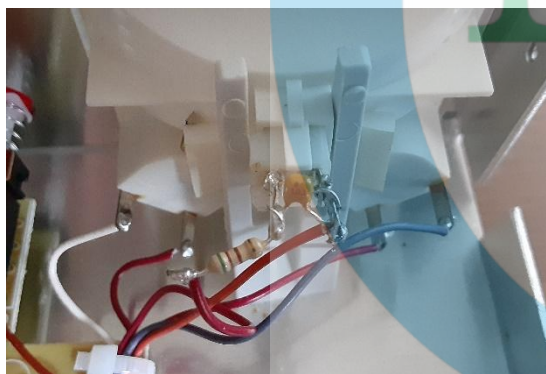
I opened up the unit – a total of eight screws, with three on each side and two across the top front of the cover – and checked to make sure that the lamp had actually failed and that there was not some other problem. With 13.8V supplied to the rear panel power inlet for the lamp, and with the lamp switch in its “ON” position, I had the full 13.8V across the (dead) lamp. Lamp failure was confirmed.

Figure 2 - Lamp holder in meter housing

I removed the lamp holder from its place in the meter housing, and then set about removing the lamp from the holder. That took a little bit of doing because of the manner in which the lamp's bare wire leads had been fed through the holder and wrapped around the socket terminals of the holder. In addition, there is a 0.01 $\mu$ F ceramic disc capacitor across the lamp, and that had to be dealt with as well. I worked at it, and eventually had the holder completely stripped and disassembled.

Disassembly of the holder was necessary in order to make a provision for the LED leads to pass through the holder base alongside the socket terminals. The LED leads are much heavier than were the lamp wire leads, and I needed to make holes for the leads to run through. That was simple enough, using a “T” pin and a pair of long-nose pliers to push the pin through the plastic alongside the terminal contacts.

I gathered up the necessary parts – a white 5mm LED, a 510 $\Omega$  250mW 5% resistor for current limiting, and a replacement for the 0.01 $\mu$ F capacitor that was unavoidably damaged in removal. The LED fit perfectly into the lamp holder, and I wrapped the LED leads around the terminal contacts. I then added the resistor to the cathode terminal, after which I installed the capacitor across the LED. I soldered the components in place and formed a small hook on the opposite end of the resistor, so as to facilitate connection of the cathode lead there. Finally, I soldered

the lamp circuit wires to the lamp holder terminal (anode) and to the resistor (cathode), cleaning up the excess lead lengths.

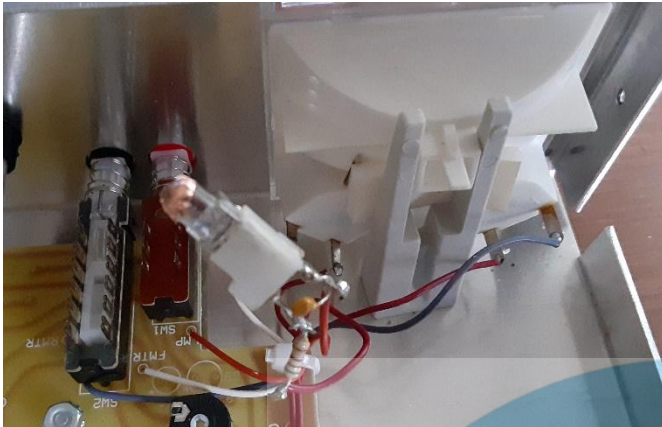
*Figure 3 - Copper tape on end of LED*

The incandescent lamp and the LED emit light in different patterns. The incandescent lamp emits its light in a diffuse pattern all around the lamp envelope without any particular focus. The LED, on the other hand, emits most of its light in the forward direction off the end of the LED envelope. This caused an objectionable “white spot” to appear in the center of the meter when the LED was powered up. I resolved that issue by applying a dome cap of copper tape to the very end of the LED envelope, blocking most if not all of the light in the immediate forward direction. As a result, the illumination

of the meter is now more diffuse while still being sufficiently bright for reading the meter under any ambient light level. I installed the cover and gave the unit a final look-over.
