# At the Repair Bench – Plasma Lamp – November 2023

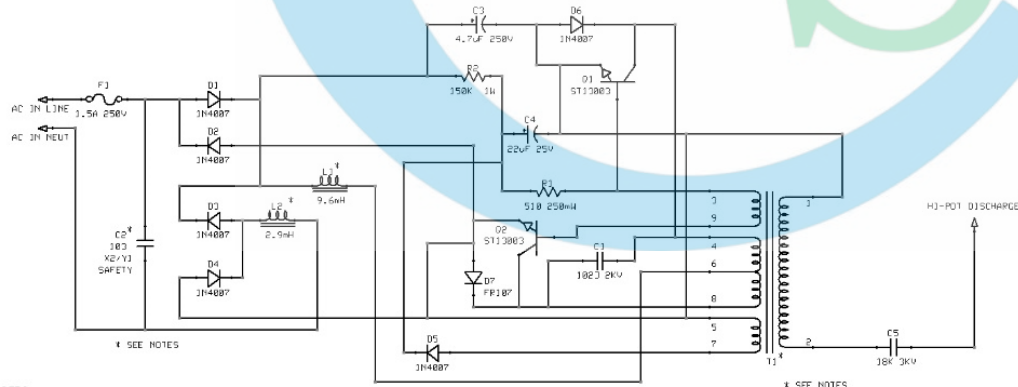
Figure 2- Derived unit schematic

circuit and put down into a schematic diagram what I was seeing. I typically use *ExpressSchematic* (part of the *ExpressPCB* package) to draw my schematics, and I did so here. The circuit (see Figure 2) basically consisted of a full wave rectifier for the incoming AC, an

oscillator, a chopper or switching transistor, and a multi-section transformer. The transformer has a winding that is part of the oscillator circuit, but largely serves as a flyback transformer to produce the high potential output needed to drive the plasma stream.

The plastic cover that I mentioned earlier is the housing of the transformer, and the diode that had melted a groove into the housing was one of the full wave rectifier set. There are two transistors used, one for the oscillator itself, and the other for the high-frequency switching necessary to create the pulse train input for the transformer. Testing revealed that the oscillator transistor had failed, and the switching transistor was severely past its “best by” date. While this transistor did operate, it was extremely below peak frequency and its *hFE* or *beta* tested out to be a mere 2.5 instead of the normal 200-plus value of a serviceable transistor.

Further testing showed that the diodes used in the unit, seven in all, were all also below spec in performance, although they were still operational. The biggest problem was that one of the diodes, an FR107 fast-recovery type, was not fast at all, having recovery time measured in the 875mS realm instead of the 500nS that it should have been. Voltage drops on the diodes in the full-wave rectifier proved to be quite variable, with one as low as 350mV and another as high as 935mV. The norm is around 535mV for these 1N4007 diodes.

Also indicative of high heat levels in this unit was the condition of the 4.7μF 250V aluminum electrolytic capacitor. This capacitor was quite leaky, acting more like a resistor than a capacitor. The equivalent series resistance (ESR) measured out at just under 5Ω. It should have been down near zero ohms. The transformer, as near as I could tell using an ohmmeter and LRC meter, seemed to be in serviceable condition, as were the resistors, the 18pF 3kV ceramic capacitor and the 1.5A fuse.

Repairs to this unit, then, included replacement of all of the diodes with like types (1N4007 x 6 and FR107 x 1), replacement of both ST13003 transistors, replacement of the 4.7μ 250V and the 22μ 25V electrolytic capacitors, and installation of the new 0.001μF 2kV film capacitor.
