# Yaesu G-5500 Rotator Controller Repair

Back at the end of September, we had a rather strange occurrence at the GCARC Clubhouse. One of our members was at the Satellite station and found that the AZ-EL rotator was inoperative. The controller for this rotator is the Yaesu G-5500 model as shown in Figure 1. A little bit of rudimentary troubleshooting led to the discovery that the power inlet fuse, a 2-ampere Type 3AG 1/4" x 1-1/4" glass fuse, had gone open. He attempted to replace the fuse, and ended up getting a shock and also blowing the new fuse as well. As that was the only spare fuse of that type on hand at the Clubhouse, I came back the next day prepared with a few of the correct fuses with me. At a first glance, we (**Frank Romeo N3PUU** and I) found that the motor output wires on the back of the controller, especially for the Azimuth output, were loose and had been shorting to each other and to the controller chassis. We made the decision to change the "wire under screw head" arrangement that existed to a more orderly system of wire terminals designed to be secured under screw heads. I installed a full set of such terminals on both the azimuth and the elevation (which also

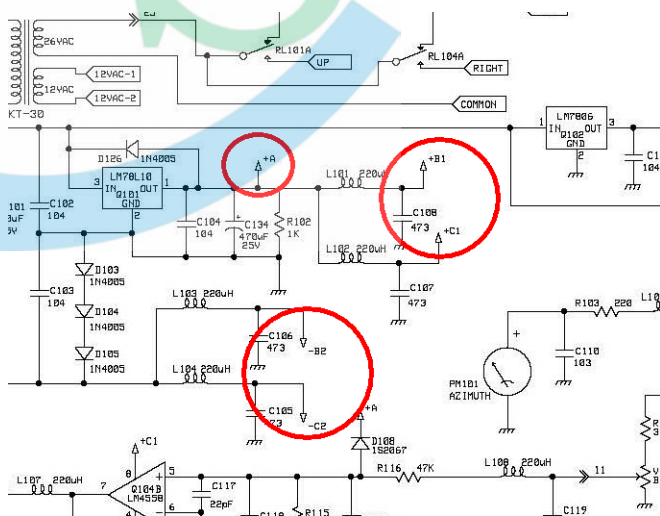
Figure 4 - Controller operating voltage sources

This controller has several operating voltages in its circuitry, identified on the schematic as +A, +B1, +C1, -B2, and -C2 (see Figure 4). While none of these voltages are clearly identified on the schematic as to amplitude, it is clear that +A is +10VDC as it is directly at the output of the LM78L10 voltage regulator. The other positive voltages, which are simply highly-filtered +10VDC sources, are derived from that +10VDC source, while the negative voltages are derived from a diode stack. A quick look at the schematic shows that the two negative voltages are simply produced via three series diode drops of approximately 0.7V each, giving us roughly a negative 2-volt potential there. The two negative supplies are filtered and each is used for one of the two 4558 op-amps, supplying -2.0VDC to the negative rails of the op-amps.

at the positive rails, we get a 12VDC operating voltage across each op-amp, rail-to-rail. It is unclear why Yaesu wanted separate filtered power inputs to the two op-amps, but they did, and that is how they did it. In addition, there is an LM7806 voltage regulator that provides a +6VDC supply used for the position-sensing potentiometer circuits at the rotator motors. A quick voltage check showed that neither the +10VDC nor the +6VDC supplies were present. Interestingly, even with the 10VDC supply defunct, the -2VDC supply was active, as it is not dependent upon the +10VDC supply as its originating source. Further, it was discovered that the 470 $\mu$ F/25V filter capacitor across the full-wave bridge rectifier output was open.

I replaced both of the voltage regulator IC's and the two 470 $\mu$ F capacitors on the board, and this restored full operation of the controller *when supplied by my bench power supply*, with the exception of the panel meter lamps, one of which was still burned out. My next job was to replace both of the panel meter lamps, going by the philosophy that they were of the same age and therefore the second one was likely to fail soon as well. That was a simple and straight-forward parts replacement job.

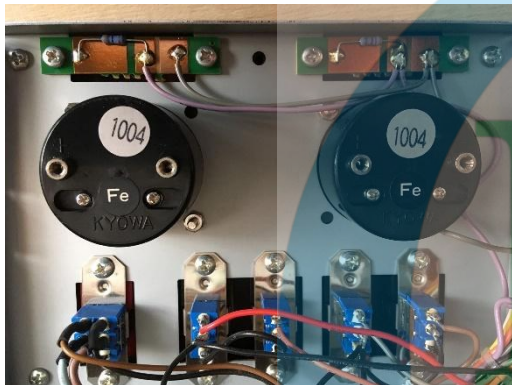
Figure 5 - Front panel rear view

The original panel lamps were of an axial or tubular design (Figure 5), having one wire lead coming out of each end of the tubular envelope. The lamps were supplied directly from the 12VAC secondary winding, and each lamp had a 47-ohm current limiting resistor wired in series with the lamp. I chose a T-1 type lamp with radial wire leads as the replacement, selecting a 14-volt 0.91-watt lamp for the replacement units. I could have converted these lamps over to LED's by adding a rectifying diode to each of the

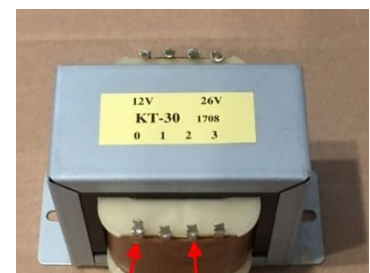
Figure 7 - Power transformer

The power transformer has three windings, a single (effective) primary and two secondaries, as already described. Figure 7 illustrates the power transformer used in this controller, with the terminals of the primary winding that are used in the 117VAC version indicated by the red arrows. In general terms, the higher a voltage to be expressed across a transformer winding will be, the higher that winding resistance will usually be. In the case of the Yaesu transformer in this controller, what I found initially was 0.8 $\Omega$  across the primary winding, and 0.1 $\Omega$  across the 12VAC secondary with 0.00 $\Omega$  across the 26VAC secondary. These readings

were low enough that they were basically unreliable, so I decided to measure them again using my Ascel AE20218 milli-ohmmeter. In this test, I measured 0.674Ω across the primary winding, 0.385Ω across the 12VAC secondary winding, and 0.128Ω across the 26VAC secondary winding. These readings, while quite accurate due to the nature of the Ascel AE20218, reveal a bit of a problem. Following the conventional “higher voltage, higher resistance” logic, the 26VAC winding should have had more resistance than does the 12VAC winding. In addition, I believed that the primary winding resistance was considerably lower than it should properly have been. In theory, it should have been the greatest of the three resistances. I resolved to measure the winding resistances of the new transformer when it arrived, using the milli-ohmmeter.

A quick glance at the table will show that the only winding of the original transformer that has a resistance measurement anywhere near that of the new (factory replacement) transformer is the 12VAC output secondary winding. In this table, those connections displayed in **bold** typeface are the connections that are used in this controller model. The values that are shown in **red** type are the failed values, while the **green** values are the acceptable values. Of course, *all* of the values in the “Replacement” column are acceptable values, as they are the values of the new transformer.

It is unusual for multiple windings to develop short circuits simultaneously *unless, of course, the failure of one winding was the direct cause of the failure of the other winding*. I believe that a cascade failure of that type is exactly what happened here.

Remember that one of the original findings was that the motor power leads were shorting at the back of the controller. I suspect that this short circuit caused excessive current draw through the 26VAC secondary winding, which in turn caused excessive current draw in the primary. I believe that it was the heat caused by this excess current that led to the failure of the transformer

On the day that the replacement transformer arrived at my shop, I spent a few minutes taking comprehensive resistance measurements with the Ascel AE20218 milli-ohmmeter before doing the transformer installation. The results of those measurements are shown below.

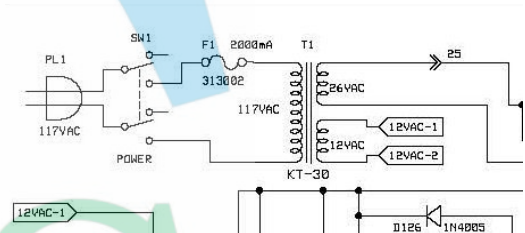
Figure 11 - Power inlet circuit

The power inlet of this controller switches both the line and the neutral wires, using a DPDT paddle switch as the power switch (see Figure 11). The circuit has the power cord line side connected to the common on one half of the DPDT power switch. From the switched terminal of that side of the switch, the circuit goes to the fuse. From the fuse, the circuit goes through the primary of the power transformer. Coming out of the transformer primary, the circuit goes back to the switched terminal of the second side of the DPDT power switch. From there, the common on that side of the switch is connected to the power cord neutral. What I found was that while one pole of the DPDT paddle switch was switching, the other pole was not, and that pole was shorted (closed) to the active circuit. It was the fused (line) side that was shorted, meaning that even when switched “OFF”, line current was available at the fuse and then at the transformer. To make things worse, the switch did not even switch that one pole each and every

time the paddle was moved, giving a hit or miss action to the switch. The result was that even when the switch lever was in the was “OFF” position, sometimes the circuit was actually “ON”, which accounts for the fuse blowing as soon as I plugged the controller in with the switch “OFF”.

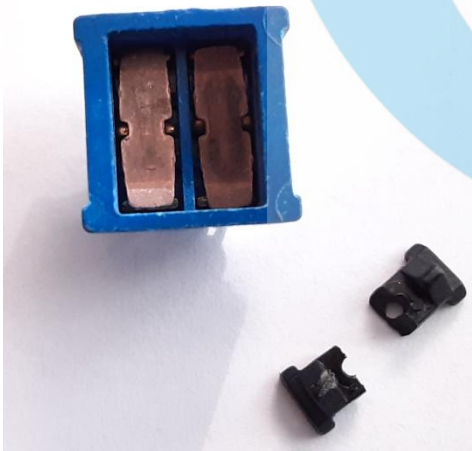
Figure 12 - Switch body and broken operating bar

Being a curious cuss, I disassembled the paddle switch by prying open the retaining tabs that secure the switch body to its upper-half operating mechanism. Inside this switch, there are two teeter-totter contact bars that are supposed to rock back and forth between the opposite ends of the switch when the switch is operated. The single paddle lever is connected to a short toggle shaft, which is inserted into a plastic operating bar, which in turn slides along the teeter-totter contacts as the switch paddle is moved, thus rocking the contacts (see Figure 11). This plastic bar was broken into two pieces, and one side of the switch had the teeter-totter contact bar welded to the output terminal.

I was able to free up the teeter-totter contact bar by exerting a little bit of force on it, breaking the tiny weld. I then used some cyanoacrylate cement to glue the two pieces of the operating bar back together (Figure 13). Finally, I was able to re-assemble the switch, crimping the tabs back into place. Voilà! The switch worked as it should, with proper snap action as the paddle was moved. However, knowing that the switch was on borrowed time, I went ahead and ordered the replacement switch from Yaesu so that I would have it if and when the switch failed again.
