# At the Repair Bench – Heathkit® IT-3121 Curve Tracer

## Tracer Redux - May 2025

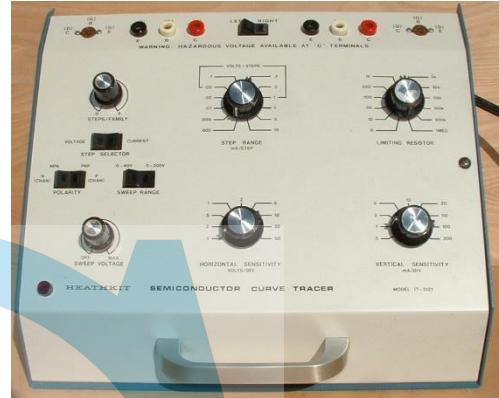
Figure 1 - Heathkit® IT-3121 Curve Tracer

Here we are, three months later, and *another* IT-3121 has landed on my bench for repair, from a different owner, but one who was referred to me by the owner of the first IT-3121 that I reported on back in February. This unit had a different apparent condition. It was blowing fuses as soon as it was powered on, without even a flicker of the panel-mounted neon pilot lamp. Tracking down a problem like this can be extremely difficult, as there are no working voltages to be measured, and all diagnosis must therefore be done without reference to voltages. Instead, we tend to look towards resistances in these situations.

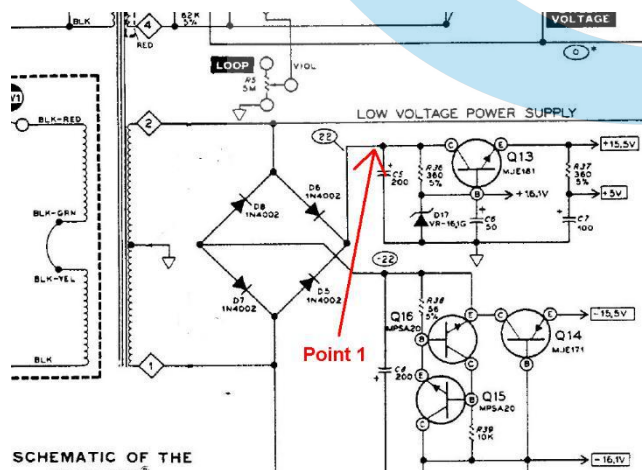
Figure 2 - Point 1 identified

The first measurement is from a point identified as “Point 1”, which is in essence the input to the positive-going low-voltage supplies, at the DC side of the full-wave bridge rectifier formed by diodes D5 through D8 (see Figure 2), which is common to the positive side of a 200µF/50V electrolytic filter capacitor C5. The specified resistance is to be at least 10kΩ from that point to chassis ground, with the positive probe of the ohmmeter at Point 1. The reading taken was 15.6kΩ, meeting the provided specification.

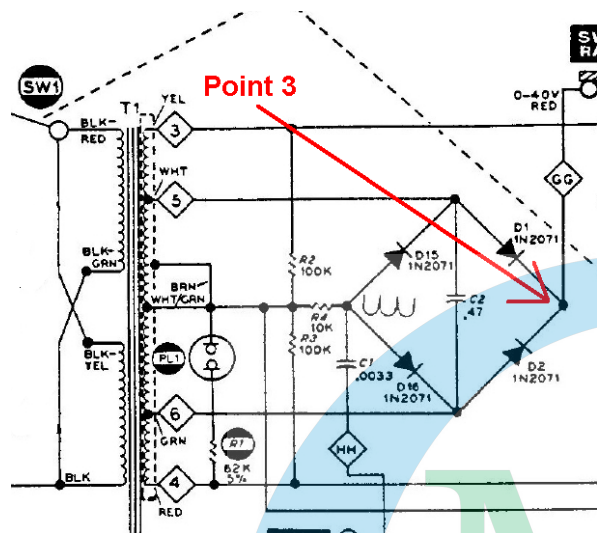
Figure 3 - Point 3 identified

Next is the measurement taken at “Point 3”, which is at the DC side of the full-wave bridge rectifier comprised of diodes D1, D2, D15, and D16 (see Figure 3). The resistance between Point 3 and chassis ground, measured with the positive probe of the ohmmeter on Point 3, is to be at least 100kΩ. It measured 221.5kΩ, again within specified limits.

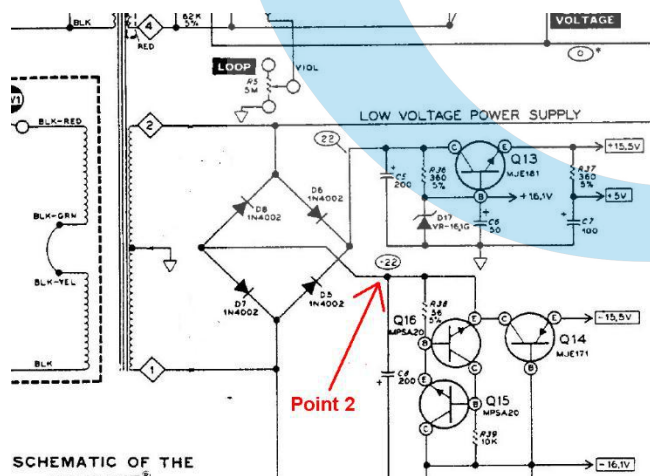
Figure 4 - Point 2 identified

The third resistance measurement was to be taken with the probes reversed, placing the positive probe on chassis ground and the negative probe on “Point 2”. This point is located at the negative output of the low-voltage supply’s full-wave bridge rectifier (the same rectifier used when measuring Point 1 above). This point is then effectively at the negative end of the 200µF/50V electrolytic capacitor C8 (see Figure 4), and it too called for a minimum of 10kΩ between that point and chassis ground. The actual reading was 17.3kΩ, making this one compliant as well.

FWBR, which were the green, the white, and the green with white tracer wires (see Figure 4). I reconnected those three wires and powered the unit up. Once again, the unit held, with outwardly normal indications. That left, by process of elimination, the remaining wire pair, the red and yellow wires, which are connected to the two extreme ends of the sweep supply secondary winding.

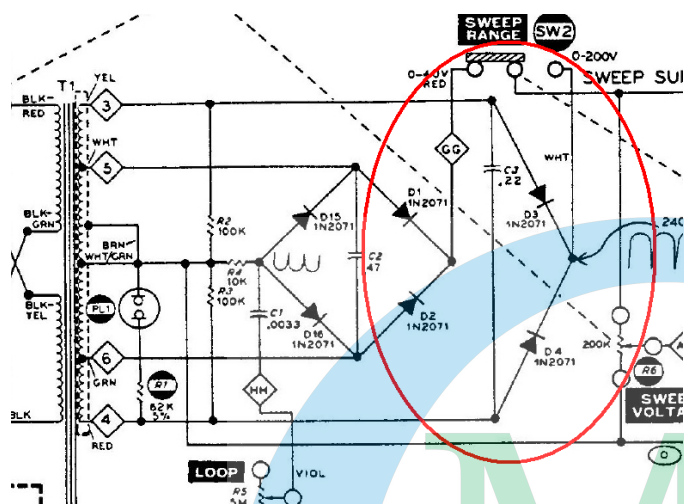
Figure 5 - Half-wave rectifier and shunt capacitor C3

Knowing that the problem *had* to be in the circuit fed by those wires, I left them disconnected and went to work with the ohmmeter. The red and green wires supply incoming AC current to a half-wave rectifier comprised of diodes D3 and D4. According to the schematic, a 0.22µF capacitor C3 (see Figure 5) is placed in shunt across this rectifier assembly as a filter device. A look at the PCB in the unit showed that somebody had been in here working on the board. This was very obvious because the 0.22µF capacitor was not

there, but instead there was a pair of 0.1µF/100V metallized polyester film capacitors placed together in parallel. With the secondary leads disconnected, I should have been able to measure the capacitance of that parallel pair, and it should have showed an initially low resistance, immediately climbing high to an open circuit condition. What actually happened, however, is that the capacitance meter errored out, and the ohmmeter showed a direct short circuit when placed across the capacitor pair. I removed the two capacitors and separated them for individual testing, and found what I expected to find at that point. One of the two capacitors tested out normally, while the other one was shorted. A new 0.22µF Mylar™ capacitor, rated at 630 volts, solved the problem. With the new capacitor in place and the secondary leads reconnected, the unit powered up and *almost* worked properly.

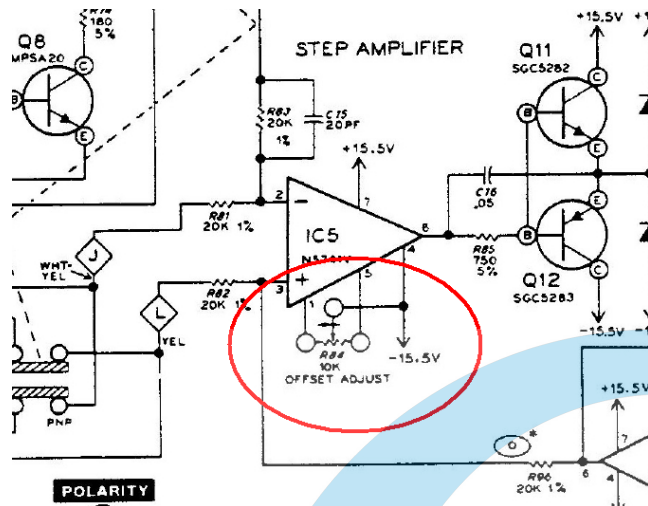
It turned out that someone, possibly the same person, had also replaced an “Offset” trimmer potentiometer that is mounted to the foil side of the PCB. The original trimpot there was a four-legged horizontal-mount 0.688” single-turn 10kΩ pot, but that had been replaced by an enclosed trim pot with a 0.375” square body and short wire leads. These leads had been extended, and only one of them was actually still connected. Two of the three leads had broken free of their apparent cold-solder joinery. This trimpot is used as a null-offset balance control for balancing the input voltages on a 741 operational amplifier IC. Without this control in place and properly adjusted, the output from the curve tracer is unpredictable at best. I happened to have a Bourns 3352U-1-103 trimpot in stock, which just so happens to be the same size, value, and type as the factory part for this application. Needless to say, that component went in as a replacement for the improperly-

Figure 6 - Offset adjustment trimpot location

installed trimpot that was there. This restored proper operation of the op-amp circuit and thus the curve tracer in general.
