## At the Repair Bench – MFJ-949 – October 2025

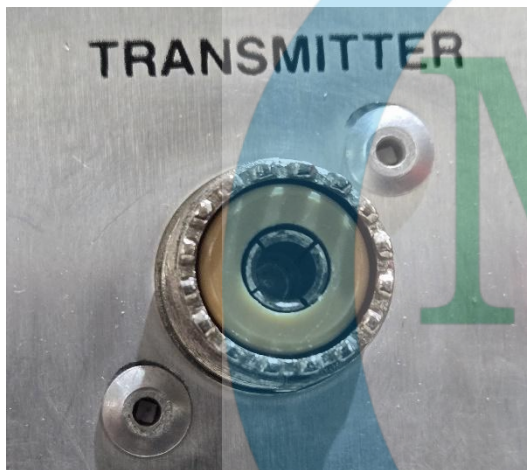
Figure 2 - Loose connector indication

My deep-dive into the physicality of the MFJ-949 turned up the cause of the SWR excursions. The GCARC Club member and the individual who was working with me to match the radio and antenna via the MFJ-949 said at the time that the unit was behaving as if there was a loose connection. In a sense, he was exactly correct in his initial assessment. It turns out that two of the three SO-239 connectors were actually loose on the rear panel.

into the chassis of the MFJ-949. It is this interruption of the ground path that caused the intermittent fluctuation of the SWR indication.

The two connectors that were loose were the *TRANSMITTER* and *COAX 2* connectors, with the *TRANSMITTER* socket being quite loose. This is evident in the Figure 2 illustration of the mounted SO-239, where black aluminum oxide marks are visible around the rivets. This looseness of the connectors was sufficient to interrupt the ground path through the connector shell and

The obvious solution to this problem was to drill out the rivets and replace them with machine screws and KEPS nuts. However, I did not stop there. I also drilled the remaining mounting hole positions and installed machine screws there as well (Figure 4). It is my firm belief that, had the SO-239 connectors been mounted with four fasteners instead of the two that were used, it

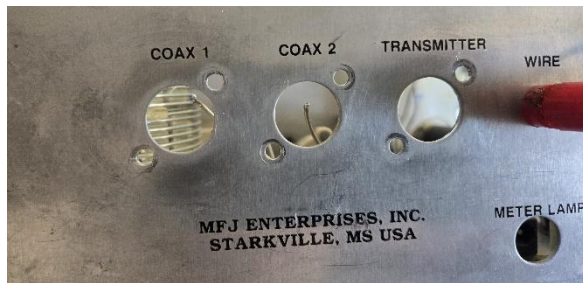
Despite the fact that the sockets themselves are of the four-hole flange type, MFJ chose to secure them with, as noted earlier, only two rivets (Figure 3). The SO-239's are mounted from the inside of the unit, so the fact that there are two unused holes on each connector is not immediately evident. However, it is my belief that the choice to secure these connectors with only two rivets is directly causal to the problem that this unit exhibited.

Figure 3 - Factory stamping of real panel

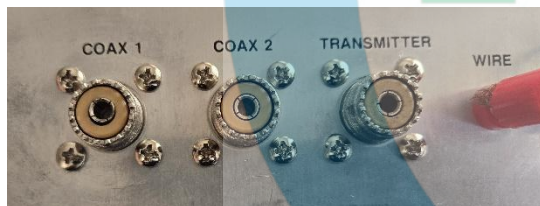
Figure 4 - re-mounted SO-239 jacks

Granted – there *may* have been some concern about the heads of screws interfering with the connection of standard PL-259 coaxial connectors to the SO-239 sockets, but that fear is groundless, as I have learned clearly through my repairs to this unit. I used machine screws with standard pan heads, and the PL-259 shells fit perfectly despite the presence of the screw heads.

Testing of the MFJ-949 after the repairs showed that the problem was gone. Thus, the repair was completely successful and the antenna tuner is now back in fully-operational condition. This is a problem that will most likely affect *any* antenna tuner with riveted connectors, and most especially those with only two fasteners per jack. It is an easy fix, but it makes a great difference in the performance of the tuner.
