## At the Repair Bench – MFJ-998RT – December 2025

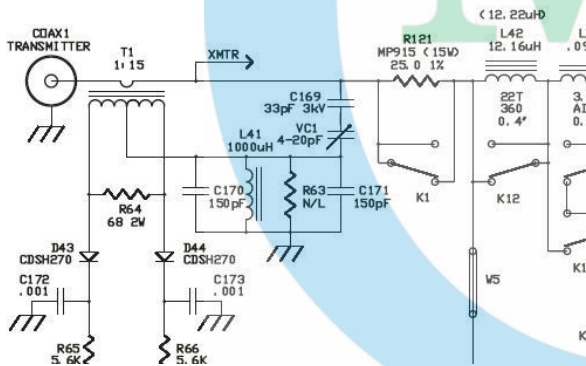
Figure 2 - MFJ-998RT schematic excerpt

schematic excerpt at Figure 2 as you continue here. As the transmitted signal enters the auto-tuner, a sample of that signal is taken off at an input transformer (T1 in the schematic). It then passes through a 1mH RF hash choke. This choke is identified in the schematic as L41 and as being 1000μH, an equivalent value. Its location is clearly visible with the yellow oval on the photo in Figure 3 – the black cylinder near the right of the oval. This is the choke that had been

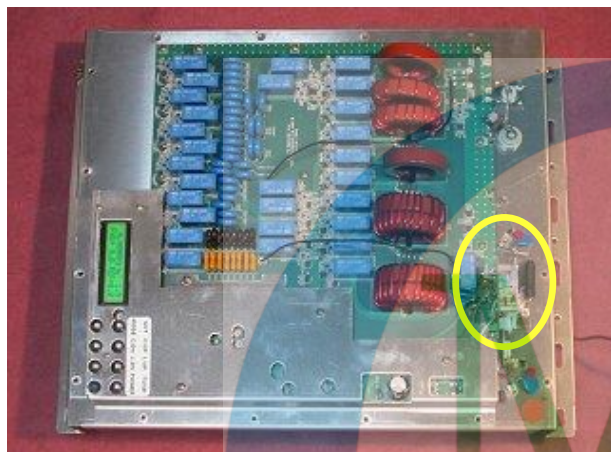
Figure 3 - MFJ-998RT mainboard exposed

completely burned up in the failure event that started this odyssey. The owner, who is not a technician but who does try to make his own repairs, was told by another user online what the correct value of the choke should be, exactly what he should buy, and exactly where he should buy it. Unfortunately, that information was incorrect, as that user told the owner to purchase a 100μH choke when the schematic clearly calls for a value of 1000μH here. However, that was only a small part of the overall problem.

My initial overall physical exam of the unit revealed a small daughterboard, mounted to the mainboard in the vicinity of the input section, that showed some distinct charring. This board holds four resistors, and all of them exhibited signs of having been severely

According to the schematic, this board was serving as R121, stated to be a  $25\Omega$  15W 1% resistor. According to the color code on the resistors, they were  $100\Omega$  each, which makes sense, as they were wired in parallel. Four  $100\Omega$  resistors in parallel would of course produce  $25\Omega$  net resistance. I desoldered one end of each of the four resistors to check them each individually. What I found was that three of the four resistors were open, and the fourth exhibited a measured resistance of  $1065\Omega$  – a far cry from the  $25\Omega$  called for in the schematic.

There were a couple of indications that these resistors had already been replaced. First of all was their size. In order for an array of four parallel resistors to provide 15W of power capability, each resistor would need to be rated at 3.5 watts. These resistors were the same exact size as the 2W resistors in my inventory. Further, the resistors installed there were, according to their color codes, 5% tolerance rather than the 1% called for in the schematic. These points led me to believe that the resistors had been replaced at some point in the history

of this unit, and not with the correct specification parts.

The daughterboard, also located within the yellow oval in Figure 3, was heavily charred in the vicinity of the one remaining “working” resistor – that is, the only one that was not open-circuit. Needless to say, this was because of two problems – a) all of the current flowing through the one resistor, and b) the inadequate power-handling capability of that one resistor. I decided that a better scheme was called for in the replacement of these resistors.

The repair was not complete at this point, however. I still needed to replace the RF hash choke with one of the correct value. While I normally stock this particular choke, a 5258-RC 1mH choke with a 0.55Ω DC resistance and a one-ampere current rating, I happened to be out of stock on it, but I already had it coming in my weekly stock order. This was a lucky break for the customer, as no shipping charges would be applied for any special-order parts.
