## At the Repair Bench – Icom IC-7300 – February 2026

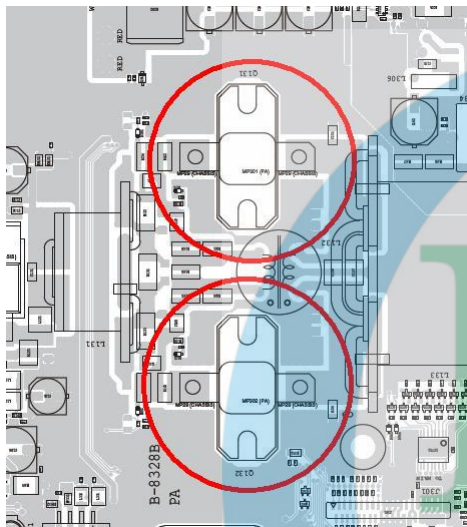
Figure 2 - PA board layout excerpt

The RD70HVF1C N-channel power MOSFET's used as the power amplifier transistors, commonly called the “*finals*”, have a unique shape as shown in Figure 2. The Figure 2 illustration is an excerpt from the IC-7300 service manual's PA PCB component layout diagram. Refer also to the datasheet excerpt in Figure 3. Note that each of these two transistors has two slotted mounting tabs through which the retaining screws pass, and then there are two foil leads that are surface-soldered to the PCB. Comparing the component outlines from Figure 1 to the datasheet excerpt in Figure 3, we can see that the *drain* lead, marked as terminal #1 in the Figure 3 drawing, has a clipped corner on the foil lead, while terminal 3, the *gate*, has no clipped corners. A careful look at the PCB will reveal that the pad for the *drain* terminal also has a clipped corner, which will align with the clipped corner on the transistor lead. Installing these transistors in an incorrect orientation will cause immediate failure of the new transistors.

To install these transistors, first identify the correct orientation as explained above. Next, with the PCB in place in the chassis and the PCB retaining screws started into their holes, drop the power amplifier transistors into their holes in the PCB and start their retaining screws into their holes, but once again, do not tighten them, and do not put the shields in place yet. Tack-solder the transistors to the PCB at both the *gate* and the *drain* terminals.

With the PCB on the bench once again, finish soldering the two power amplifier transistors Q131 and Q132 to the PCB, being sure to adequately solder each of the foil leads to the PCB pads. The PCB is now ready for reinstallation.
