## At the Repair Bench – MFJ-993B – January 2026

Figure 1 - MFJ-993B IntelliTuner

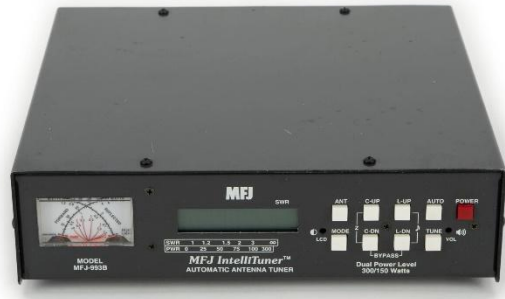
Some of you may have taken note of an earlier *Repair Bench* article that I wrote a few months back, describing the problems with the mounting of the SO-239 connectors to the rear panel of an MFJ-949E Versa-Tuner. This tuner had the same issue, caused by an identical connector mounting scheme. I see this purely as a cost-cutting move on the part of MFJ, but it is ill-advised and certainly leads to problems for the user. To describe the issue, start out by noting that the common flange-mounted SO-239 connector has a four-bolt mounting pattern, with the holes spaced on 0.750" centers forming a square.

Now... any right-thinking engineer would surely mount the connector using a positive retention method such as machine screws and locking nuts, or at least standard hex nuts and toothed lock washers that would properly "dig into" the aluminum panel material, forming a good and secure mount. However, that is not at all what MFJ chose to do with many of their tuners. Instead, they used aluminum pop rivets to retain the SO-239 connectors in place. Not only did they use pop rivets, but they populated only two

diagonally-opposite mounting holes in each connector flange rather than the full complement of four fasteners. With time and use, these pop rivets work their way loose, either through stretching or wear – most likely through stretching. This, of course, leaves the connector loose on the panel and without a secure ground connection. That was the condition in which I found the coaxial connectors on this tuner.

Another issue, though completely trivial in nature and very easy to repair, was the loose grounding (earthing) stud on the rear panel of the tuner. This stud is, in actuality, a Phillips pan head machine screw that is inserted from the inside of the rear panel and extends through the panel, secured in place by a KEPS nut. For those who may be unfamiliar with the term, a KEPS nut is a hex nut that has a captive swiveling externally-toothed lock

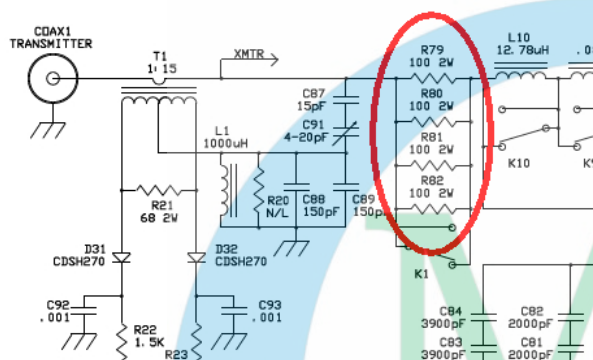
Figure 2 - MFJ-993B schematic excerpt

failure of a set of parallel resistors on a small daughterboard, and the typical lead-free solder joint failures that we see so often. Let's talk about the resistor failures first.

Directly in line with the input signal path from the transmitter is a set of four parallel resistors. In the schematic (Figure 2), they are indicated as resistors R79, R80, R81, and R82. In reality, the unit mainboard has the location of these resistors identified as R78. What is installed there is a small daughterboard that simply holds the four 2W 100Ω 5% resistors connected in parallel. This connection method yields an 8W 25Ω resistance at that point in the circuit. Once again, some of you may recall another earlier *Repair Bench* article wherein I described the repair of an MFJ-998RT remote automatic antenna tuner unit. That model used a very similar scheme, and it too had failed, though not with the same failure modality as with this unit. In that case, three of the four resistors had gone open and the remaining resistor had suffered a value increase to over a thousand ohms. In this case, the net resistance across the daughterboard was a mere 0.9Ω (see Figure 3). Each of the resistors had failed, with two of them going open, one decreasing its value to ten ohms, and the fourth decreasing its value to about one ohm. The net result was the measured resistance of 0.9Ω – using the product over the sum equation for parallel resistances, we have the following:

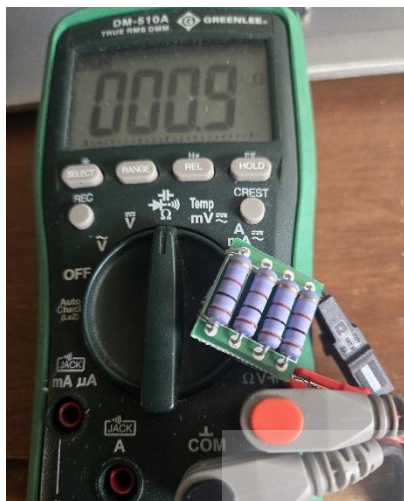
Figure 3 - Resistance through failed resistor set

$$\frac{1 \times 10}{1 + 10} = \frac{10}{11} = 0.90909\Omega.$$

The fix for this issue was to remove the daughterboard and to replace all four resistors, of course. In removing that board, I discovered that the board's two connecting leads, basically just short wire segments, were loose in the mainboard with cracked solder joints. This effectively presented at least a partial open circuit in the signal path through the tuner. More about that later.

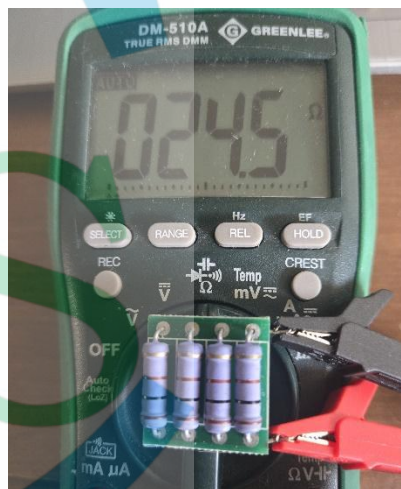
Figure 4 - Resistance after repair

I would have preferred to replace the resistors with 1% tolerance devices, if they had been in stock in my parts inventory. The 1% tolerance would have presented a resistance range from  $24.75\Omega$  to  $25.25\Omega$ , very close to the schematic value of  $25\Omega$  for the parallel set. Instead, I used 5% tolerance 2W resistors as the manufacturer had done in building the unit.

This left us with a resistance range of  $23.75\Omega$  to  $26.25\Omega$ . The actual measured resistance post-replacement was  $24.5\Omega$  (see Figure 4).

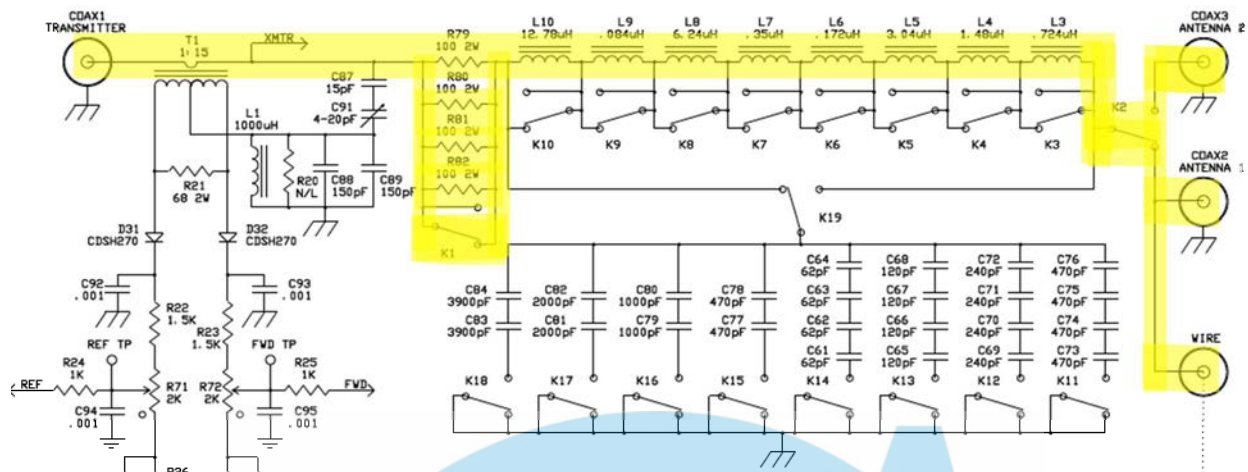
Figure 5 - MFJ-993B signal path (yellow line)

The MFJ-993B IntelliTuner is an automatic antenna tuner, and as such, it switches the various inductances and capacitances into and out of the circuit by use of a set of relays. There are eight relays for the inductors, and another eight relays for the capacitor banks. The basic circuit (see Figure 5) is an “L”, with series inductors and shunt capacitors. This is an important point, as we will see shortly.

In examining the unit mainboard, I found several locations where there were open or partially open (resistive) solder joints. These were *all* directly in the signal path, in the inductor mountings or in the associated relay connections. This brings us to a discussion of the problems related to lead-free solder joints.

While the relay pins are all relatively small by comparison, the leads of the inductors used in this unit are quite substantial, forming rather large solder joints where they are soldered to the printed circuit board (PCB). Several of these inductor joints had failed, two of them (both ends of the same toroidal inductor) having gone completely open, while others were partial failures. The partial failures result in increased resistance in the solder joint. Ideally, the resistance of a proper solder joint will be nil, or as close to nil as to be unmeasurable for all practical purposes.

Now... back to the key point of the tuner failures. Remember that I said that the basic circuit (Figure 5) is an "L" circuit? This design places the inductors directly in the signal path, which means that any open circuit in the inductor solder joints creates a break in the signal path. That in turn means that the radio is operating without any load on its output side when the inductor or relay with the open circuit is switched into the circuit. This is, of course, directly responsible for the failure of the radio that was experienced.

Repair of any failed lead-free solder joints is best done using rosin-core solder of a eutectic 63%/37% tin/lead alloy. I typically start out by adding the leaded solder to the joint to dilute the lead-free solder, and then remove the mix using either some solder braid or my vacuum de-solder tool. Then I re-solder the joint with the lead-alloy solder to finish the joint. This is the process that I used on this PCB. As a preventive measure against future failures, I re-flowed *all* of the inductor joints as well as all of the relay solder points, in both the inductor relay field and the capacitor bank field.
