## At the Repair Bench – Icom IC-746 PRO – May 2026

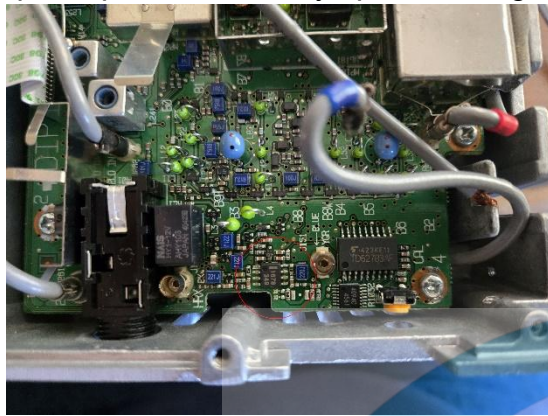
Figure 3 - IC151 location on RF UNIT board

That brings us to the modifications, comprised of adding heat sinks to two very susceptible devices. These devices are the YGR amplifier MMIC, the  $\mu$ PC1678G device labeled as IC151 on the RF UNIT board, and the 2SC1971 pre-driver transistor Q2 on the PA board. Historically, there is a high failure rate for these two devices in normal use of the IC-746 PRO transceivers.

In the case of the YGR amplifier (Figure 3), it is a case of the amplifier being on the underside of the radio so to speak, as the RF UNIT board is located at the bottom rear of the radio. This puts the MMIC in such a position that the considerable heat generated in

it as the RF signal passes through has nowhere to go except through the IC and up into the chassis above it, but there is no cooling provision made for this IC.

With both of these devices, I modify the radio by adding a machined copper heatsink to the semiconductor device substrate, using a thermally-conductive mounting tape from 3M. The  $\mu$ PC1678G gets a 6mm square heatsink, while the 2SC1971 gets one that is slightly larger at 9mm square. While this is not a perfect cure, as it still does not correct the direction of heat flow as related to the IC151 MMIC, it is surely better than the way the factory left these devices. To date, I have not had a repeat failure of these devices in any radio to which I have applied these modifications.

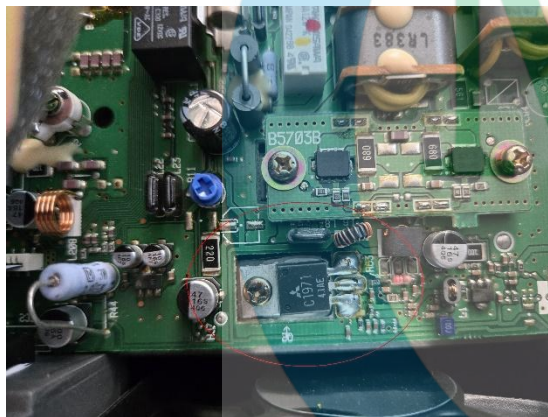
Figure 4 - Q2 location on PA board

In the case of the pre-driver transistor (Figure 4), its heat is forced to move in an unnatural downward direction into the chassis through the transistor mounting tab. This device is mounted near the upper portion of the radio, on the PA board which is in the top front portion of the chassis. Apart from its securement to the chassis underneath the device, no additional cooling provision is made.

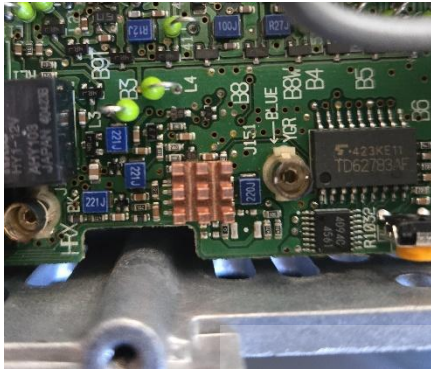
Figure 5 - IC151 with heatsink applied

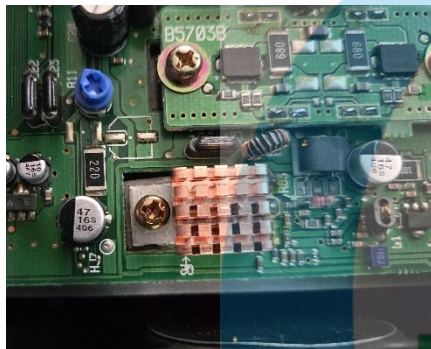
Figure 6 - Q2 with heatsink applied
