## At the Repair Bench – Alinco DX-70T – April 2026

A short while ago, one of my fellow GCARC members came to me with an Alinco DX-70T HF mobile radio (Figure 1) that had lost the majority of its output power. We quickly determined that he had had some antenna and feedline issues that likely caused the failure, so this one was basically just an evaluate and repair proposition.

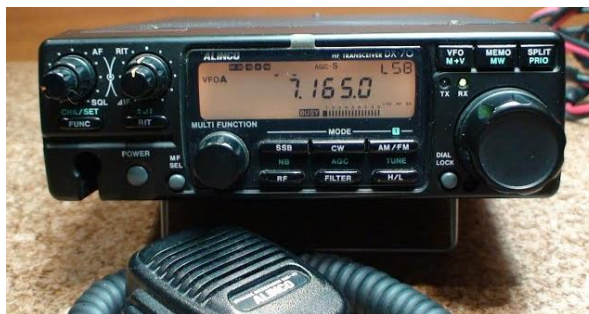
Figure 1 - Alinco DX-70T transceiver

The Alinco DX-70T is a multi-band HF plus 6-meters mobile-designed transceiver that has a nominal 100-watt maximum RF output power. This unit has only two output power levels, a low-power setting at a nominal 10 watts, and a high-power setting at the full maximum output. When tested, the maximum output from this unit was just about seven watts, and then even that fell off to a zero output during testing.

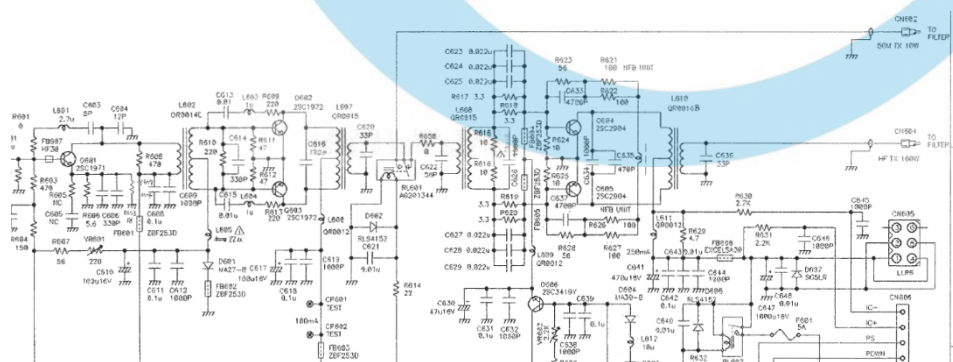
The *PA* board uses a rather strange arrangement of multiple transistors to do its work (Figure 2). A 2SC3419Y transistor is used as a bias-level controller. A 2SC1971 transistor is used as a pre-driver, a pair of 2SC1972 transistors as drivers, and finally a pair of 2SC2904 transistors are used as the power amplifier devices. All of these transistors are

Figure 2 - PA board schematic excerpt

In-circuit testing and voltage measurement revealed that with the exception of one of the driver transistors, all of the transistors on the *PA* board had failed. I decided to replace the driver transistors as a matched pair, and obviously, the remainder of the transistors on that board required replacement as well. I set out to do so.

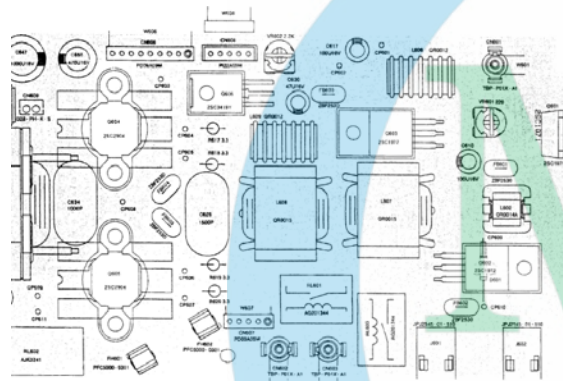
Access to the *PA* board requires removal of the *FILTER* board from the chassis, as well as disconnection of numerous interconnecting wire harnesses and coaxial cables. Mounted to the *PA* board is a small daughterboard, which sits above the power amplifier transistors. All of the transistors are secured to the chassis via machine screws through their mounting tabs, or through their flanges in the case of the 2SC2904 devices. One of the two driver transistors is installed vertically to the side wall of the chassis; the rest are all installed horizontally through the *PA* board (Figure 3).

Figure 3 - *PA* board transistor layout arrangement

Replacement of the transistors was a straightforward removal and installation process... almost. In removing the bias and driver transistors, it was discovered that the *PA* board had also been damaged by a prior repair activity. Several of the printed circuit board (PCB) traces had lifted from the board, and were held in place only by the solder on the transistor leads and the leads themselves. This was extremely difficult to work with as far as re-installing the new transistors was concerned. I decided to make more permanent and effective repairs to the PCB. In the case of most of the damaged PCB traces, they were damaged easily because they were very small, effectively being islands of copper trace material connected to traces on the lower side of the *PA* board by *vias*.

I made most of the individual repairs by scraping some solder mask from the appropriate trace on the lower surface in the location of a usable via, preparing an area to which I could solder a repair conductor. I then used a short length of solid 22AWG wire that I passed through the via and bent over against the board's lower surface. I soldered the bent wire to the scraped trace area, making a through-board connection to that trace. Then, on the upper surface of the board, I cut the wire to the proper length to fit the location under repair, and then bent the wire down against the PCB top surface, aligning it with the transistor lead. Finally, I simply soldered the transistor lead to the wire segment, and the repair was complete. I made several pad repairs in this manner, coating each repair on the PCB underside with brush-on solder mask.

Additional repairs were needed that did not pass through the board. They were made by once again scraping some solder mask from the damaged trace and soldering in a short length of wire. The wire was formed along the path that the damaged trace had originally followed, and then the relevant transistor lead was soldered to the wire.

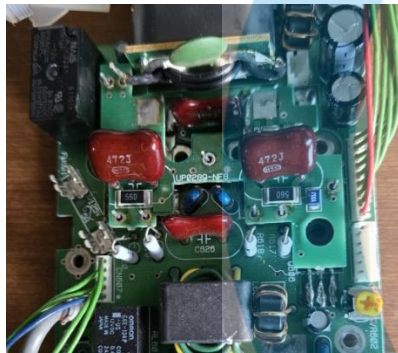
Access to the 2SC2904 power amplifier transistors is best obtained by removal of the daughterboard mentioned previously, though removal of it is not absolutely necessary. However, in examining this radio, it was discovered that the daughterboard was cracked and bent. This made it apparent that this radio had been worked on in the past, and that a poor job was done at that time. This necessitated removal of the daughterboard so as to make a repair to that board. As it turned

out, although the ground plane on the board's lower surface was broken, the ground plane on the upper surface was flexed but not broken, providing the necessary ground path for the components mounted to the daughterboard. We will discuss the daughterboard repair later.

Figure 4 - Repaired daughterboard in place in radio – not yet soldered in

Once all of the transistors were replaced and the *PA* board had been re-installed into the chassis, it was time to repair the daughterboard. This was done by first heating the board with some hot air, and then flexing the heated board back into its proper flat form. Next, I scraped some solder mask from the bottom surface of the board on either side of the crack. I completed the repair by soldering a length of bare bus wire along the edge of the crack on either side, and then soldered the two wires to each other, effectively bridging the crack. I then coated the entire repair with brush-on solder mask. To finish the job, I re-installed the

daughterboard to the *PA* board (Figure 4).
