## At the Repair Bench – Heathkit® HP-23B - October 2022

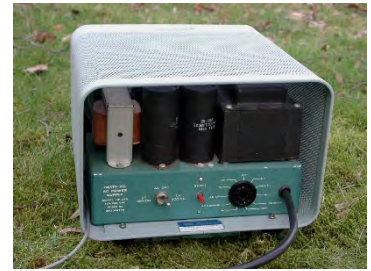
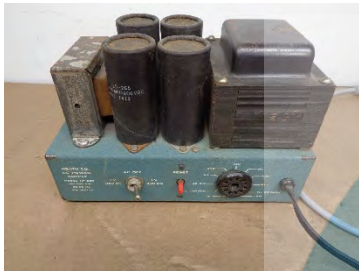
The Heathkit® HP-23B is a multi-output power supply used in conjunction with several of that company's ham radio equipment offerings. The PSU provides outputs of 700VDC at 250mA, 350VDC at 150mA, 250VDC at 100mA, -100VDC at 20mA, and 12.6VAC at 5.5A. The incoming power is a standard 120VAC at about 350 watts. The unit is heavy, weighing in at about sixteen pounds.

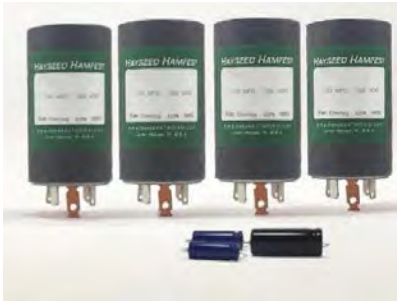
The installation of the capacitors was a straightforward repair, as all of the parts are intended to fit exactly in place of the originals so as to preserve the factory appearance of the unit. Post-repair testing showed all to be functional and the voltages to be at the manual specified levels. I wrapped and boxed the PSU and shipped it back to the owner (after he paid my bill, of course!)
