## At the Repair Bench – Heathkit® IM-5284 and IPA-5280-1 – October 2023

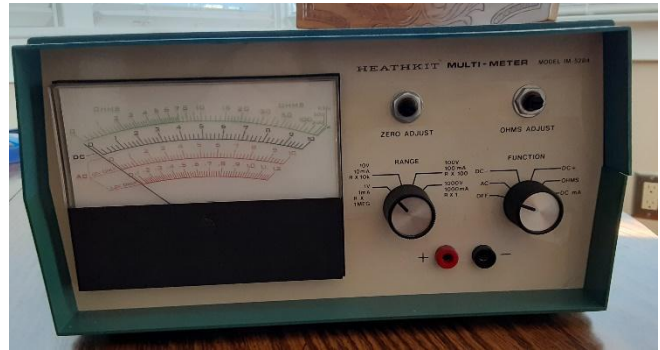
Figure 1 - Heathkit® IM-5284 multimeter as refurbished

The multimeter was a mess. This unit has two front-panel wafer-type rotary switches and two front panel potentiometers. All four of these controls were seized and would not turn at all. On the rear panel of the enclosure is the connector to which the power supply cable connects,

which we already discussed, and also a slide switch that is used to select between the power supply as a power source and the internal battery bank as the power source. This switch was also seized and would not slide at all. When I opened up the enclosure, I found more damage. While the two nine-volt battery snaps were unpopulated, they were none the less severely corroded, beyond saving. There was a leaking "C" cell in the holder for the ohmmeter power source. The alkali from this cell had leaked all over the inside of the enclosure, coating the bottom of the enclosure and soaking into the paint on the front panel. Several wires had corroded off their attachment points, and the battery contacts for the "C" cell were corroded beyond use, with one of them actually broken into two pieces and the other corroded so badly that there were holes through the metal.

I began by completely disassembling the unit and starting the clean-up of the various pieces. That was when I discovered that the alkali had damaged the front panel paint to the point where the paint all the way across the lower edge of the front panel washed off when I rinsed the panel under cold running water. I cleaned the enclosure sections with warm water and dish soap, removing all traces of the alkali and the corrosion. I cleaned the front panel the same way. Fortunately, the damage to the paint remained below the portion of the panel where there were markings for the various controls, so it turned out to be an easy fix with a rattle-can of the right color paint, first masking out the lettering on the panel to avoid overspray damage there.

The rotary wafer switches required complete disassembly in order to free up the moving parts and to clean the wafers properly. I did this for both of the switches, restoring them to working condition. Next, I disassembled the two front panel potentiometers and cleaned and lubricated them in the same manner. DeoxIT is the best choice for cleaning and lubricating these components.

The next thing that I tackled was the rear panel slide switch, removing the original one and installing a new replacement switch in its place. Then I set about repairing the damaged wiring, including replacing the two nine-volt battery snap connectors. Once all of the damaged wiring was repaired, I had to fabricate two new battery contacts for the "C" cell position. This was done by cutting some 24-gauge copper sheet metal to the correct size, and then making two cuts in the bottom edge of each new contact, reaching up about three-quarters of the way to the top of each contact. The center strip, between the cuts, was bent forward to form a spring contact that projects forward from the plane of the contact. I soldered the contacts to their wire leads, and then slid them down into their proper locations in the "C" cell battery compartment.

Once the multimeter was fully assembled, I went through the calibration steps as detailed in the factory manual for this unit, successfully calibrating the multimeter. To complete the job, I made up a set of probe leads for the multimeter and put them into the storage compartment built into the upper enclosure half. Job done... and now it was time to turn to the power supply.

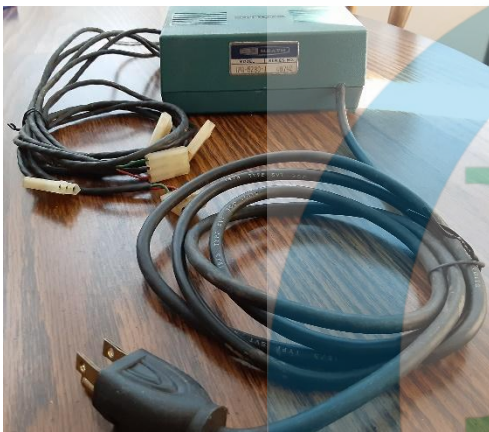
Figure 2 - Heathkit® IPA-5280-1 power supply

Let's talk about condition first. The power supply was plugged in to the multimeter and could not be unplugged. It turned out that the -9VDC wire in the connector body had overheated and melted the connection together, leaving cutting the wires as the only means of removing the power supply from the multimeter. More about the power supply later.

When tested, the power supply was dead. I opened it up and found that the fuse was blown. Digging deeper, I discovered that one of the full-wave rectifier diodes was shorted as was one of the 500 $\mu$ F filter capacitors. I replaced the failed diode and all of the polarized capacitors in the unit – two of the 500 $\mu$ F capacitors and a pair of 10 $\mu$ F capacitors at the outputs of the voltage regulator IC's. I then replaced the fuse and tested the unit. It came right up and operated correctly, so I placed it under a load to verify the voltage regulation. The unit held rock steady at +9VDC and -9VDC at the two outputs. I assembled the power supply enclosure and replaced the cut-off plug that was melted when connected to the multimeter, and the power supply was as good as new.
