## At the Repair Bench – Heathkit® IP-2718 Power Supply – September 2023

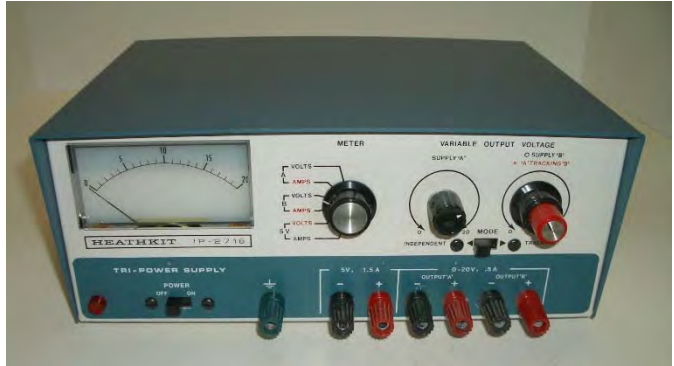
Figure 1- Heathkit® IP-2718 Tri-Power Power Supply
