## At the Repair Bench – Heathkit® IT-5283 Signal Tracer – March 2024

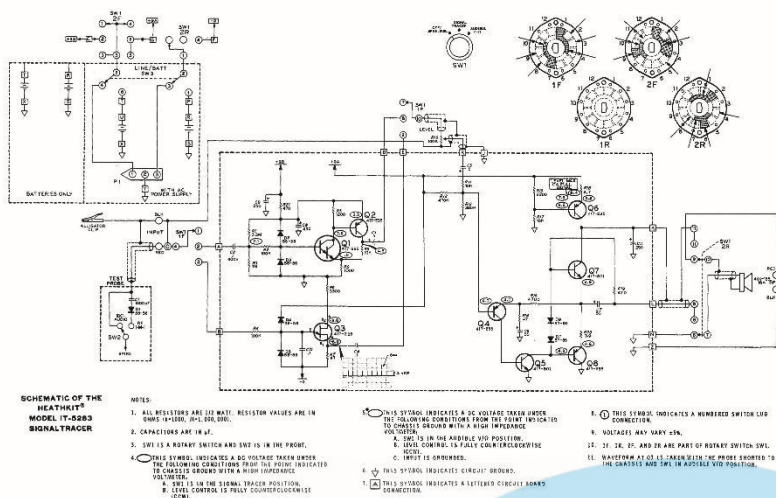
Figure 3 - IT-5283 schematic diagram

I opened up the housing to access the circuit board, and got out a schematic of the unit (Figure 3) from my Heathkit® library, and started to check for voltages on the printed circuit board (PCB). Once again, the owner was correct in that there was absolutely nothing alive on the PCB. Knowing that I had a pair of good batteries, I went to the power switch, which is a section of the rotary function selector switch on the front panel. The switch was badly oxidized, so I cleaned it

simple fix for this one, I thought. Simply dismount the switch, rotate it 180°, and remount it. Once I saw that problem, I simply moved the switch to the correct position (I would turn it around later) and continued with my testing.

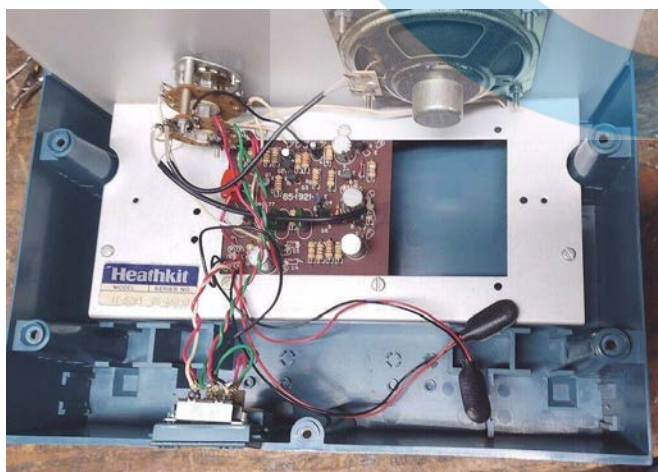
Figure 4 - IT-5283 interior, showing mounted PCB

I started probing the PCB (Figure 4) for actual voltages in accordance with the schematic, and I quickly found that the operating voltages for transistors Q6, Q7, and Q8 were very low, with no voltage present at all on Q8. According to the schematic, there is a 250 $\mu$ F electrolytic capacitor (C11) that is connected to the collectors of Q6 and Q7, and if shorted or very leaky, would drag those terminals, and by extension Q8, right down to low levels. I removed that capacitor and tested it. It turned out to be *extremely* leaky, testing out more like a 98 $\Omega$  resistor than like a capacitor. I replaced it with a 220 $\mu$ F 25V electrolytic from my inventory, and the unit came alive.

I was not finished there, however, as although it was alive, it was extremely noisy when the level (gain) potentiometer was rotated, and from time to time there was a loud “pop” in the speaker as well. Some more investigation turned up another failed capacitor, this one a 10 $\mu$ F electrolytic in the level control circuit. I replaced it with a like 10 $\mu$ F 16V electrolytic capacitor from my inventory, and the “pop” was gone. Some DeoxIT® spray took care of the noisy level potentiometer as well.

With two of the seven electrolytic capacitors in this unit having failed, I opted to replace all of the electrolytics, three (total) 250 $\mu$ F (replaced by 220 $\mu$ F), two 50 $\mu$ F (replaced by 47 $\mu$ F), and two (total) 10 $\mu$ F capacitors. Once that was completed, I went over the rest of the unit to check for any other problems, and I found one wire in the "LINE" power circuit that was not soldered to the PCB. It was in the hole in the PCB, and because it was solid rather than stranded wire, it stayed in place, but the circuit would have been problematic at best, if it worked at all. Of course, I soldered this wire in place properly. I then remounted the power source selector switch in its proper orientation, gave the unit a good cleaning, and buttoned it up. Finished!
