## At the Repair Bench – LF&C Survey Meter – February 2024

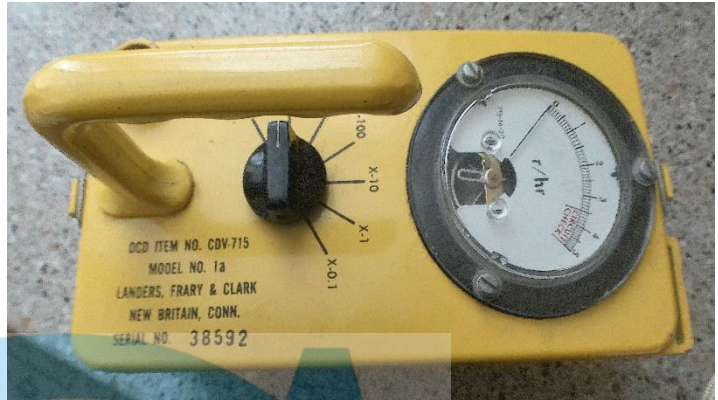
Figure 1 - CD V-715 Radiological Survey Meter

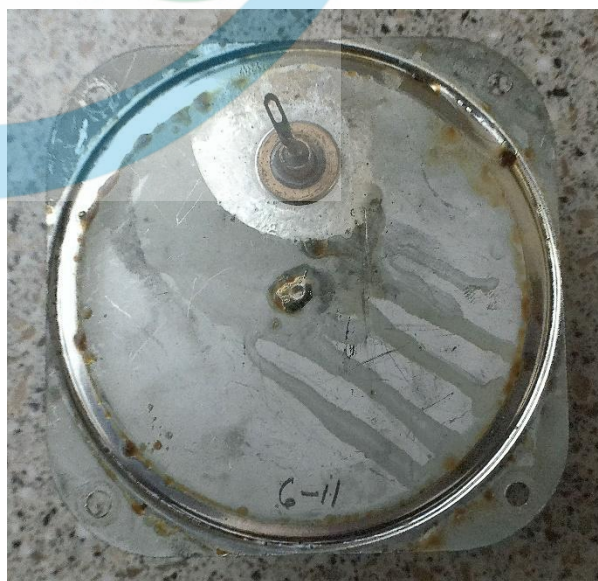
As mentioned previously, the sensing element is a hermetically sealed plated steel ionization chamber. This chamber (Figure 3) consists of a shell and an insulated center electrode called a collector, which is mounted to a high-resistance insulated feed-through connector. A strong voltage potential is applied to the collector and ionization chamber shell, which makes the shell (with respect to electrical common) negative by about a sixty-volt differential. This negative charge attracts the positively-charged ions that are formed by gamma radiation passing through the air that is contained within the ionization chamber. The ions striking the

Figure 3 - Ionization chamber

ionization chamber shell cause a current to flow in the collector. This current is proportional to the number of ions striking the shell, and therefore proportional to the strength of the radiation field. What appears to be a date (June of 2011) is penciled on the top of the ionization chamber. It is a possible surmise that this is an historical replacement date for the ionization chamber.

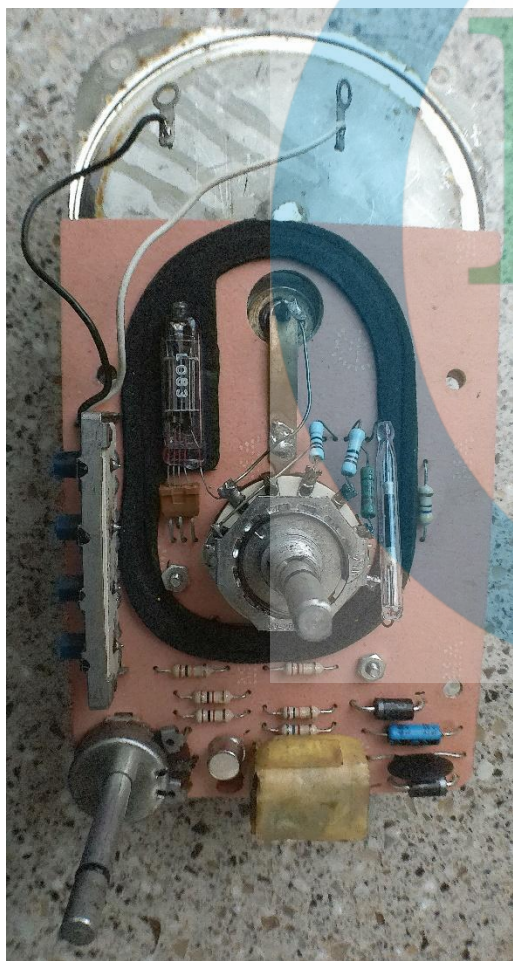
Depending upon which range has been selected by the range selector switch, this very small collector current flows through and develops a measurable voltage across one of the extremely high value resistors discussed earlier and clearly visible, attached to the range switch in the Figure 4 photo. This voltage is applied to the grid of the triode-connected 5886 Electrometer Tube, causing a small current to flow in the grid circuit. To give some idea of just how small this grid current really is, I took a quick look at the *Tung-Sol 5886 Pentode Electrometer Vacuum Tube Datasheet*. The *maximum* grid current, in accordance with the datasheet limitations, is  $2.5 \times 10^{-13}$  amperes when the tube is used as a triode, as it is in this circuit. Written in another form, this current we are talking about measures a mere 0.00000000000025 amperes! The grid current causes a proportional plate current to flow in the tube, with any change in the plate current being shown on the 0-50 $\mu$ A meter movement that is the user's indication of a detected radiation source.

Figure 4 - Complete PCB after repairs

The LC&F meter circuit uses three semiconductor devices – one transistor (mentioned earlier) and two rectifier diodes. The only information provided about the rectifier diodes is that they were “rectifiers”, meaning that they were intended for use in a power supply to convert the AC into DC, and that one had a 50V PIV rating, while the other had a 100V PIV rating. It is unclear why two different diodes were chosen here, as the 100PIV diode should have worked in either location. The original diodes had heavy oxidation on their leads, compromising the lead integrity to the point where they both broke off easily when moved slightly during de-soldering. Through test measurements, I was able to determine that they were both of silicon composition, so I replaced them with a 1N5400 50V PIV 3A diode and a 1N5401 100V PIV 3A diode, both of which were in stock. These rectifier diodes are visible in the Figure 4 photo at the bottom right corner of the PCB.

of the original transistor was which terminal of the transistor, which then easily translated to a match with the terminal versus pin assignments of the new transistor. Seeing that everything matched up, I was very confident that I had located a proper replacement for the failed transistor in this unit. I went ahead and installed the new transistor, which can be seen at the lower left area of the PCB in the Figure 4 photo, just to the right of the meter “zero” control potentiometer.

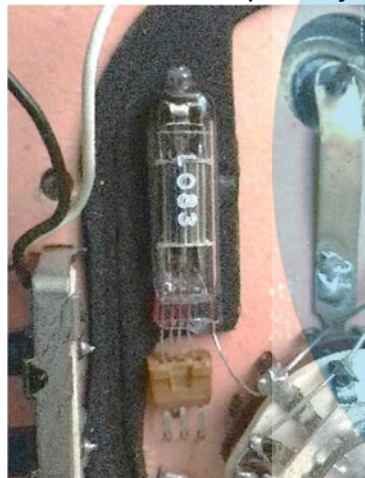
Figure 5 - 5886 vacuum tube

Figure 5 shows a close-up view of the 5886 Pentode Electrometer vacuum tube. I illustrate this tube simply for its curiosity value, as it is somewhat different from those devices that we customarily recognize as *vacuum tubes*. None the less, it is a vacuum tube. Earlier in this article, reference was made to the fact that the current

from the collector of the ionization chamber is directed to both the high-value resistor(s) via the range selector switch and to the (control) grid of the triode-connected vacuum tube. Note the bare wire lead from the vacuum tube, from the right side of the tube as shown in the Figure 5 photo. This lead ties directly to the common terminal of one deck of the range selector switch, and then also connects directly to the collector lead of the ionization chamber. Note that apart from that one wire, which is soldered, the vacuum tube is connected into the circuit by use of a vacuum tube base socket as are most vacuum tubes. A quick look at the schematic in Figure 2 shows that the cathode is directly heated, and that the cathode is tied directly to the emitter of the transistor.
