# At the Repair Bench – MFJ-259B – January 2024

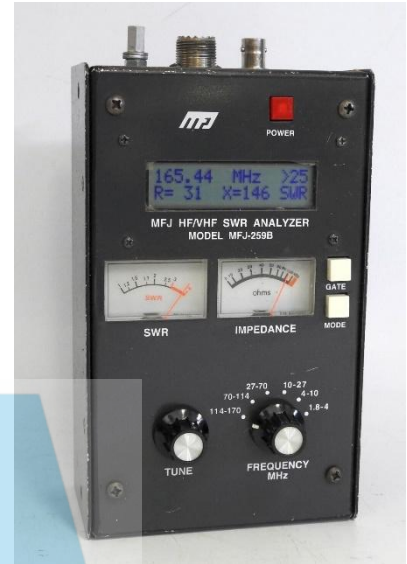
I next took a look at the ground side of the LCD panel. Pin #1 of the LCD harness is the ground wire, while Pin #2 is the +5VDC lead. When I measure the voltage between these two points, I got no voltage reading at all. When I measured Pin #2 to chassis ground, the +5VDC was

present. I next placed a temporary jumper wire from Pin #1 of the LCD panel to chassis ground, and the panel came alive and worked normally.

OK – was there an open in the harness to the LCD panel? Or was the problem elsewhere? I moved the jumper wire from the LCD panel to the Pin #1 wire connect point on the main board, and the panel remained operational. This told me that the wire harness was OK, but that the connection point on the main board had lost its ground connection somehow. I re-flowed that joint again, but that still did not solve the problem.

Ultimately, I resolved the issue by soldering in a jumper wire from the Pin #1 connection on the main board to another chassis ground point on the main board. Problem solved.

What is interesting about this unit, and something that I believe led to the failure of the PCB connection, is the fact that the battery holder for this unit is mounted directly to the PCB, at two points that span the area of the LCD panel connection to the main board. It is likely that the stresses imposed by removing and re-securing the battery compartment caused some flexing of the printed circuit board, resulting in the failure.
