# Orion OR-2300 Rotator System Resurrection

Figure 1 - Orion OR-2300 rotator system

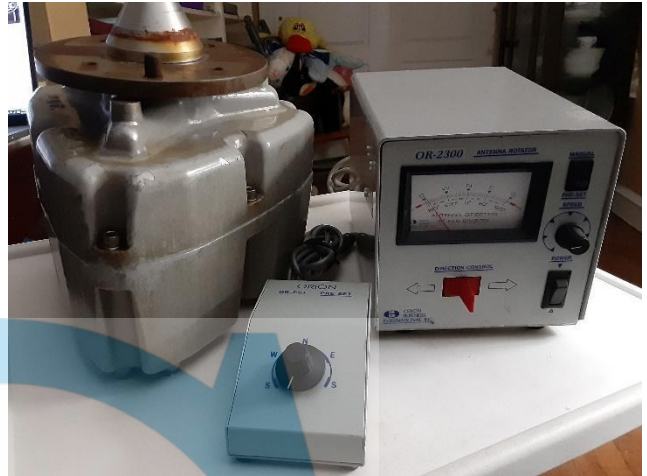
This Orion OR-2300 system (Figure 1) belongs to GCARC member **Darrell Neron AB2E**, and it has considerable sentimental value to him. Because of that perceived value and because I enjoy a challenge, I decided to attempt the Herculean task. You see, this rotator system had been stored inside polyfilm bags which were in turn inside a cardboard carton. The whole shooting match had been in storage in Darrell's garage, where unfortunately, a flood had saturated the system. In fact, the water level was several inches deep and remained at that level for a while, trapped inside the polyfilm bags and having plenty of opportunity to cause extensive damage to the rotator system.

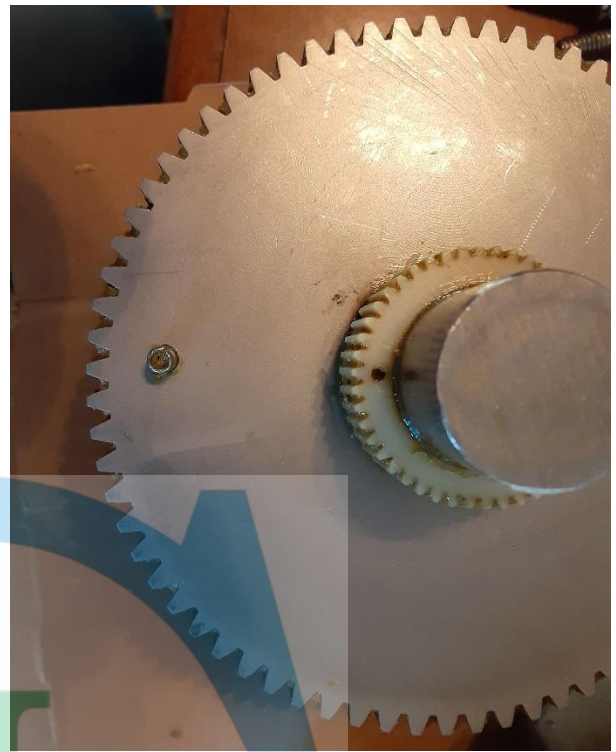
Figure 10 - Roll pin and pot drive gear under output spur gear

The output spur gear has a short heavy roll pin driven into a hole about an inch in from the edge of the gear (Figure 10), on what becomes its lower face when the gear is installed. This roll pin protrudes proud of the gear face by about a quarter of an inch. The sole purpose of this roll pin is to engage the limit switch actuating lever and then to cause the activation of the limit switch(es) as the gear continues to rotate. The circumferential position of this pin becomes quite important when the gear is installed, as it is a crucial element in the output gear to potentiometer driven gear timing system.

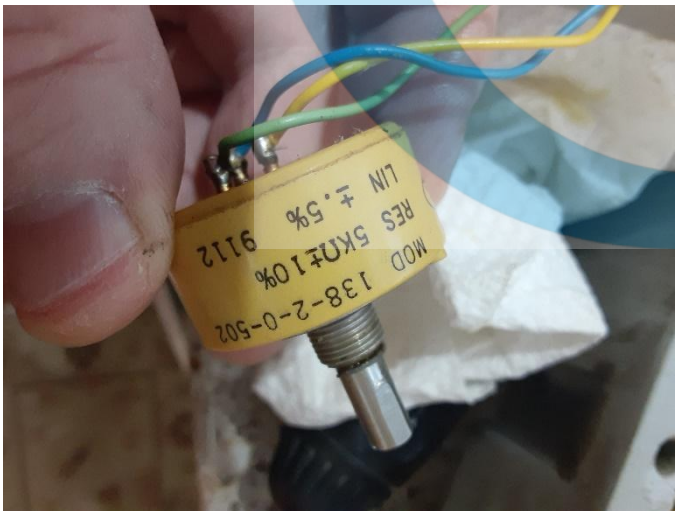
Figure 13 - Position-reporting potentiometer

Now let's go back to the position-reporting potentiometer (Figure 13). According to the Owner's Manual that was brought to me with the rotator, the potentiometer is wired with the BLU wire to the high resistance end, the GRN wire to the low resistance end, and the YEL wire to the wiper. However, upon opening up the motion unit, it was wired differently, with the YEL to the high resistance end and the BLU wire to the wiper. The GRN wire was in the position indicated in the manual, at the low resistance end of the potentiometer. Because the active resistance between these two dislocated wires is measured between the wiper and the upper side of the pot, it really does not matter which wire is in which position. It *would* have made a difference if the upper and lower ends had been swapped, but that is not the case here.

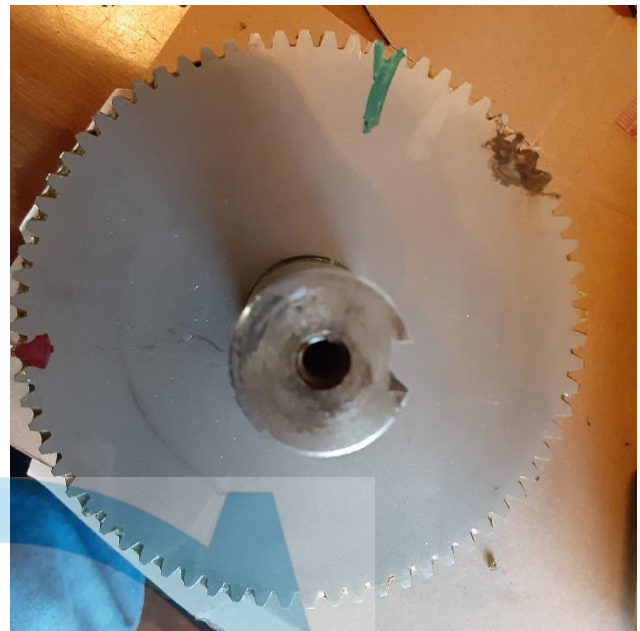
Figure 12 - Timing markings on output spur gear

Proper timing of this gear pair is accomplished by first carefully identifying and then marking the midpoint of the potentiometer's rotational travel. Then, with the pot established at the midpoint of its rotation, install the output spur gear in such a manner that the switch activation pin is diametrically opposite the center point of the gap between the limit switches, which puts the pin in direct (though not directly observable) alignment with the limit switch actuating lever. The best way to handle this issue is to transfer the location of the roll pin to the upper face of the output gear (Figure 12), using a Sharpie® marker to mark the

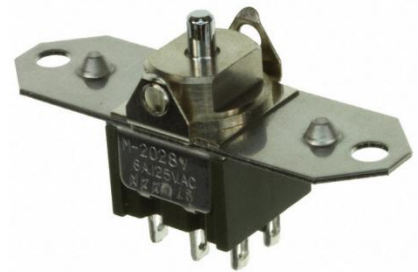
Figure 20 - New direction switch

The controller front-panel direction control switch is a DPDT paddle-operated rear-of-panel mounted toggle switch (Figure 20), which has a pivot frame mounted to the switch bushing to support the operating paddle (Figure 21). The paddle is a separate part number from the switch, as this same switch body can be used with a number of different actuator types offered by the manufacturer. Because the paddle lever was missing from this unit upon its delivery to me, I ordered both a

switch and its mating paddle lever so that I could be sure that the two parts received would work together. The are dimensional differences between the products of different manufacturers, and the original switch was not carrying any obvious manufacturer's markings. This made it difficult to obtain the exactly correct paddle lever; hence the replacement of both parts of the switch system.
