## At the Repair Bench – P-touch® 1400 – May 2023

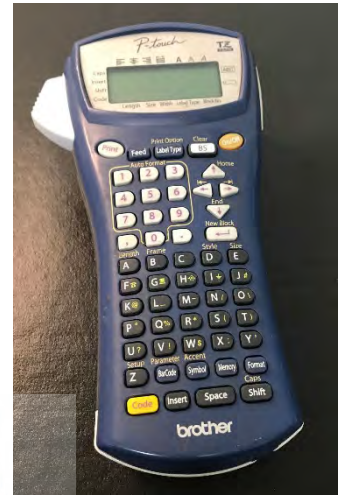
Figure 1 - Brother P-touch 1400

Fairly recently, I was presented with a somewhat different type of repair. One of my fellow radio club members asked me if I would take a look at a favorite and trusted piece of his shack equipment, namely a Brother P-touch® 1400 hand-held label printer (Figure 1). The printer had stopped responding to the “Y” key, and its owner was hoping that I could repair the machine for him. Enjoying a challenge, I told him that I would take it on, but without any up-front guarantee of success.

The owner brought the machine to me, and I quickly determined that not only did the “Y” key not work at all, the other keys along the right edge of the keyboard were rather “mushy” and not crisp and quick as they should have been. I opened up the unit to find that the printed circuit board on which the key contacts were etched had delaminated at a mounting pad along its right-hand edge, directly in alignment with the “Y” key, and breaking the circuit traces for that key and one other. This was apparently a product of years of use and pressure on that portion of the board.

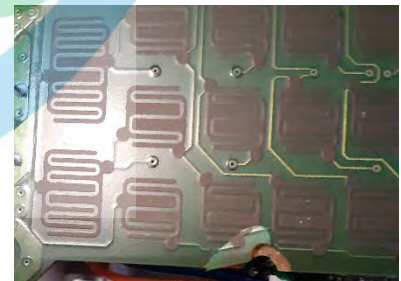
Figure 3 - Torn PCB traces

The keyboard consists of a matrix of conductive pads etched onto the top surface of a phenolic board that also serves as a printed circuit board for some of the related circuitry. Each key contains a carbon button on its underside that bridges the conductive pads when the key is pressed. Simple enough, right? The problem was that the board had split between its layers (Figure 2), tearing the circuit traces on its upper surface. I was faced with a dual problem – how to first repair the delaminated phenolic board, and then how to repair the circuit traces (Figure 3) so that the machine would operate properly afterwards.

At some point during the night, and driven by some unknown and not understood "force", I hit upon an idea that might just work. I had read a while back about pens that write with conductive ink, which contains powdered silver in a volatile carrier. It was well worth a try, so I ordered one of the pens from Amazon and waited another day for it to arrive. Lo and behold, when I tried the pen on some paper, and then measured the resistance of the drawn lines, I found them to be very low impedance traces, and with almost no appreciable height on the paper surface.

To make this idea work, I would have to expose some of the conductive surface of the existing traces for the ink to connect into the original circuit properly. That was a chore best done with the edge of a hobby knife blade, and that is exactly how I achieved the exposure that I needed. I then laid the ink down in place (Figure 5) over the almost invisible cracks in the repaired surface of the board, and checked the results with an ohmmeter.

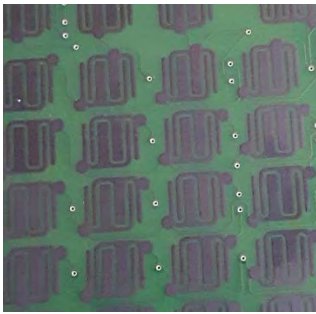
Figure 4 - PCB contact "fingers"

The most common method of repairing lifted or broken printed circuit traces, by far, is to simply scrape the trace to expose the conductive surface, and then to overlay the trace with some bare wire, and to then solder the wire to the trace. While this might work in some cases, it would clearly *not* be an effective repair in this situation, as one broken trace was directly in the area where the “Y” key’s carbon button would have to make contact with the board if that key were to be pressed. Any raised area of the board would be problematic in allowing the carbon button to successfully bridge the pads, which actually contain interlaced “fingers” (Figure 4) rather than being geometrically shaped areas. I needed a better solution.

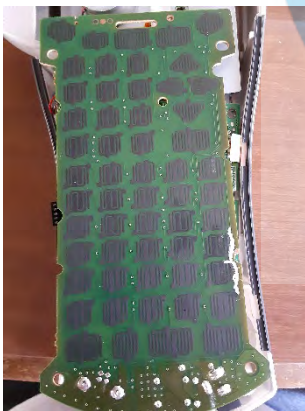
Figure 6 - Repaired PCB

After that, all that was required was to reassemble the machine with the repaired PCB (Figure 6) and to do a final working test of the entire keyboard. That post-assembly test proved successful, and so the repair was complete.
