# At the Repair Bench – Para Dynamics Dummy Load

August 2024

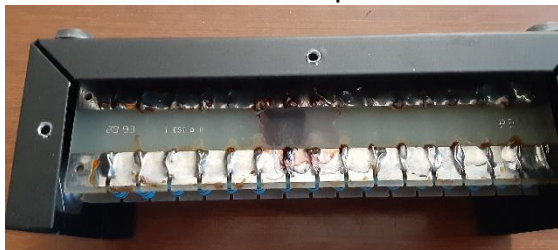
body of the dummy load. There, it was obvious that a resistor had gotten very hot, as the board was charred.

I attacked the unit with the soldering iron, first removing the dummy load body from its enclosure, and then removing the three resistors in the series string that was centered at the charred spot. What I found was that *all three of these resistors had failed catastrophically*, and that that particular series string was in fact not in circuit at all, but was fully open.

Figure 2 - Charred spot on PCB

So... why did these three resistors fail, and why did they fail in the manner in which they did? I cannot answer that with any degree of certainty. I can make the assumption, however, that excessive power was input into the load and that this failure was the result. Maybe they were the “weak link” in the resistor chain. Maybe the soldering at those resistors was poor and heat developed as a result. “Maybe” is a big and powerful word, because it can mean so much and so little at the same time. All that I know for sure is that

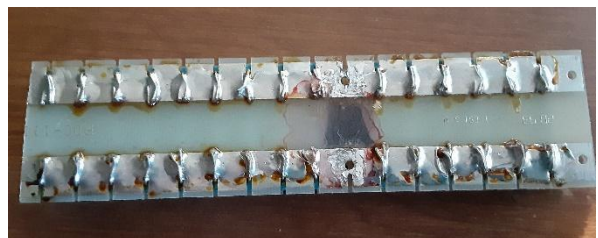
Figure 3 - PCB with resistors removed

I had the same type and value resistors in stock, so it was a simple job to install three new resistors at that location in the array. I did so, and then I reassembled the dummy load. Now when measured with the ohmmeter, the resistance showed as 50.1 ohms from the SO-239 center pin to the body of the dummy load.
