# RCA WO-33A Three-inch Oscilloscope Rejuvenation

Not too long ago, I picked up a well-used three-inch oscilloscope, an RCA WO-33A unit (Figure 1), with the expressed intention of converting this 'scope into another piece of test equipment, namely a graphic semiconductor curve tracer. The main working parts of the 'scope would remain untouched, but an additional small power supply and a circuit board would be added in to provide the new functions that I wanted. The oscilloscope had its rubber bezel, but it did not have a graticule. This did not make any difference, because the graticule is not specifically needed for the curve tracer to operate acceptably. Down the road, I may make a new graticule out of some colored acetate sheeting onto which I can imprint a grid and scale, but that is another project.

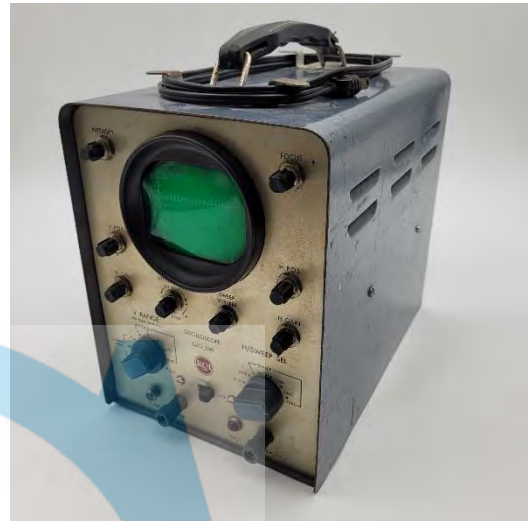
Figure 1 - RCA WO-33A oscilloscope (with graticule)

The 'scope had been, as already mentioned, very well used, and its overall condition reflected that fact. The non-polarized two-wire power cord was in bad shape, with cracks and splits in several points along its length. The faceplate had been splattered with light blue paint droplets, and the vertical input BNC jack on the front panel was bent and badly corroded, making it unusable as an input jack.

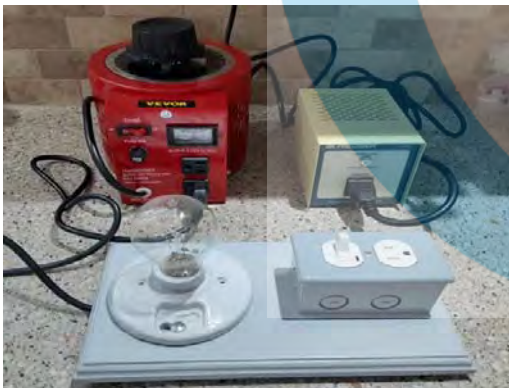
All of these were minor issues in the overall scheme of things. Far more important to me was the electrical condition of the unit. I removed the 'scope from its cabinet and I hooked it up to what I call my "safety trinity" (Figure 2) – my dim bulb current limiter, my Variac™, and my isolation transformer – to see what it would do. When I powered it on, the dim bulb went to full brightness and just stayed there, never dimming as it should have done if the 'scope were intact electrically. This indicated either a direct short circuit from line to neutral, or else some severe capacitor leakage.

Figure 2 - Safety trinity

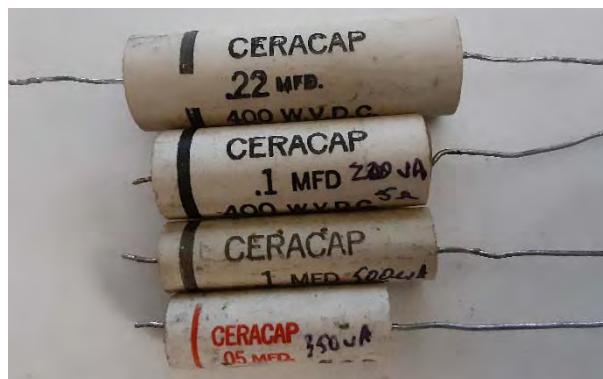
Anyway, the capacitors that I believe were all factory components were all of a type – ceramic tubes with wax filling, all marked as being CERACAP devices (Figure 3) from American Radionic Company, Incorporated. Some research showed that American Radionic is still around today, located now in Palm Coast, Florida, some sixty miles south of Jacksonville, where they relocated after leaving Danbury, Connecticut in the late 1980's. Their AmRad line of motor-run capacitors are considered to be world-class products. However, in the 1950's and 1960's, they were a major supplier of wax and paper capacitors to consumer TV and radio manufacturers.

Figure 3 - CERACAP examples

As is evident from the data in Table 1, all of the capacitors believed to be originals had significant leakage and had considerably higher than acceptable ESR values. As such, it was best that these capacitors were all replaced. The aggregate leakage of these capacitors was a contributor to the excessive current drawn by the 'scope on power-up.

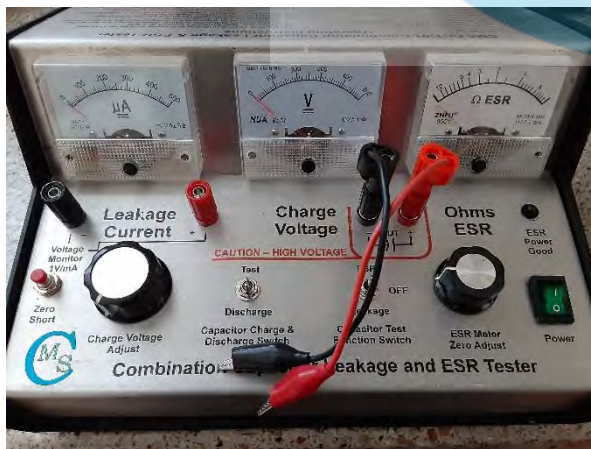
After replacement of the capacitors, I decided to investigate the exact condition of the capacitors that I had removed. I did this using a capacitor tester of my own design and build (Figure 7), which tests capacitors for leakage and for ESR. What I found, detailed in Table 1, is quite revealing.

Figure 7 - Capacitor leakage and ESR tester

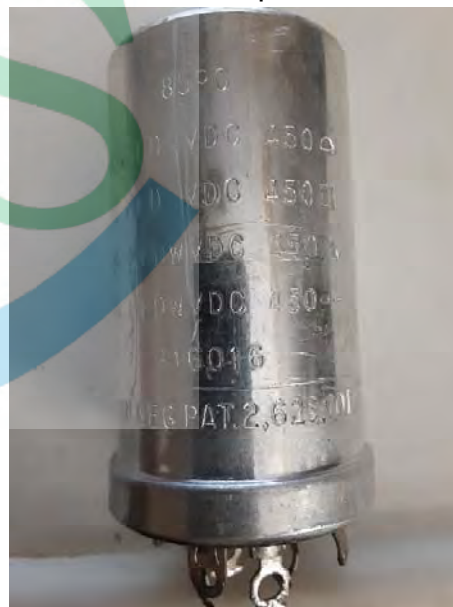
locations C38A-D and C39A-D. C38 is in the 6BR8A pentode/triode vacuum tube vertical input amplifier circuit, while C39 is used as the incoming power filtering capacitors immediately subsequent to rectification by the 6X4 dual-diode vacuum tube. The original capacitors in these locations were unmarked as to manufacturer or date, but they were marked with a patent number and a part number (Figure 8). A quick Google search on the patent number showed that the patent was a 1952 (23 December 1952) application, made by Jerome J Kurland and Joseph J Kurland. Some more research showed that these two gentlemen were the co-owners of a company called Illinois Condenser Company of Chicago, Illinois. From that information, one would have to conclude that these capacitors were manufactured by the Illinois Condenser Company.

*Figure 8 - Original C38 capacitor*

As can be concluded from the values in the table above, the electrolytic capacitor sections all exhibited extremely high leakage. High leakage is quite typical of electrolytics, but generally not to the extent seen here. This leakage, taken together with the leakage of the film capacitors, was clearly enough to cause the excessive current draw seen in the initial power-up test.

The replacement devices are the product of CE Manufacturing of Tempe, Arizona. CE Manufacturing produces a fairly extensive product range of multi-section can-type electrolytic filter capacitors, intended primarily as replacements for guitar amplifiers and older radio receivers. I have used their capacitors in several refurbishing projects over the past few years, always with great success. They are drop-in replacements as far as size, pinout, and appearance are all concerned.

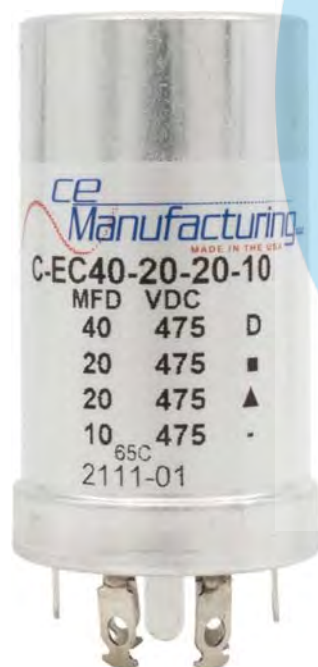
On capacitors of this type, the individual sections are identified by a symbol (▲, ■, or ●) adjacent to each terminal. In a four-section device, the fourth terminal is unmarked or marked with a line or dashes (--). In most cases, a legend is marked or labeled on the body of the

capacitor (Figure 9), indicating which section carries which ratings, both as to capacity and as to voltage. The capacitor shell is the common negative side of the internal capacitors.

Figure 9 – Capacitor label

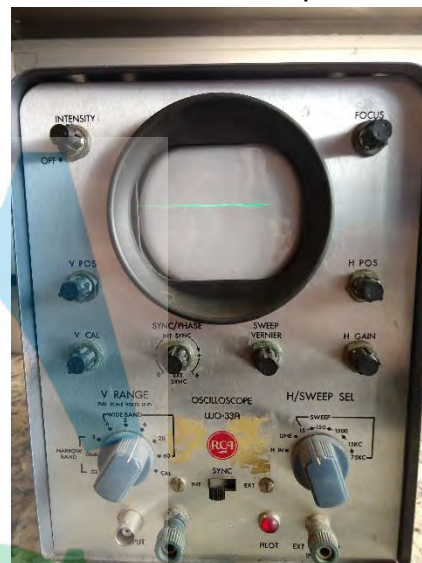
Figure 12 - Working oscilloscope

At this point, the RCA WO-33A oscilloscope is operating in accordance with its design standards (Figure 12), and is ready for its final conversion to its new purpose and life as a semiconductor device curve tracer. The next step is to design and construct both the power supply and the curve tracer interface board. Once they have been designed and bread-boarded, I will have the PCB's manufactured. After that, I can install them into the oscilloscope enclosure, mounting them to the chassis rails. I will write another article describing those processes as they progress to completion. For now, I will say farewell!

With the repairs and cleaning completed, it was time to pay some attention to the external appearance of the unit. This turned out to be a relatively minor issue, as the blue paint which had been splattered across the front panel, the upper surface, and the left side panel all came off with some acetone on a soft cloth. The remainder of the stains and debris on the enclosure all came off with some denatured alcohol and another soft cloth, using an old toothbrush to scrub the corners and crevices. A final wipe-down of the front panel with the denatured alcohol finished the clean-up of the unit, though I still need to find a way to safely remove some tape residue without damaging the RCA logo, as can be seen in the Figure 12 photo.
