## At the Repair Bench – Simpson 260 – September 2022

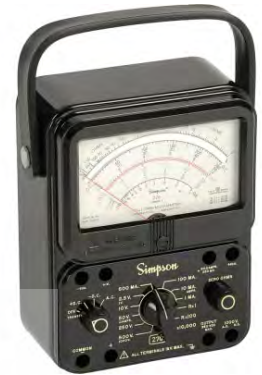
A few weeks ago, I received a carton in the mail, with a plea for help tucked into the carton alongside a Simpson 260 Series 5 analog VOMM. (Yes – VOMM is correct in this case, as the meter is a volts, ohms, and milliamperes meter.) The owner wrote that it had quit working in all modes and he had no idea why. Of course, I was up for the challenge, and it turned out to be quite interesting.

I began a more thorough examination of the meter componentry, looking for burned components or broken wire solder points. What I found instead was quite surprising, and goes to show that you cannot always believe what people say. A close inspection revealed that the PCB on which most of the meter’s components are installed was cracked along its left (from the rear) side, about an inch in from the edge of the board and at an angle from the outer corner towards the center.

I removed the PCB to examine the opposite (foil) side, and found that five traces were broken along the crack. This might turn out to be a simple repair. I began by applying some cyanoacrylate glue to the crack to strengthen the board. When the glue had cured, I simply solder-bridged the cracks in the foil traces, a task made easier by the fact that the traces were solder-covered. I re-installed the “AA” and “D” cells, and tested the meter. Full operation was restored! I did some cleaning of the switches and pots inside the meter with some DeoxIT® Gold, cleaned up the exterior, and secured the back to the meter assembly.

The meter’s folding handle was quite misshapen (read: bent). I decided to remove it and repair it. The handle is secured by a shoulder bolt on either side of the case, so I removed those bolts. The handle itself is a sandwich of metal encased by a plastic covering, making it a simple task to straighten the handle completely, and then to re-bend it to its proper contour. I then re-installed the handle and the job was done.
