## At the Repair Bench – Yaesu FT-65 – March 2025

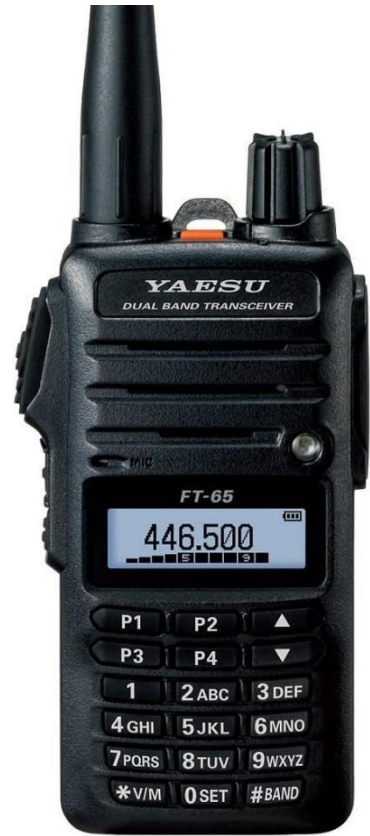
Figure 1 - Yaesu FT-65 handheld radio

Sometimes, repairs will come in that are not actually “repairs” at all, although they seem to be to the owner of the equipment of concern. That was exactly the situation with a recent “repair” to a Yaesu FT-65 handheld dual-band transceiver (Figure 1).

That fact caused me to look more deeply into the various settings in the repeater configurations of the radio. The first thing that I did was to connect the radio to a PC via a programming cable and back up the existing configuration. Then, I took a look at what was shown in the downloaded data from the radio. What I found was surprisingly simple... the squelch mode was set to “OFF”.

I disconnected the radio from the PC and went into the menu system to make some changes manually. As soon as I set the squelch mode to “TSQL” (tone squelch), the unit came up as expected on the repeater.

To finish up after all of the testing was complete, I reset the radio to factory settings and then re-programmed the frequencies that were in memory when I received the unit by restoring the backed-up configuration to the radio. Finally, I once again manually set the TSQL value again, and the job was done.
