## At the Repair Bench – Yaesu FTM-400 – May 2024

Sometimes, a repair does not only involve schematics, components, and solder. That was the case recently when a Yaesu FTM-400XDR (Figure 1) came in for repair. The FTM-400XDR is a dual-band 2m/70cm mobile radio with digital, data, APRS, and Bluetooth capability in addition to the usual analog modes.

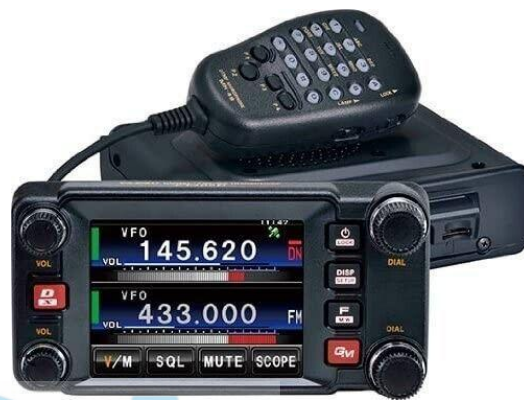
Figure 1 - Yaesu FTM-400

The radio's owner brought it to me, saying that it would not allow him to reach the club's repeater at 147.180MHz. He and I, several weeks prior, had spent some time noodling around with the radio for the same complaint, and I found then that it worked quite well in simplex mode, and that when I entered the correct CTCSS frequency and set the radio for automatic repeater offset operation and proper squelch mode, it worked well on the repeater as well. I told him to go through the programming of the radio and at that point I believed that the problem was resolved.

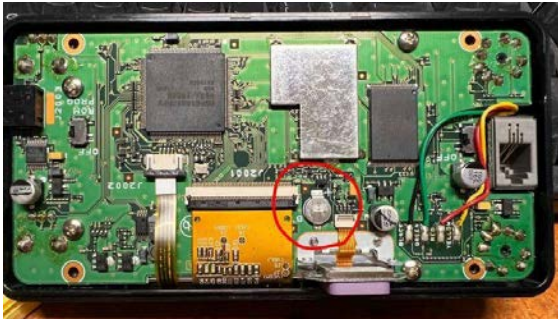
Figure 2 - Front panel coin cell location

Investigation of the radio service manual showed that the radio actually uses two batteries, which are actually coin cells – one each in the Front Panel module (Figure 2) and the Main module (Figure 3). In both locations, the cell is an industry standard ML614R-TT31 cell carrying a Yaesu replacement part number of Q9000895. This is a lithium-ion secondary cell with a 3.0V 2.5mAh

expired at the time of installation. It is not unreasonable to find these cells to be failing at three years of radio life. Upon opening the radio's Main module and measuring the mainboard cell, I found it to be at 2.58V. Next, I opened up the Front Panel module and measured that cell. The Front Panel module cell measured out at a very low 0.612V. It was obvious at this point that replacement of both of the cells was necessary, so I ordered them in. As it turned out, even though the FTM-400 uses two of these cells, Yaesu's USA service center *Standard Horizon* stocks only one of these cells. They get \$1.49 for each cell and about \$11.00 for the shipping, and said that the second cell would have to come from Asia and would entail additional shipping charges. Instead, I ordered a set of ten cells from an Asian supplier at a reasonable cost and with less than a two-dollar shipping fee. The only rub is that the cells, ordered in the middle of May, are not projected to arrive until almost the end of July, about the same lead time that Yaesu had offered.

OK – the batteries – or cells, to be more accurate – have arrived and have been installed. Now the voltages measured are as follows: 2.98V on the mainboard, and 3.02V on the front panel board. Hopefully, this repair will keep the memories in this radio operational for several years. These cells are lithium-ion secondary cells, which are rechargeable, and they do receive a charging current during radio operation. However, there is a finite limit to the number of discharge/charge cycles which the battery can experience before it will fail to accept additional

Replacement of the cells was straight-forward. I used my SMT soldering tweezer to heat both tabs of each original cell at the same time, simply lifting the cell clear once the solder flowed. The soldering tweezer was *not* used to install the new cell, as I did not want to place a short across a new cell. I simply placed each cell into its proper position onto the pre-tinned pads on its respective board, and then soldered it in place with my pencil iron. To simplify the installation, I pre-tinned the solder tabs and the PCB pads before placing the cells on their boards. Having done that, the final step was a simple reflow of the tinning solder.
