# At the Repair Bench - Yaesu FTM-7250DR – Special Report

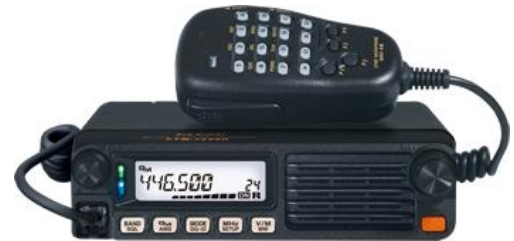
Figure 1 – Yaesu FTM-7250DR

A fellow GCARC Club member brought me a radio for repair, due to a failure of the radio to output an RF signal. When I placed the radio on the bench and powered it up, I immediately noticed an additional problem, one of which the owner was unaware. So started the odyssey of the Yaesu FTM-7250DR 2-band mobile transceiver.

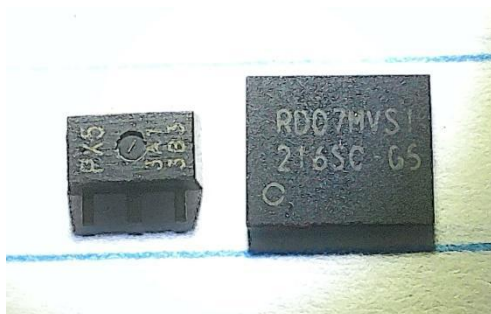
Figure 2 - Q1075 (L) and Q1101 (R)

I went ahead and began the power output testing of this radio, and I found some considerable problems in the output amplifier chain. This radio uses a three-part amplification chain for the RF output. We start with transistor Q1075, which is a RQA0004PXDQS, a high-output, high-efficiency enhancement-mode silicon N-channel power MOSFET manufactured by Renesas. That transistor is called the “pre-driver” transistor. Its output is directed into the driver transistor Q1101, a Mitsubishi RD07MVS1-T512 device, which happens to be a non-polarized 7-watt silicon power MOSFET. Finally, the output of Q1101 is directed into Q1150, another Mitsubishi transistor, this time an RD70HUF2-T5105 dual enhancement-mode N-channel power MOSFET rated at 70 watts. This device is used as the final power amplifier.

Injected RF signals failed to pass any of these three semiconductor devices with any appreciable amplification. Most of the operating voltages were at or near their normal levels, except that both the TXV9V+ and TXU9V+ transmit voltages were slow to rise to their nine-volt levels when the mic was keyed. These two voltages are key in operating the final amplifier in either the VHF (TXV9V+) mode or the UHF (TXU9V+) mode. Not finding anything else of concern in the radio, I decided to remove these three transistors and replace them. It was evident that none of the three devices was amplifying the RF signals fed directly into them, so that was the obvious move.

for the new components when they arrived. I started out the whole project by doing a close-up inspection of the PCB, as it was evident that there had been some localized heat on the board, particularly in the areas of the pre-driver and driver transistors. I found that some small components were completely missing, while others were displaced on the board. For example, in the immediate vicinity of the pre-driver transistor Q1075, capacitor C1103 and resistor R1103 were both gone. Inductor L1101, resistor R1101, and inductor L1102 were displaced a short distance from their proper locations.

The next transistor installed was the driver, Q1101. This one was soldered in using the fine-tip pencil iron and hair-thin rosin-core solder, but with plenty of additional liquid flux applied to the board. The transistor went in with no problem, which was a relief, as this was the one with the repaired board damage. A bit of a clean-up of the flux, and I was done until the rest of the parts came in.

When the Q1075 pre-driver transistor finally arrived from Great Britain, it was time to install it. That was also done using the fine-tip pencil iron and the thin solder. In this case, however, there were actual gull-wing leads on one side of the transistor and a tab on the other side, so it was a much easier install job. Of course, “easier” is a relative term. When it is understood that the overall width of this transistor is 0.150” (3.81mm) and the lead pitch is 0.050”, “easy” takes on a new meaning. What made this particular transistor install somewhat simpler is the fact that the transistor has a tab on the one side. That meant that I could tin the pad where the tab would seat, place the transistor on the tinned pad, and heat it to secure it. Once the transistor could not move around, soldering the fine leads got much easier.
