# At the Repair Bench – Yaesu G-2700 – December 2024

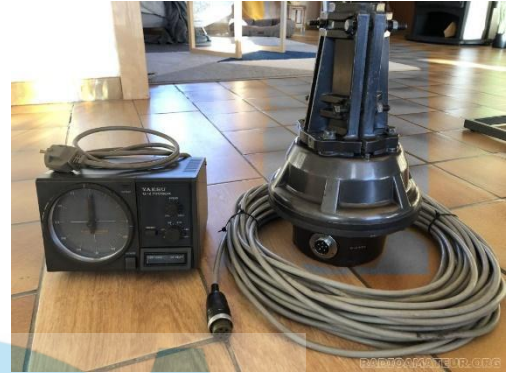
Figure 1 - Yaesu G-2700XDS rotator system

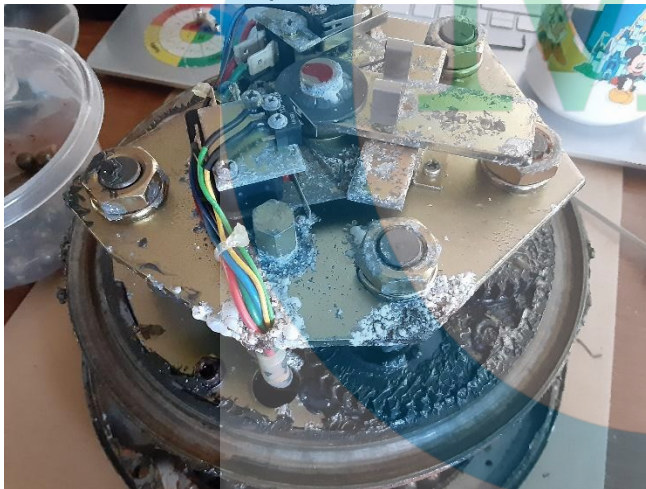
Figure 2 - Condition of motion unit

When I opened up this particular motion unit, I found plenty of indication of water entry into the housing, in the form of heavy corrosion on most of the internal parts (Figure 2). This included the stamped steel gear that drives the shaft that in turn drives quill gear that drives the potentiometer gear (Figure 3). In this illustration, it is quite difficult to see the drive gear – note the set-screw in the gear hub and then move out from there. The drive gear is the piece with all of the red corrosion on it.

I spent a lot of time cleaning the corrosion and contaminated lubricant out of the motion unit. The two rows of ball bearings required special attention as they had fine coatings of rust on many of the balls. The ball tracks in the housing halves were thoroughly cleaned, as was the remainder of the motion unit gearing and motor assembly.

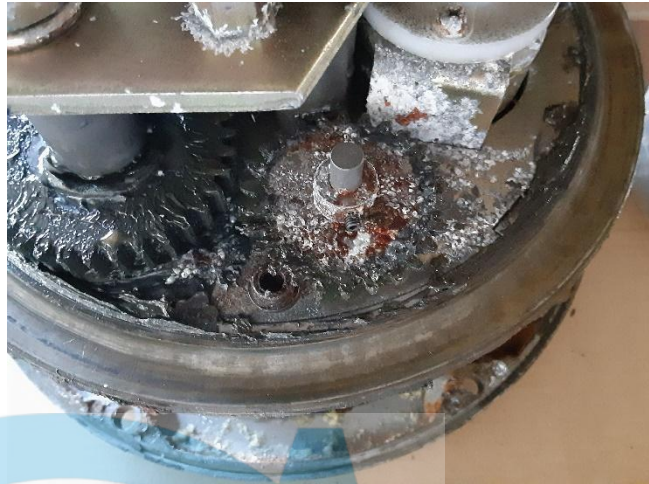
*Figure 3 - Condition of potentiometer drive gear*

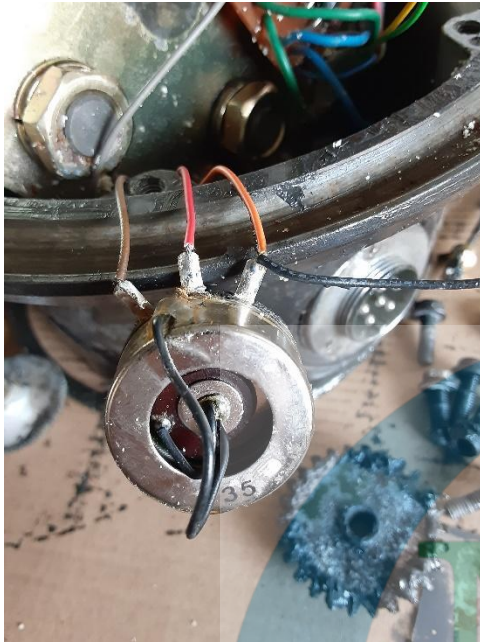
*Figure 4 - Potentiometer dismounted*

I thought that it might just be a matter of replacing the potentiometer with a new one, but as it turned out, the seizure of the potentiometer caused damage to the hub of the gear. To start with, the gear hub, which like the gear is made of nylon, had fractured longitudinally along the length of the hub, in two diametrically-opposed locations. This meant that tightening the set-screw would not secure the gear to the potentiometer shaft, but would only serve to spread the fractures wider apart. I cured this by first cleaning the hub thoroughly with residue-free solvents. Then, I did some plastic-welding of the cracks in the hub, using the soldering iron. Finally, using some safety wire, I made a couple of wraps of wire around the hub and then twisted the ends tight, so as to form a clamp around the hub. This clamp would keep the hub from spreading as the set-screw was tightened.

The second manner in which the gear hub was damaged was that the hub bore was badly worn on the side opposite the set-screw. This is an apparent result of the gear rotating on the potentiometer shaft rather than turning the shaft. In any event, this wear caused the gear to be pulled off-square when the set-screw was tightened on the new

I removed the cap screws that secure the motor mounting plate to the housing, and lifted the motor unit up and out so as to get to the potentiometer and gear. Next, I removed the stamped steel drive gear and the drive shaft by loosening the set-screw in the small quill gear at the lower end of the drive shaft. Once the shaft was out, I could remove that quill gear and had an isolated potentiometer and its drive gear. A quick check of the potentiometer gear for the ability to rotate showed that the potentiometer was seized. It only took a couple of minutes to remove the potentiometer gear and then the potentiometer itself from the unit (Figure 4).

potentiometer, leaving the gear to “wobble” on the shaft and causing changes in its mesh with the quill gear. I resolved this issue by building up the potentiometer shaft slightly, using two different lengths of copper tape applied to the potentiometer shaft opposite the point where the set-screw would touch the shaft. I first laid down a slightly longer strip of copper tape, and then applied a somewhat shorter length at the direct opposite point from the set-screw. This tape took up the slack in the bore of the gear hub, causing the gear to tighten securely and as squarely as possible,

The leads for the potentiometer were very short, making it extremely difficult to manipulate or maneuver the potentiometer in the housing to any extent. To aid in the installation of the new potentiometer, I extended the three leads, using 22AWG stranded wire of the same colors, and covering the soldered splices with heat-shrink tube insulation. When replacing this potentiometer, be sure to place the mylar sheet back in place under the body of the potentiometer, as it serves to ensure that there is no shorting of the potentiometer leads to the frame of the motion unit. I added four inches of wire to each lead.

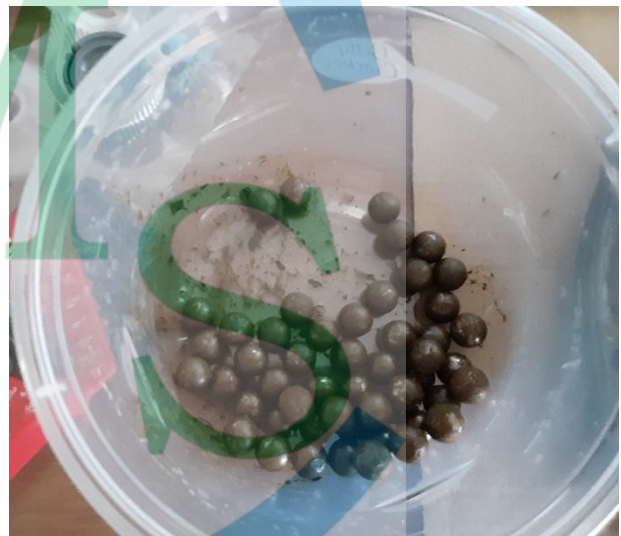
*Figure 5 - Condition of replaced ball bearings*

Next, I reassembled the potentiometer and its drive system, positioning the potentiometer at the midpoint of its rotational range. I then lubricated the ball tracks and installed the cleaned ball bearings, replacing those that merited replacement. The balls were coated with lubricant as they were installed into their tracks, and then the installed row of balls had some additional lubricant applied to them for good measure. The lubricating grease on these ball bearings is the only water barrier present on this motion unit, so it is important to have adequate coverage of the lubricating grease on these ball bearings.
