# Zenith R723 (Chassis 7H04Z2)

## AM/FM Table Radio Refurb

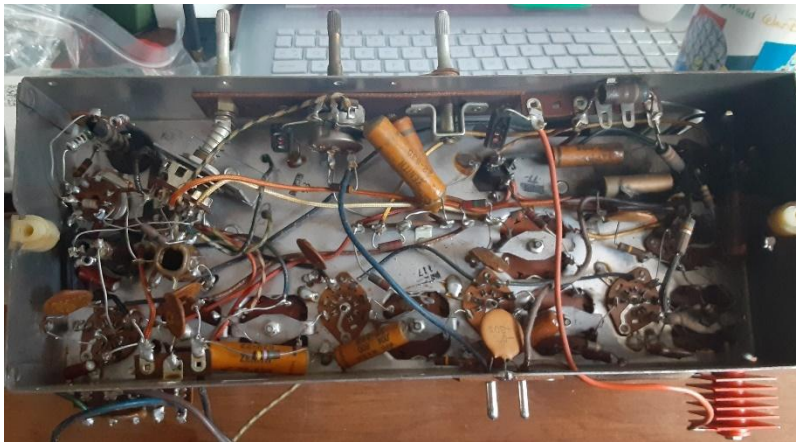
*Figure 2 - Under-chassis view before repairs*

Upon removal of the chassis from the cabinet, several things were immediately apparent. There were failed components evident in several locations throughout the under-chassis. The failures were so widespread that it was hard to understand how this set received any stations at

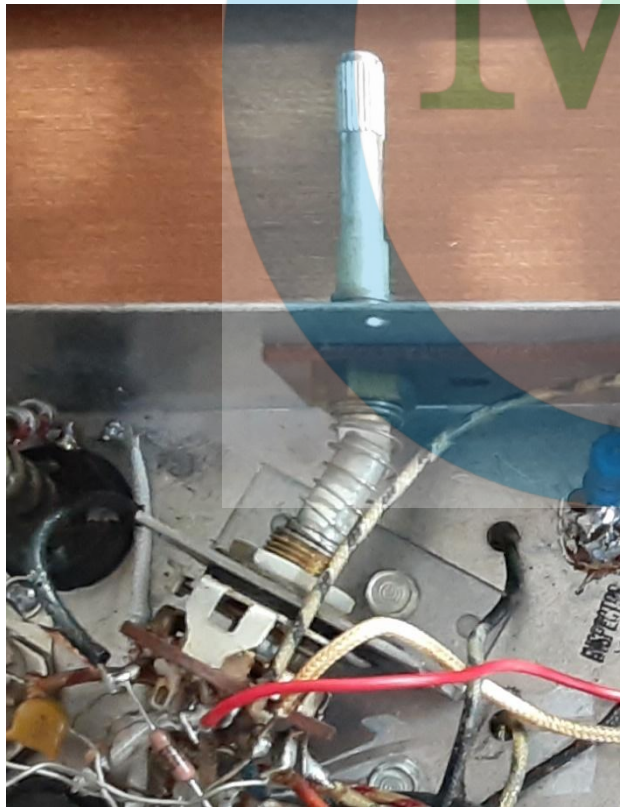
Figure 5 -Band switch arrangement

A very unusual methodology is evident in the band switch mechanism. In this chassis, the band switch is situated at an angle to the front of the chassis proper, and a flex joint is used to transmit the rotation of the knob and shaft to the switch itself. This can be seen in the photos of the chassis, and I am hard put to figure a reason for this complicated system. It is possible that it was done to keep lead lengths at a minimum in that portion of the circuit, but the same could have been accomplished without the need for an angle-drive switch shaft. The flex joint consists of a short knob shaft with a flatted end, which in turn fits into a slot in the switch shaft. The junction of these two shafts is enclosed inside the tubular structure of a coil spring, which keeps the shafts from disengaging. The switch itself is a six-pole/two-throw rotary type, mounted to an angle bracket secured to the underside of the chassis top surface. Switch rotation is about 30° between the two band positions.

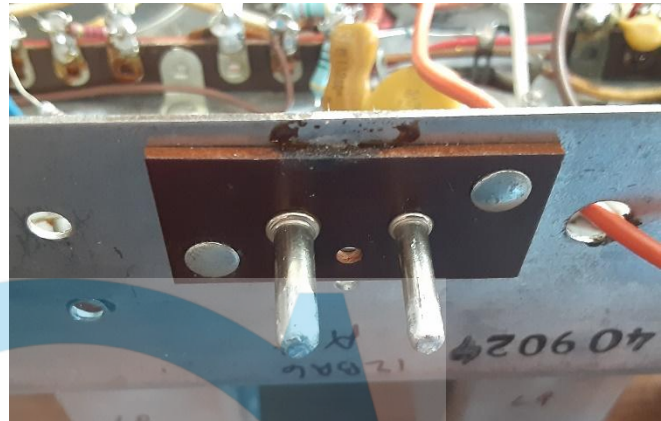
Figure 6 - Interlock pins, clearly showing size difference that indicates polarization was intended

This radio has one side of the incoming AC power tied directly to chassis ground via the power switch. The power cord on this radio, as presented for repair, had a lever-type replacement plug installed to it, which was a non-polarized plug. This sets up a potentially unsafe condition in which the line side could be connected to chassis rather than the neutral side being connected there. The radio uses a rear-panel disconnecting interlock that breaks incoming power from the chassis when the rear panel is removed, and it clearly is polarized in that it utilizes two different diameter pins as its inter-connecting features. This indicates that the manufacturer intended for polarization to

exist and to be carried through into the set. For that reason, one of the first items slated for replacement was the power cord, so that a cord with a proper molded and polarized plug could be installed.

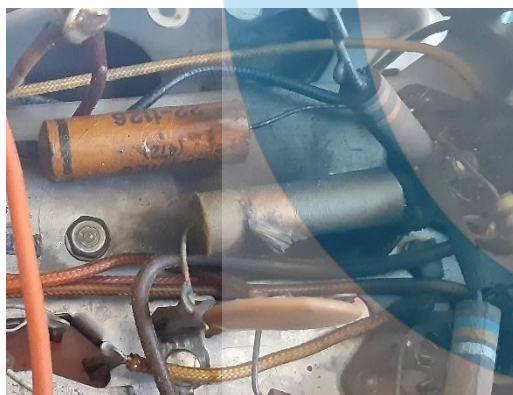
Figure 7 - Exploded tubular wax-and-paper capacitor – note blackened chassis under capacitor

Several capacitors had fractured, and one of the standard ceramic discs had evidently been replaced at some point with a spark-gap type of disc capacitor. One of the tubular paper and wax capacitors had exploded. The two-section can-type filter capacitor had expressed electrolyte through its lower seal. There were resistors that had broken off their leads or lead connections, and one tube socket had a broken pin connector tab, which showed evidence of arcing. One mica capacitor had a broken lead right at the body of the capacitor. The wax coatings on all of the capacitors so equipped, both tubular and disc, had melted mostly off, leaving wax puddles in the chassis lower shield tray. This was evidentiary of high heat inside the chassis at some point in time.

I decided that all of the resistors and all of the tubular and disc capacitors were to be replaced. In addition, two of the mica capacitors warranted replacement, one for its broken lead, and the other for a crack in the capacitor body. The dual capacitor across the incoming power connection was also to be replaced by a pair of 0.01μF X1-440V/Y2-300V safety capacitors.

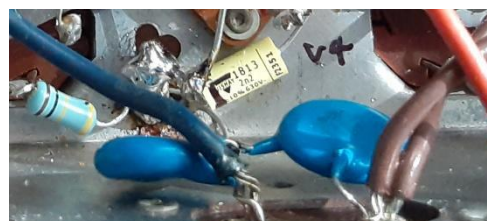
Figure 9 - Safety capacitors installed at power entry point

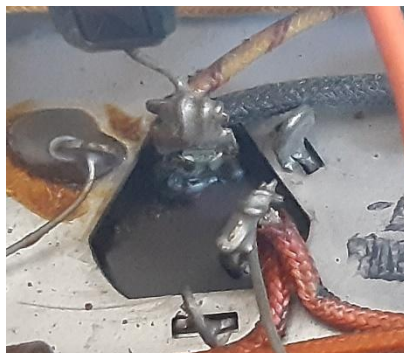
One situation where the component size did not change was in the replacement of the can-type dual filter capacitor. The original component was a two-section 80 $\mu$ F■/40 $\mu$ F▲ three-tab capacitor with a one-inch diameter and three-inch length. I had absolutely no success in locating an exact replacement for this part. Note that the geometrics after the values above are standard indicators used on filter capacitors to

Figure 12 - Electrolyte leaking from filter capacitor

Replacement of the filter capacitor was straightforward after de-soldering the twist tab from the chassis, which required the use of my 140-watt Weller soldering gun, as the chassis purely sucked up the heat. The new capacitor, being of the same form factor, fit in perfectly, and I then used buss wire to connect two of the three separate 40 $\mu$ F sections into a parallel combination to yield the desired 80 $\mu$ F capacitance for the first (■) section. The remaining (third) 40 $\mu$ F section stood as the second (▲) section of the working capacitor.

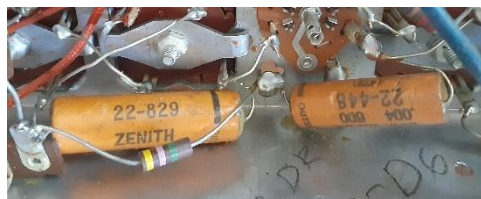
Figure 13 - Wax-and-paper capacitors with "outside foil end" marked

An interesting note here is the placement of the tubular wax-and-paper capacitors in the chassis, specifically as regards the stripe on one end of each of the tubular capacitor bodies. Back in an earlier era, it was commonplace for capacitor manufacturers to identify one end of a non-polarized capacitor with a stripe or other prominent marking, often adding the adjacent label "outside foil end" to the body of the capacitor. This end of the capacitor was normally connected to the lowest-impedance side of the circuit in which the capacitor was installed. The capacitor body would often serve as both an antenna, picking up nearby RF, and as a shield, shunting that RF off to ground. Equipment manufacturers relied upon that marking as an aid in the assembly process, so that they could properly place the capacitor in such a manner that it would in fact act as that shunt path. This was done as a means of reducing hum pickup and passage within the radio, and it was quite effective. Installing one of these capacitors in the opposite direction would often cause considerable hum to be present in the delivered audio.

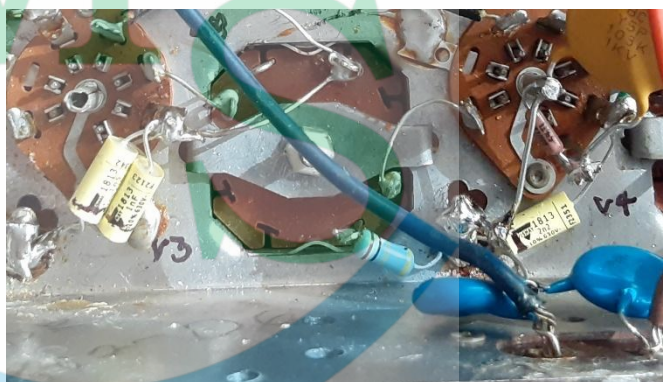
Figure 14 - Replacement capacitors with my markings on outside foil end – note the three tubular capacitors installed in parallel to achieve desired value (at left side)

foil end? It just so happens that a while back, I built an instrument whose sole purpose is to locate and identify the outside foil end of a capacitor. A device with a similar function can be seen online at [https://www.youtube.com/watch?v=BnR\\_DLd1PDI&t=972s](https://www.youtube.com/watch?v=BnR_DLd1PDI&t=972s). There are several follow-on videos to that one, with increasing complexity and utility, but I will leave it to the reader to explore that detail. In any event, I my newly-arrived non-polarized film capacitors and, using my device, identify and mark the outside foil end of each capacitor. It takes just a few seconds for each capacitor, but it pays definite benefits in performance later, when using those components in repairs. Once identified, I simply make a stripe around the outside foil end with a Sharpie® marker. The capacitor end

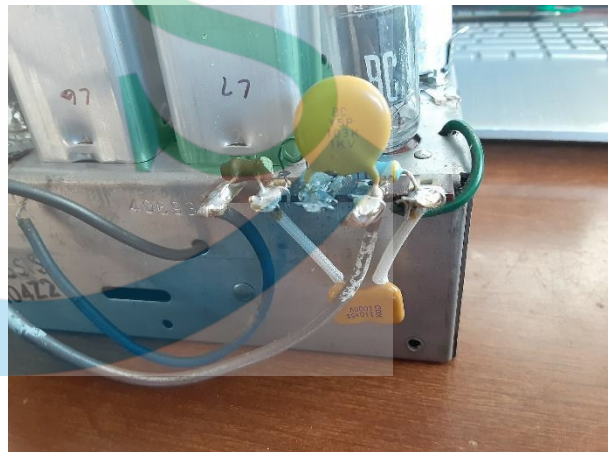
Figure 19 - Signal input area of chassis

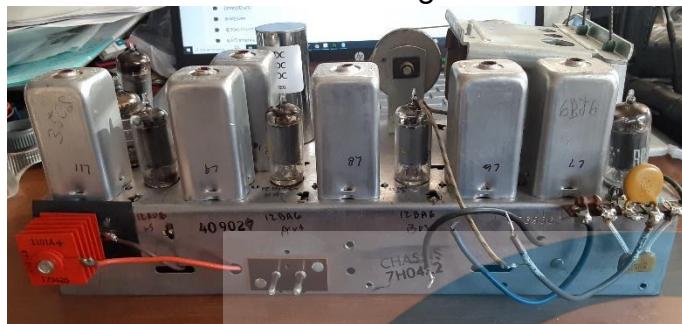
Figure 21 - Chassis rear view - note handwritten markings by various technicians, as well as factory stamps

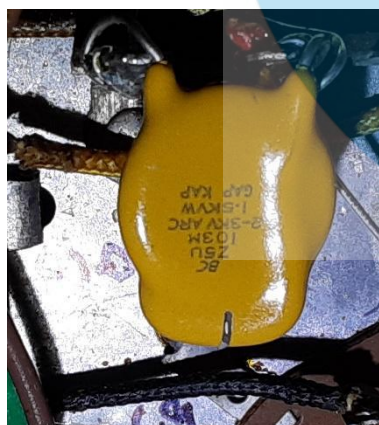
Figure 22 - Spark-gap capacitor

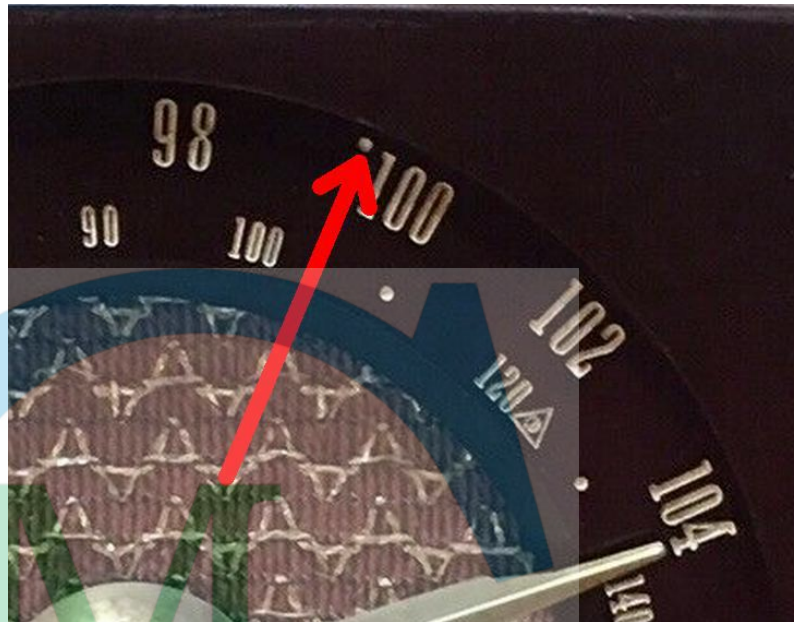
*Figure 23 - Close-up of dial section showing the 99.5MHz WEFM locator dot on the dial.*

do the dials on many Zenith radios, also has a small dot just below (to the left of) the 100MHz location on the FM dial. This was to pinpoint the 99.5MHz dial position of a Zenith corporate broadcast FM station, WEFM of Chicago. The company-owned and operated station's call sign reflected the initials of the then chief executive of the company, one *Commander E.F. McDonald*.
