## At the Repair Bench – Ameco PT Pre-amp – June 2025

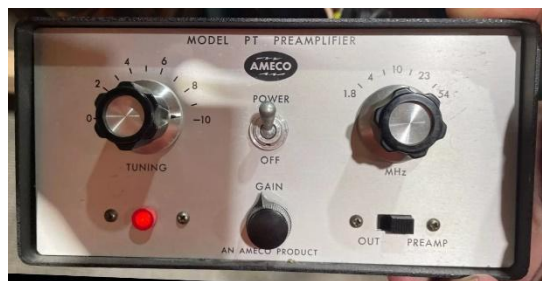
Figure 1 - Ameco PT Preamplifier

Recently, Club Member **Darrell Neron AB2E** brought to me for repair an old tube-type preamplifier unit known as an Ameco PT Preamplifier (Figure 1), which, at the time it was made, was a product of the Aerotron company. This was the first of a series of different preamplifier models manufactured under the Ameco nameplate.

The problem with this one was that it would shut down as soon as the preamplifier circuit was energized, but it would function OK in bypass mode. Now, this unit is a very simple circuit, utilizing a single 6EH7 vacuum tube as the amplifying element. It also uses an older design dual filter capacitor, which had two 20 $\mu$ F 150V electrolytics in a single axial component (Figure 2). That was a common methodology in the past, in which the capacitor would have a single lead off the negative end, and two leads off the positive end, one for each section of the capacitor. These were so-called “dry” electrolytics, which used a solid electrolyte rather than a liquid or paste-style compound.

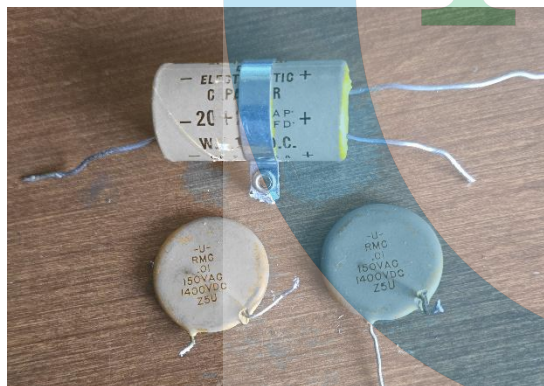
Figure 2 - Removed capacitors

I decided to test the dual filter capacitor for leakage, first in-circuit, which led to failed tests. I then tested the unit out-of-circuit, and once again found that both capacitors in the device had failed in a very leaky condition.

I used my homebrewed capacitor leakage tester for testing the electrolytics, and it showed exactly what I thought that it might, what with the age of the dual capacitor. Needless to say, I replaced the dual capacitor with a pair of modern 20 $\mu$ F 150V axial-type electrolytics. After installation of the capacitors (Figure 3), the unit powered up and remained operational even in the pre-amp active mode of operation.

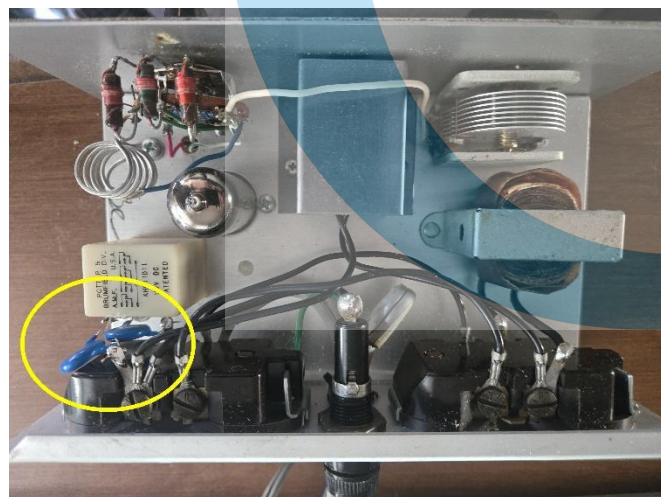
Figure 4 - Chassis top side - note blue safety capacitors

typically use are 0.01μF X1-440V/Y2-300V ±20% Y5V-type ceramic disc safety capacitors. The capacitors originally installed in the Ameco PT Preamplifier were 0.01μF 150VAC/1400VDC Z5U-type ceramic discs, and there were as already mentioned two of them, connected in the “Y” configuration from each of the AC line leads to chassis ground. As these capacitors are not safety types, and are therefore just as likely to fail shorted as they are to fail open, they needed to go.

Once the new safety capacitors were installed (Figure 4), the unit was tested for proper operation one more time, and then the job was considered finished. I put the cover back onto the chassis and tied up the connected cables for return to Darrell.
