## At the Repair Bench – MFJ-259/269 Series – July 2025

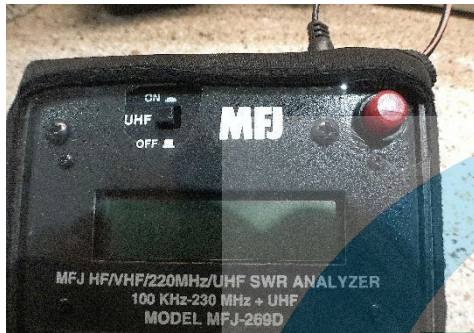
Figure 2 – The infamous pushbuttons

Starting again with the cover, it was disturbing to discover that no provision had been made in the plastic film for the power switch actuator pushbutton. This meant that I had to first install the cover and mark where to make a hole, then remove the cover and cut the required hole in its marked location. In addition, this model also has a latching pushbutton switch used to select either the “UHF LO” or the “UHF HI” frequency range

when working with UHF frequencies. This switch too required the marking of a location and then the cutting of a hole at that location so as to be able to comfortably operate the switch (Figure 2).

Once again going back to the power switch, the switch actuator on this model differs from that on the MFJ-259D in that it is a physically longer actuator, meaning that it sits considerably further out from the ring that surrounds the switch opening on the instrument front panel. This additional length also means that in its “ON” position, the actuator cap is still proud of the surrounding ring. Thus, it is very easy to inadvertently bump this switch and turn it “ON” without the user being aware that it has happened.
