## At the Repair Bench – Baofeng BF-F8HP – November 2025

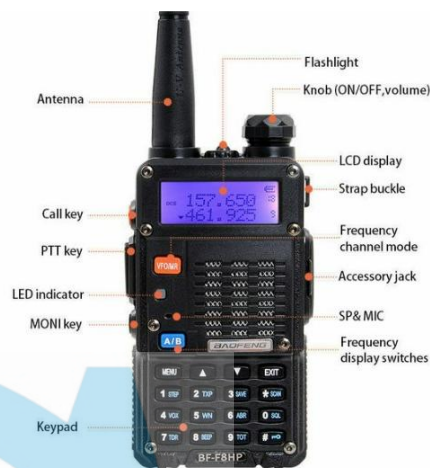
Figure 1 - Baofeng BF-F8HP

Not very long ago, one of our fellow Club members had come to me with a radio that held some particular nostalgic value for him, as it was the first amateur-band radio he had ever owned. The problem was that the radio apparently had no TX audio output, though it showed full output power when transmitting. The problem was that no modulated audio was passed through in the resulting transmission.

My initial thought, after asking him if the radio had ever been dropped and getting an affirmative reply, was to look at the microphone solder joints where it is mounted to the mainboard in the radio. I disassembled the radio and carefully inspected, then tested, the microphone solder points, to find that it was OK, and that the problem was apparently elsewhere. I then had a bright idea, and decided to test the radio in transmit mode using an appropriate headset plugged into the K-1 jack pair on the side of the radio. Lo and behold, the audio came through in the transmission just fine when a headset was used, but not without one. That told me that the problem was most likely either a bad solder joint at one of the two jacks, or a failed switch within the mic jack. The owner decided that he wanted to repair the radio, so I took it to my shop for repair.

This was an extremely simple repair, especially because I had the correct parts on hand. I should point out that I had originally considered using a pair of jacks from a “dead” Baofeng BF-F8HP that was given to me for parts. However, this particular radio, a very early version of this model, used a different jack setup with round pins in a slightly different pattern than that of the subject radio. I think that I actually came across that before, which is why I had the correct jacks in stock. Due to their age and the fact that they are used as a pair, both connected and disconnected simultaneously, I decided to replace both jacks. Needless to say, post-repair the radio worked flawlessly.
