## At the Repair Bench – Conar 231 Tuned Signal Tracer – April 2024

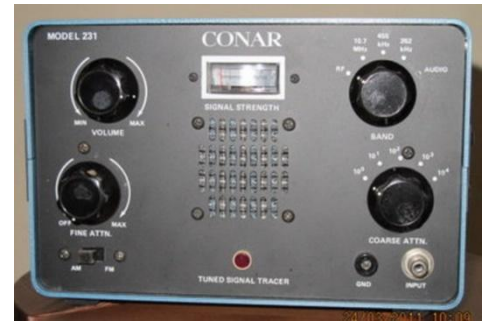
Figure 1 - Conar 231 Tuned Signal Tracer

The unit came in to my shop as an inoperative piece of equipment that was also missing its test probe and ground connector. Those two items are actually the subject of one of my build articles previously published at this point, as I designed and built a replacement active amplifying probe with the high input impedance necessary to avoid loading of the circuit under test and therefore obtaining undistorted waveform samples. The subject of *this* article is the actual repair of the Conar 231 main unit.

All in all, a fairly easy repair, though there were multiple failures to be tracked down and corrected. The moral of this story is that it's not done until it is *all* done. I packed the unit up together with the new probe and ground lead that I had fabricated, and shipped it back to its owner.

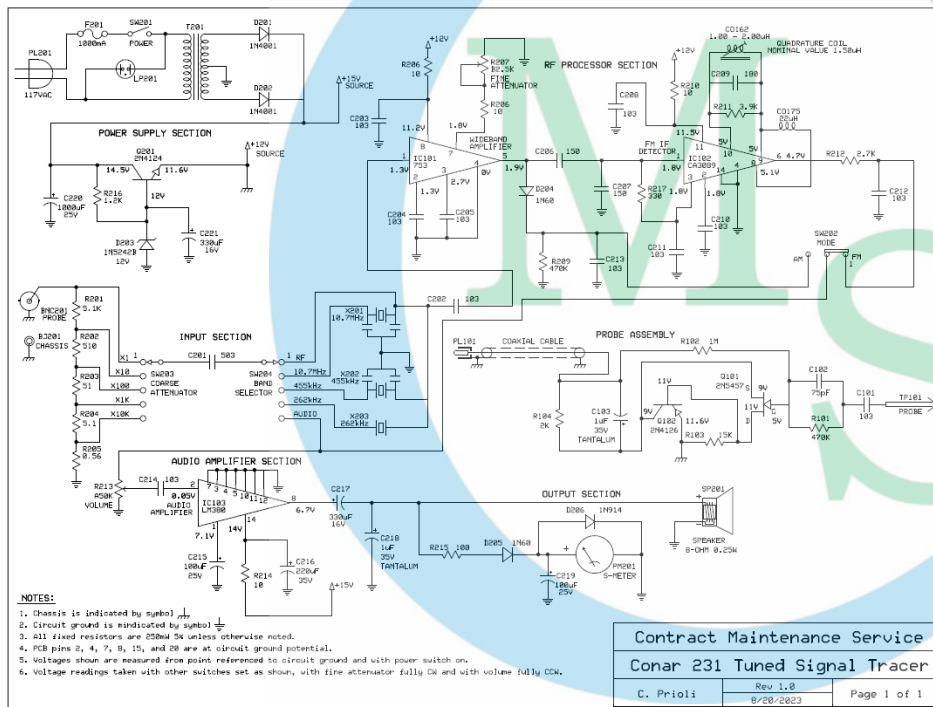
Figure 2 - Conar 231 schematic diagram

repairing the defect. The Model 231 also provides two untuned input selections, an RF option and an AUDIO option. The unit schematic is shown in Figure 2. This schematic was derived from the unit itself and was drawn in the *ExpressSchematic* software that I like to use.

With three failed polarized capacitors in this unit so far, and considering the age of the unit and therefore its capacitors, I elected to go proactive and replace the remaining polarized capacitors, which included a pair of 100µF/25V axial electrolytics, a second 330µF/16V radial electrolytic, and a single 220µF/35V radial electrolytic. It was good repair practice to replace all of these capacitors based upon the rate of failure already seen and the overall age of the parts involved.
