## At the Repair Bench – Heathkit® IT-3121 Curve Tracer - February 2025

Figure 1 - Heathkit® IT-3121 Curve Tracer

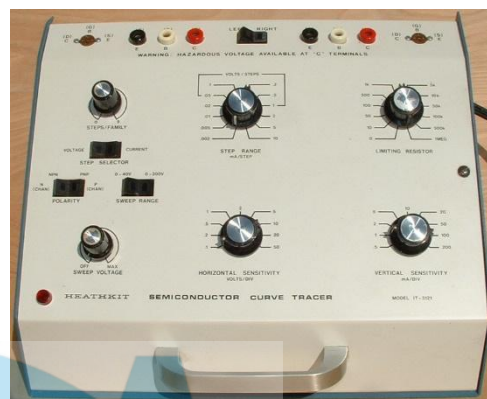
In the situation at hand, this was a piece of test apparatus that would not operate as intended. The specific complaint was that although the pilot light would illuminate, there was no output from this unit when connected to an oscilloscope.

With all of the capacitors replaced, I did a quick clean-up of the unit, and then I put it through some actual-use testing to verify its functionality. All was as it should have been, so I called this job “*done!*”
