## At the Repair Bench – Icom ID-4100A Shutdown – March 2023

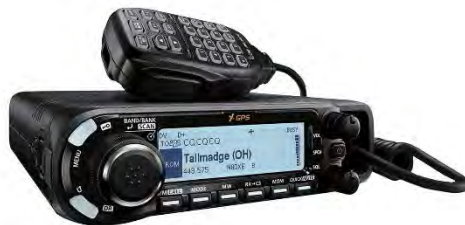
Figure 1 - Icom ID-4100A

I had been having occasional problems with my Icom ID-4100A (*Figure 1*) powering itself off, most often at the end of a transmission, but occasionally during receive operations. There was no rhyme or reason to when this would happen. It might happen twice during a net, or it might go several weeks without occurring. I was always able to restore the radio to operation by power-cycling the power supply, and I was therefore half convinced that the problem was internal to the radio, so I set about trying to locate the problem.
