# At the Repair Bench – MFJ-407D Keyer – October 2024

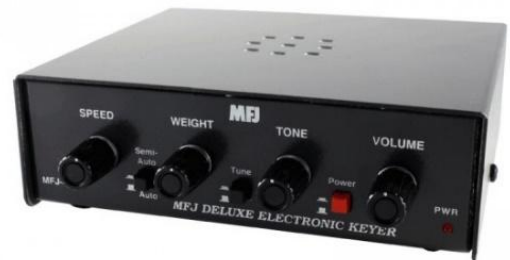
Figure 1 - MFJ-407D Electronic Keyer

Last month, I wrote about an Astron power supply unit that had come in for repair. The ham who owns the Astron brought an MFJ-407D Electronic Keyer (Figure 1) to me at the same time, with the complaint that the keyer had no keying output.

The customer suspected the output transistor, which did in fact turn out to have been in a failed condition. However, what the customer did not suspect is why the transistor had failed, nor were intermittent operation and power drop-outs mentioned at all. These two last conditions were conditions that I noted during test and repair operations. Of course, the unit would not be repaired until those problems were cured as well.

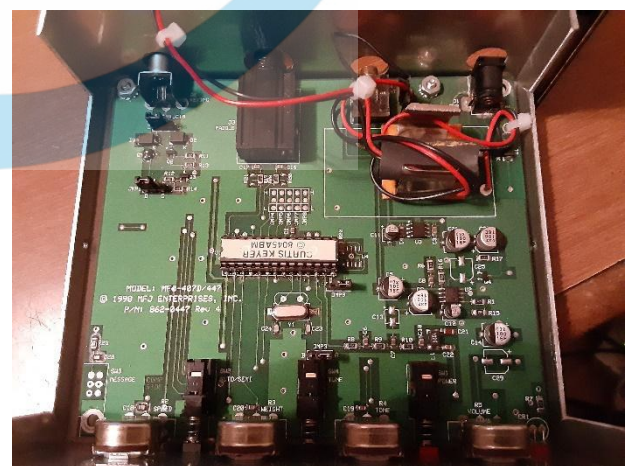
Figure 3 - MFJ-407D interior view

A short-circuit path had been formed at each of the pin headers between the D pin and the ground plane. The green corrosion formed there was conductive and led to a condition wherein both the gate and the drain of the MOSFET were shorted to ground. It is unclear exactly what the failure mechanism of the MOSFET was, but there is no doubt that it showed itself to be failed

I set out next to cure the intermittent problems that this unit exhibited. I noted that I could affect the intermittency by putting pressure on the board in various spots, which led me to look closely at all of the solder joints on the board. As this is largely a surface-mount construction, most of these joints were on the component side of the board. Ultimately, I found and repaired cold solder joints at the IC socket pin rows for the microcontroller ( $\mu$ C or  $\mu$ Controller), a PIC16C72 device (Figure 5). Reflowing the joints along this IC socket cured the intermittency problems that had existed. As it turned out, one of the indications of power drop-out that I mentioned earlier was the fact that

the front panel LED would intermittently go out. It happens that the LED ground is made through the  $\mu$ C, and that the LED's behavior was part of the larger cold solder joint intermittency issue.

when the transistor was tested under both in-circuit and out of circuit conditions. The corrosion was completely removed from the board and the cleaned areas were sealed with clear enamel.
