# At the Repair Bench – Plasma Lamp – November 2023

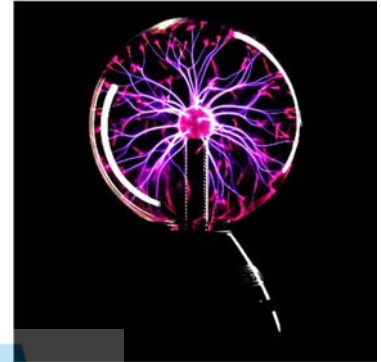
Don't get me wrong. The repair itself was relatively easy. It is just that this item is so far removed from my usual type of repair that I found it to be intriguing. The item was a plasma lamp (Figure 1), and it had just up and quit working.

Figure 1 - Operating plasma lamp
