# Yaesu G-5500 Rotator Controller Repair

Back at the end of September, we had a rather strange occurrence at the GCARC Clubhouse. One of our members was at the Satellite station and found that the AZ-EL rotator was inoperative. The controller for this rotator is the Yaesu G-5500 model as shown in Figure 1. A little bit of rudimentary troubleshooting led to the discovery that the power inlet fuse, a 2-ampere Type 3AG 1/4" x 1-1/4" glass fuse, had gone open. He attempted to replace the fuse, and ended up getting a shock and also blowing the new fuse as well. As that was the only spare fuse of that type on hand at the Clubhouse, I came back the next day prepared with a few of the correct fuses with me. At a first glance, we (**Frank Romeo N3PUU** and I) found that the motor output wires on the back of the controller, especially for the Azimuth output, were loose and had been shorting to each other and to the controller chassis. We made the decision to change the "wire under screw head" arrangement that existed to a more orderly system of wire terminals designed to be secured under screw heads. I installed a full set of such terminals on both the azimuth and the elevation (which also

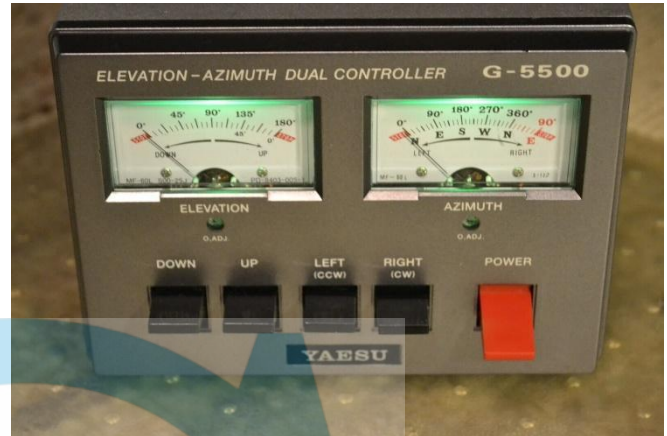
Figure 1 -- Yaesu G-5500 controller

Once again, the controller blew its fuse immediately. This showed conclusively that the problem was internal to the controller. I brought the controller to my shop for further investigation.

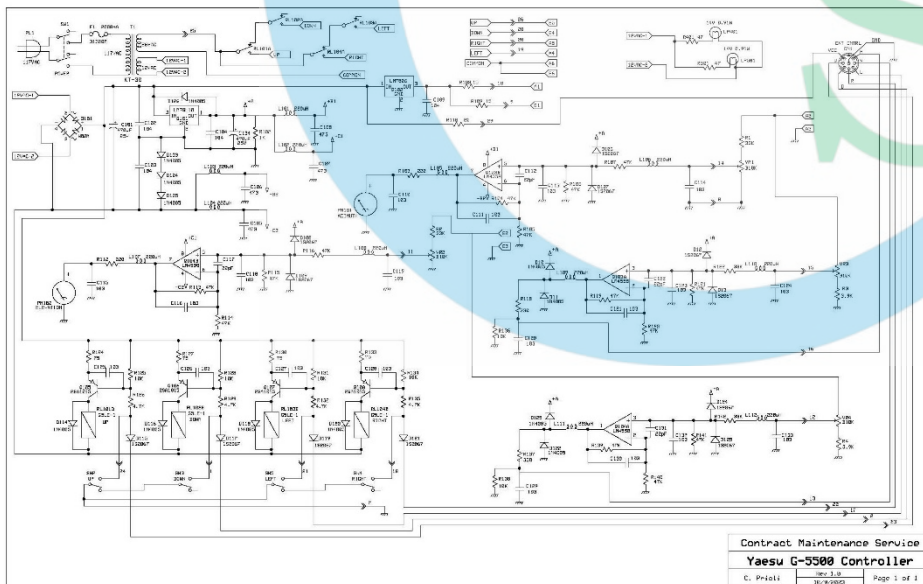
Figure 2 - G-5500 controller schematic diagram

One of the things that Frank and I had done was that we had taken a preliminary resistance measurement of the power transformer primary winding to see if we had a direct short circuit there, which we did not, though the resistance was very low at  $0.8\Omega$ . Not having any resistance specifications for the transformer windings, I did not want to condemn the transformer... yet... though we both suspected that the resistance reading obtained was too low. What I did instead was to disconnect the transformer secondary windings from their tie points into the controller circuitry, and then to try some substitution therapy. A quick look at the schematic (Figure 2) shows that the transformer has two secondary windings, with outputs of 12VAC and 26VAC respectively. The 26VAC output is

I replaced both of the voltage regulator IC's and the two 470 $\mu$ F capacitors on the board, and this restored full operation of the controller *when supplied by my bench power supply*, with the exception of the panel meter lamps, one of which was still burned out. My next job was to replace both of the panel meter lamps, going by the philosophy that they were of the same age and therefore the second one was likely to fail soon as well. That was a simple and straight-forward parts replacement job.

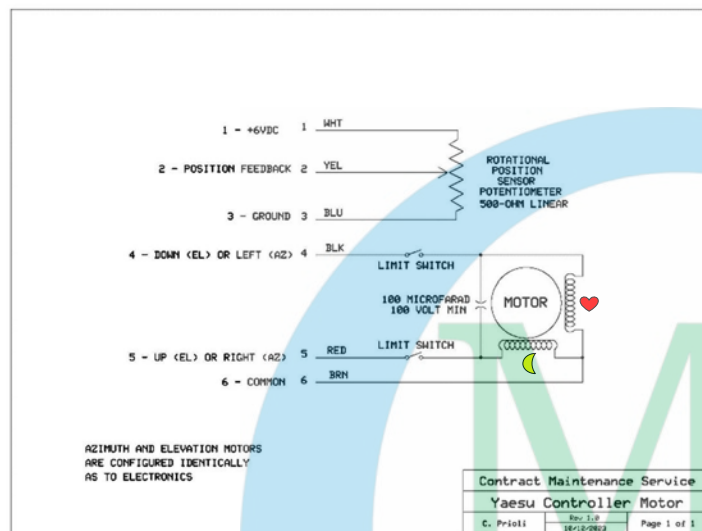
Figure 3 - Rotator motor electrical arrangement

accurately, with two motors with each motor having two separate windings. Figure 3 shows the electrical arrangement found in each of the rotator motors. The pair of windings in one motor changes the azimuth angle, while the pair of windings in the second motor changes the elevation angle. One winding of each pair produces motion in one direction, while the second winding provides the motion in the opposite direction. Let's call the motor windings AZ-forward and AZ-reverse, and EL-forward and EL-reverse. To move the antenna in the forward azimuth direction, we apply operating current to the AZ-forward winding in the azimuth motor. To move the antenna in the reverse elevation direction, we apply operating current to the EL-reverse winding in the elevation motor. In actuality, the windings are labeled as UP, DOWN, RIGHT, and LEFT, and each motor winding is controlled by a single relay that turns the current to that winding on or off. The 26VAC current flows through the relay contact sets, but the relay coils are controlled with current that is derived from the 12VAC secondary. Each axis of motion is equipped with a limit switch at each extreme of the motional range to cut off the motor current when the movement reaches the preset limit in that particular direction.

In reality, the directional control is a tad bit more complex than just one winding or the other, because in reality, *both* motor windings are energized when turning the motor in *either* direction. Refer to the Figure 3 diagram to follow along with this discussion. Let's assume that we are looking at the azimuth motor; the operation of the elevation motor is identical. When we want to swing the azimuth angle to the left, we engage the front panel switch marked "LEFT", which

causes a relay to close and pass the 26VAC out to pin #4 in the Figure 3 diagram. Pin #5 is open at the controller end, as it too goes through a set of relay contacts which are in their open condition. Pin #6 is the common current return lead for the motor and is active when the motor is turned in either direction. The current flowing from pin #4 into the motor goes into the winding with the “heart” next to it. At the same time, current also flows into the circuit branch with the capacitor, through the capacitor, and into the winding with the “moon” next to it. However, the capacitor causes a phase shift of 90° between these two currents, meaning that the two magnetic fields created in the motor are *not* unified and in phase, but that one field leads the other. The phase difference causes enough of a lag between the two fields that it can be used to “steer” the direction of rotation. The difference in the timing of the current flow through these two windings is what causes the rotator to move in that direction. If the current, on the other hand, is applied to pin #5, we have a slightly different condition. At this point, pin #4 is open at the controller end because the relay contact points for that lead are open. The current enters the winding labeled with the “moon” symbol and simultaneously flows into the capacitor in the opposite direction and into the “heart” winding, again setting up a magnetic field that is offset in phase from the field of the “moon” winding. This time, however, the offset magnetic fields cause the motor armature to rotate in the opposite direction. This technique is known as “split phase” directional control.

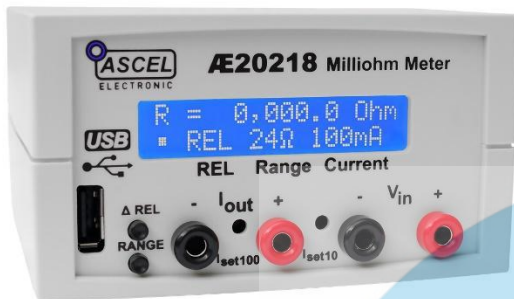
Figure 8 - Ascel AE20218 milli-ohmmeter

I said earlier that the Ascel AE20218 (Figure 8) is "quite accurate" in its results. This is partly due to the design of the meter itself, and partly due to the fact that it uses the Kelvin measurement technique, which removes all wire lead resistance from the reported results. In the case of a standard ohmmeter, the test meter leads are in-circuit and are therefore contributing their resistance to the reported value. The Kelvin system, which uses four test leads (Figure 9) instead of two and places a known and highly accurate current through the subject resistance, removes the resistance of the test leads from the equation. You can learn more about the Kelvin lead system by reading the explanatory article at <https://storage.googleapis.com/production-domaincom-v1-0-0/180/1603180/ZMb5Nhvj/25e8a371f25642848308d72e18779604?fileName=Kelvin%20Resistance%20Measurement%20Method.pdf>.

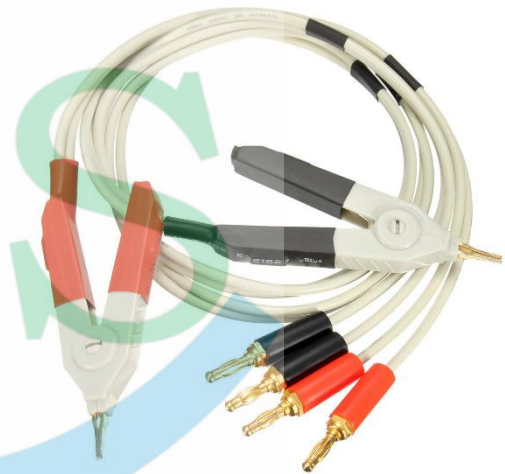
Figure 9 - Kelvin lead set for Ascel AE20218

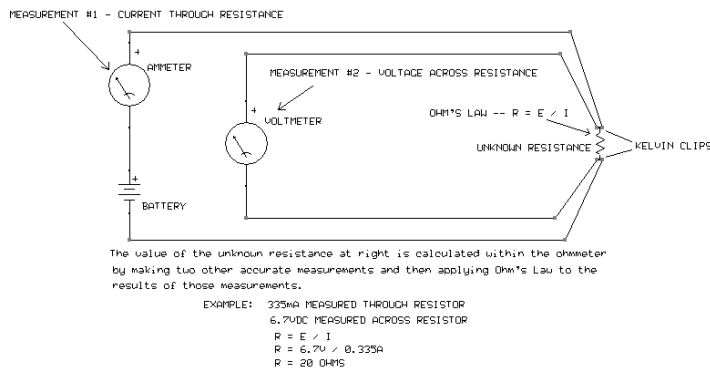
The graphic at Figure 10 illustrates the Kelvin four-wire resistance measurement system diagrammatically, providing an example of how the system works. While it is obvious that the wire leads used in making these measurements still have internal inherent resistance, that resistance is factored out by the fact that the voltmeter is connected in parallel and is a very high

Figure 10 - Kelvin resistance measurement
