## At the Repair Bench – MFJ-949 – October 2025

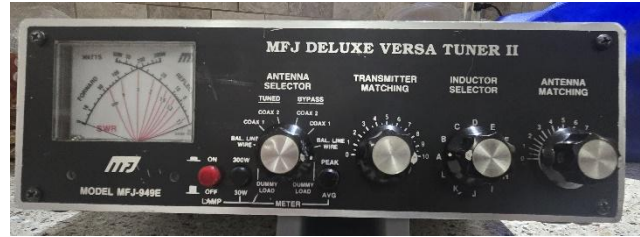
Figure 1 - MFJ-949 antenna tuner

I had noted that the inductor selector switch felt rather “mushy” when operated, and since that was what we were adjusting when we noticed the SWR excursions, I decided to start there. Of course, apart from the fact that the switch was loose in its mounting and the knob was incorrectly indexed, the switch itself was OK. I secured the switch properly in the front panel. As to the mis-indexed switch knob, that was a simple matter of placing the switch in its “A” position (selecting the highest tap on the coil) and then installing the knob with its pointer aligned with that “A” position marking on the front panel.

In a similar manner, both of the tuning capacitors were loosely mounted to the front panel. This was less noticeable because the capacitors do not have detents as the inductor switch has, but it was an annoyance nonetheless. I corrected that problem by once again tightening the securing shaft nuts – one on each capacitor – and then properly indexing the knobs to the front panel markings.
