## At the Repair Bench – MFJ-998RT – December 2025

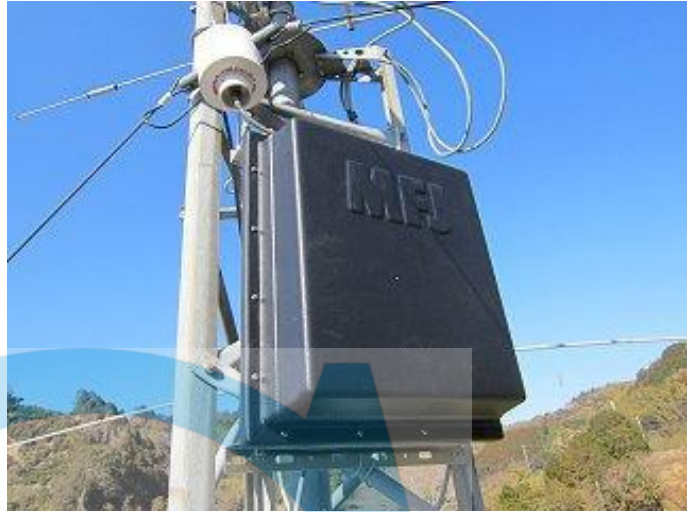
Figure 1 - MFJ-998RT installed on tower

Shortly before our 2025 HamFest, I received a communication from a gentleman located in Dover, Delaware who had some questions for me regarding his remote HF station and some problems he was currently experiencing. His system incorporates an Icom IC-7300, and MFJ-998RT auto-tuner, and a BLA-350 linear amplifier. His problem was that the BLA-350 was dropping out on transmission due to a loss of input signal at the appropriate frequency. He described an earlier failure that he had attempted to repair. That failure was the annihilation of an RF hash choke at the signal input stage of the MFJ-998RT auto-tuner. After talking it through for a bit, we decided that the auto-tuner was the heart of his ongoing difficulties, and that he should bring it to me for repairs. He did so after the HamFest on that rainy Sunday afternoon.
