## At the Repair Bench – Icom IC-746 PRO – May 2026

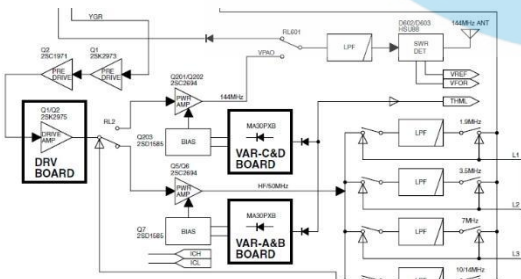
Figure 2 - IC-746 PRO block diagram excerpt

The Icom IC-746 PRO uses an MMIC identified as IC151, a  $\mu$ PC1678G amplifier known as the YGR amplifier to prepare the RF signal for handling by the PA board. On the PA board, the YGR RF signal passes through a 2SK2973 N-channel enhancement-mode MOSFET pre-driver and then through a 2SC1971 pre-driver before going into the push-pull combination of two 2SK2975 MOSFETs that serve as the output driver. After that, the RF signal path splits, depending upon the frequency selected. The HF and 50MHz path goes through one push-pull pair of 2SC2694 transistors, while the 144MHz signal path is passed through a second push-pull pair of 2SC2694 devices. Thus, there are actually four “final” transistors in this unit. For each “final” pair, bias control is handled by a separate 2SD1585 transistor. All of this can be seen in the block diagram excerpt in Figure 2.

The RF signal into the power amplifier (PA) section was normal, so there was no problem with signal genesis. That left the PA as a possible problem location. Moving on to voltage tests throughout the PA section, I found that all of the transistor operating voltages were within normal limits, though both of the bias voltage values were a bit low. Tracing of the RF signal through the PA showed respectable gain at
